CK-2273

STAVE RIVER 30.9km

2016 Inspection

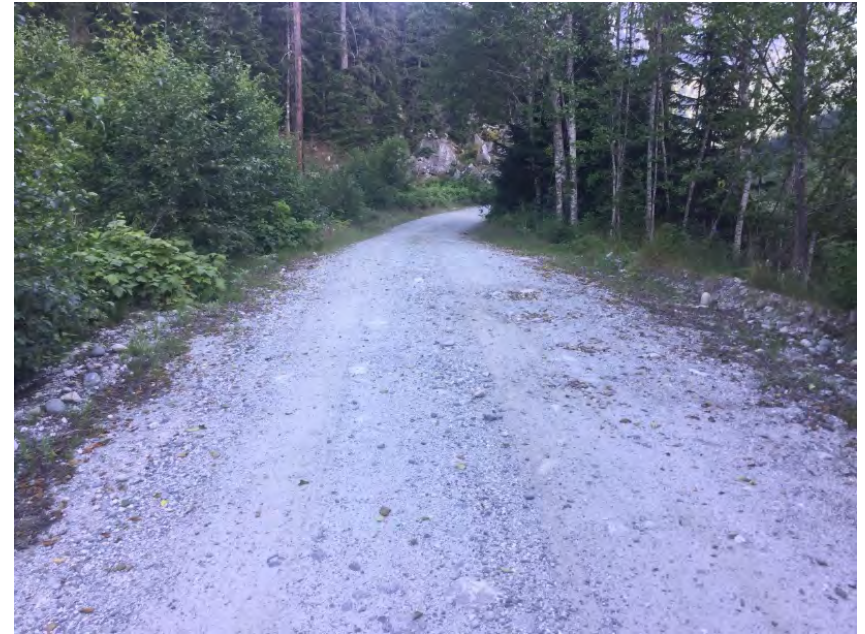
Roadway Over Culvert

Potholes in roadway.

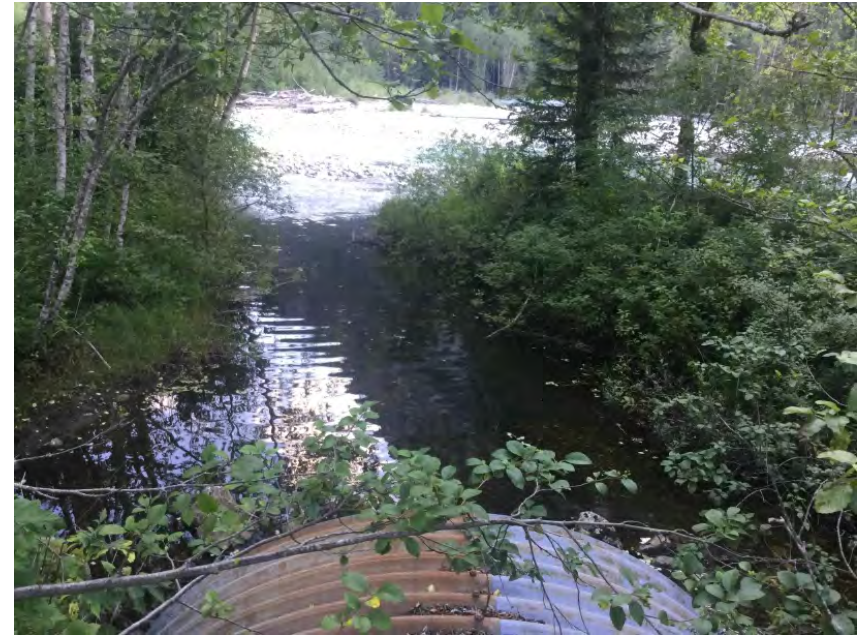
Looking Downstream

Comments    Slow moving channel.

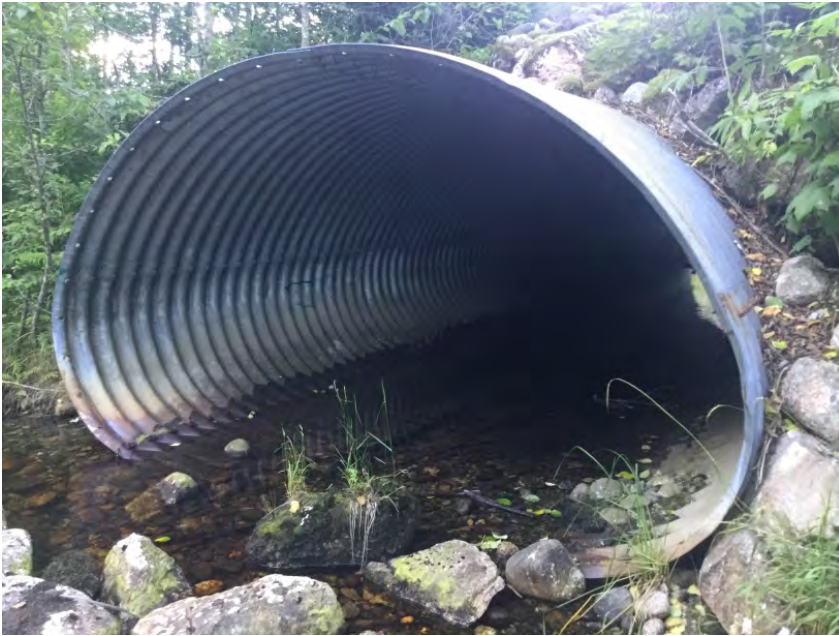
| Outlet | Fair | Light corrosion on top of culvert at outlet. |

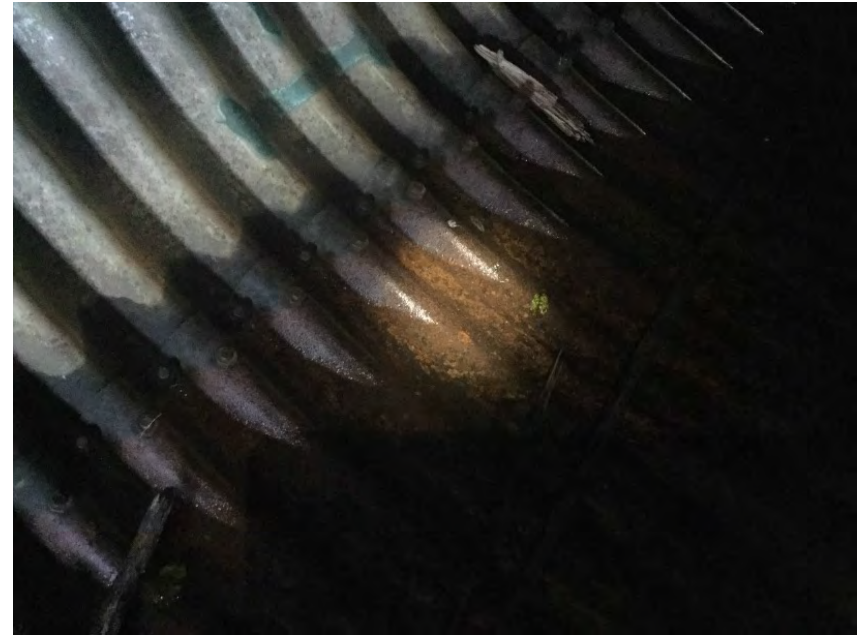
Floor Condition

| Bolted Connections | Fair | Light corrosion of bolts on floor of culvert. |
| Coating | Fair | Light corrosion on floor of culvert. |
| Floor | Fair | Light corrosion on floor. |

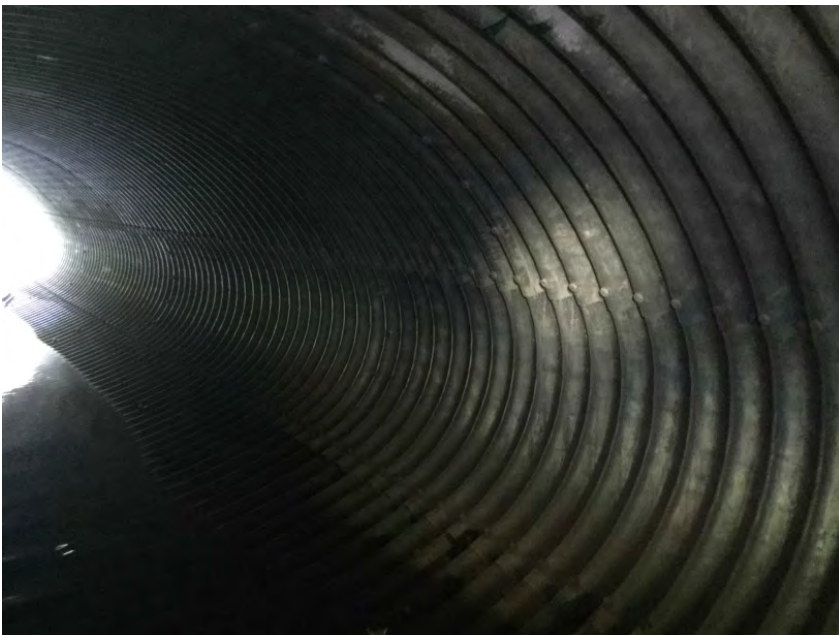
Wall Condition

| Sidewalls | Good | |

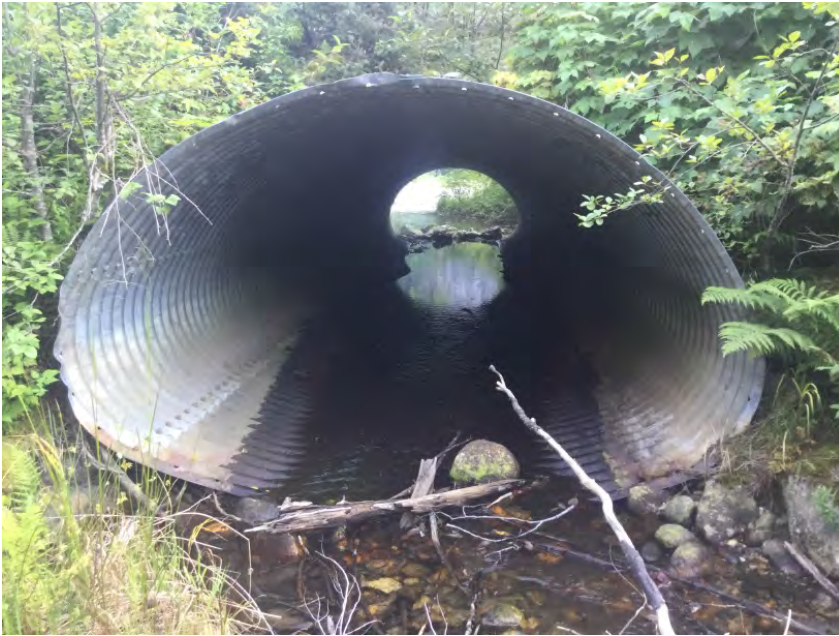
| Inlet | Fair | Light corrosion on top of culvert at inlet. |

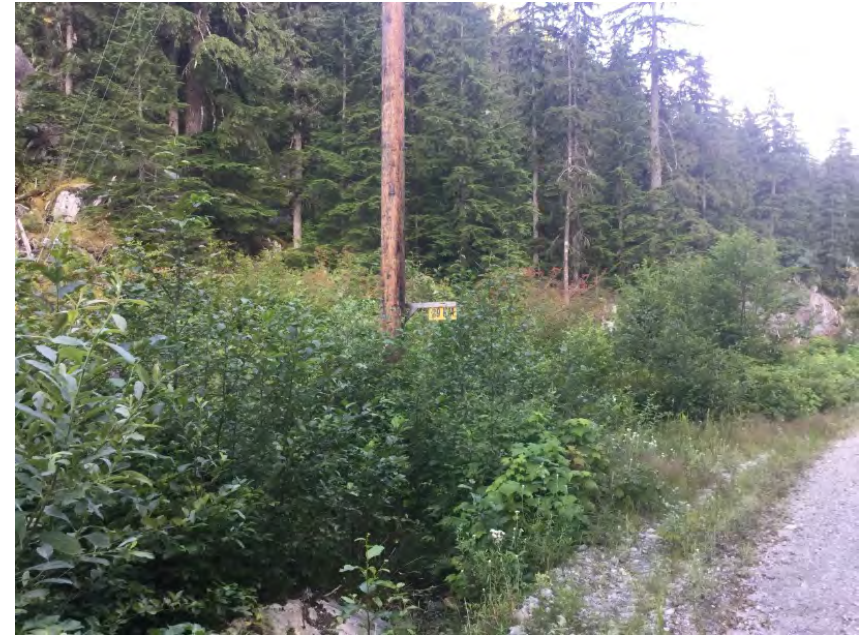
Km Sign on Approach

Updated km to 29.0 based on road km markings.

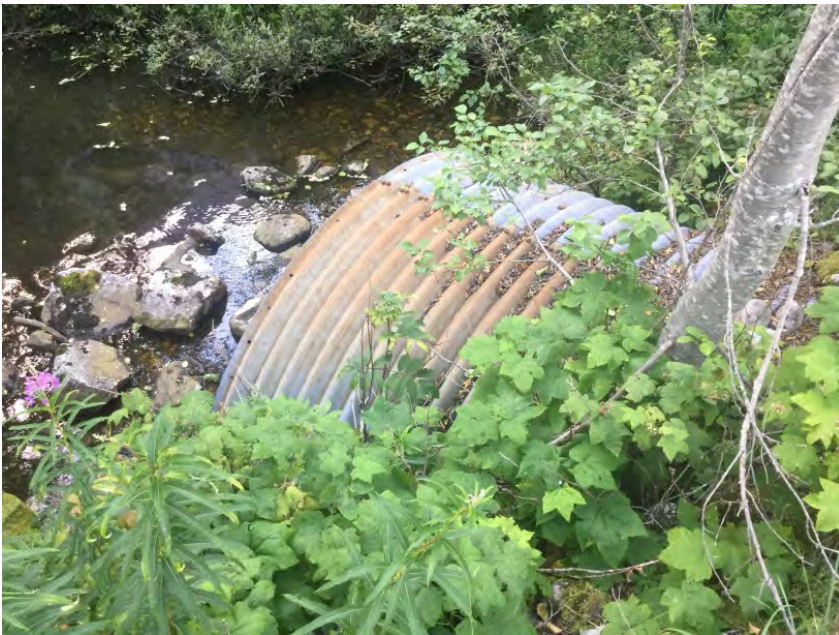
Typical Light Corrosion on Top of Inlet & Outlet
