CK-2274

STAVE RIVER 31.6km

2016 Inspection

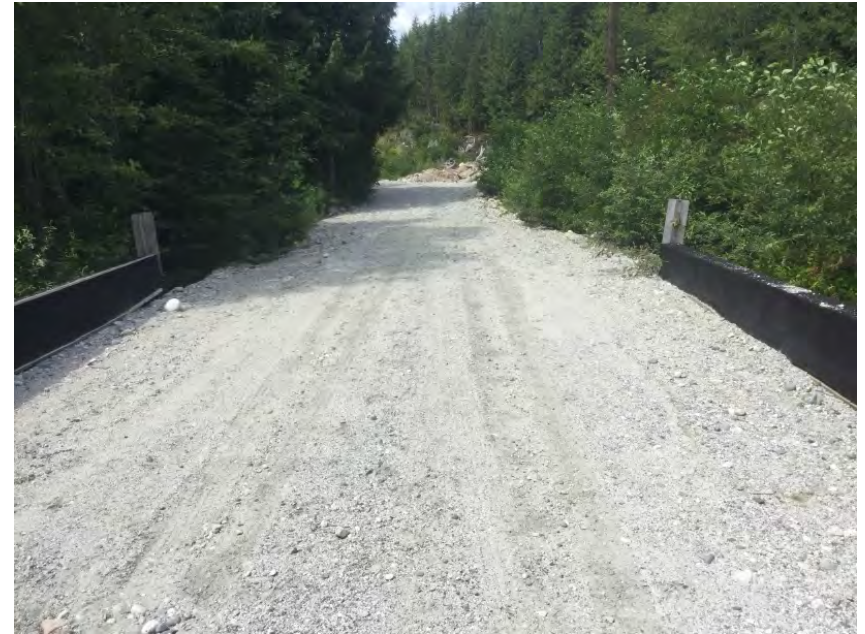
| Overall Deck Condition | Fair | Potholes in gravel surface. |

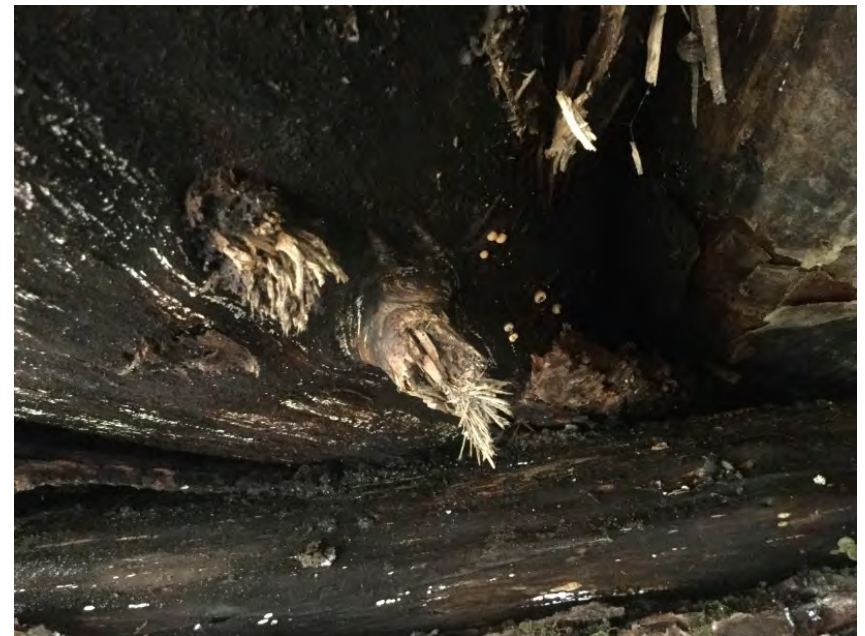
| 15 | Hw | N | 420 | 0 | Fair | Small Fungal Growth |

Stringer 14 Small Fungal Growth

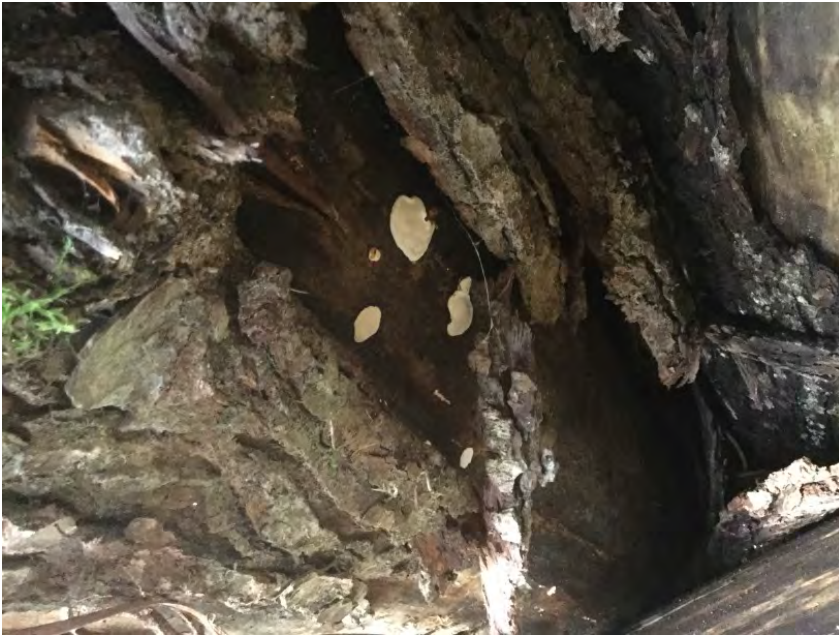
| 17 | Hw | N | 430 | 0 | Fair | Small Fungal Growth |

Stringer 15 Fungal Growth

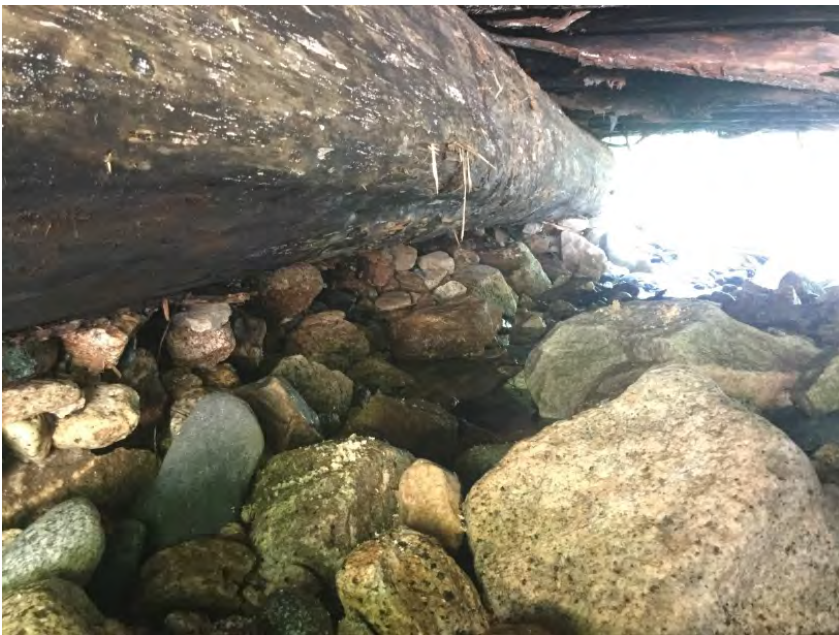
Significant scour below left abutment log. 700 mm dia. log with up to 800 mm of scour behind front face of log. Post bridge based on condition and repair or replace for industrial activity. Monitor after significant flow events until repaired or replaced. Stringers numbered from upstream to downstream. Error in App, subtract 1 for actual stringer number. Updated user km to 29.4.

The fill under the left bank log sill continues to erode away. Limit loading to 10 tonnes and monitor while in use, especially during/after heavy precipitation or rain on snow events. Post load rating sign. This structure is questionable whether or not it can withstand Q10 flows, therefore plan to replace soon. Monitor.

Caps or Sills Poor Left abutment log sill ~9.5 m long and is almost completely undermined over 6 m, with the remaining 3.5 m being partially undermined. 2 stacked logs at right abutment.

| Comments | Significant scour under left abutment log. 700 mm dia. log with up to 800 mm of scour behind front face of log. | | | | |

Left Abutment Scour

| Repair Item | Priority | Repair Description |
|---|---|---|
| 1 | High | Reinstate material below left abutment log and place riprap, or replace bridge. |

| Item | Monitor Description | Frequency |
|---|---|---|
| 1 | Monitor left abutment scour after significant flow events until repair/replacement. | Other |

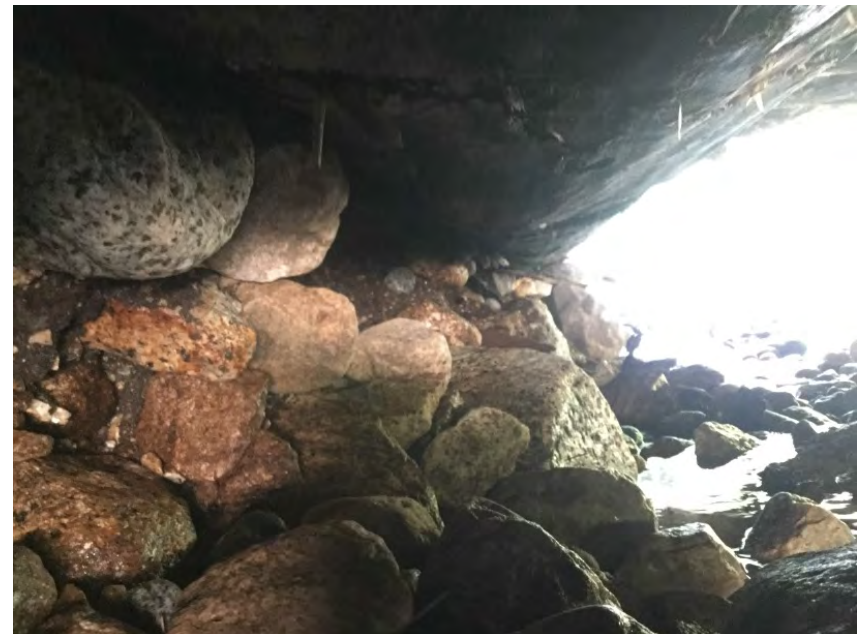
Left Abutment Scour
