CK-2275

STAVE RIVER 32.8km

2016 Inspection

| Structure Class | Major Culvert |

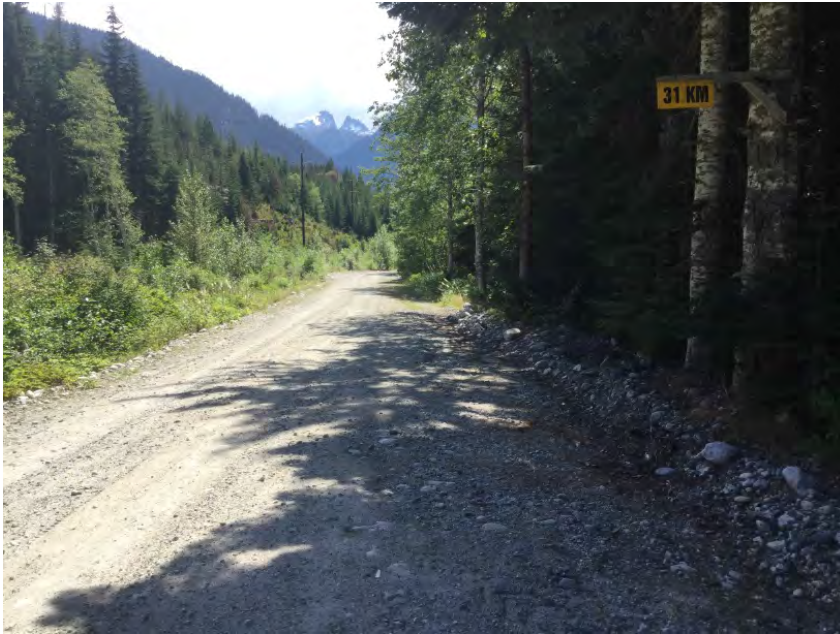
3 adjacent CSP culverts. Culverts locate at km 30.9 rather than at km 32.8 as noted on file. Woody debris noted upstream which may cause blockage in future.

Right Approach Looking Towards Culvert - Note km

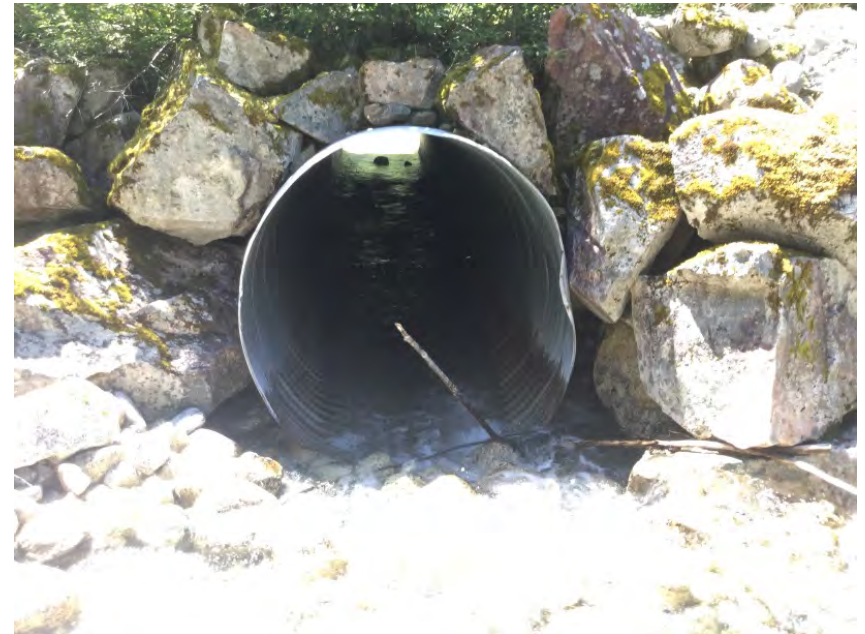
| Inlet | Fair | Minor damage to inlet of culvert 2 & 3 |

Inlet 2

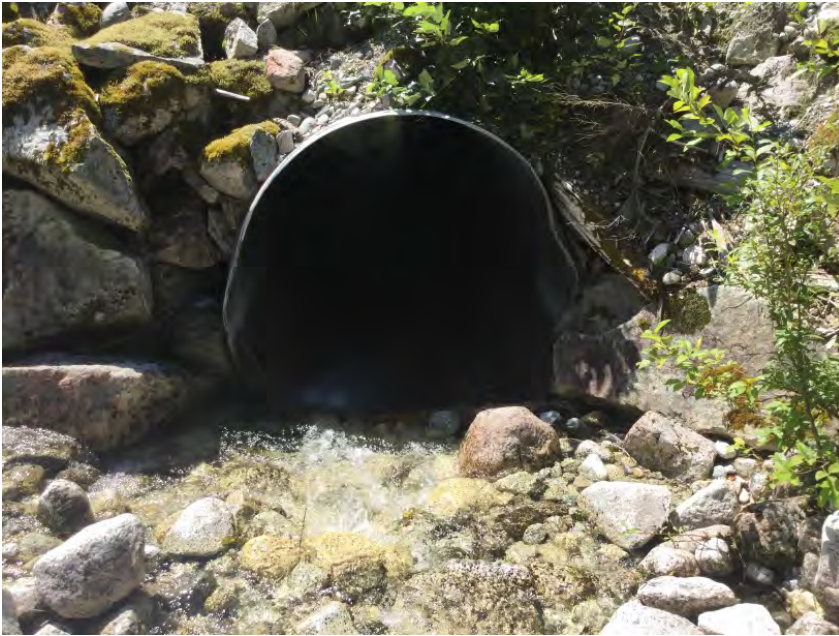
Inlet 3

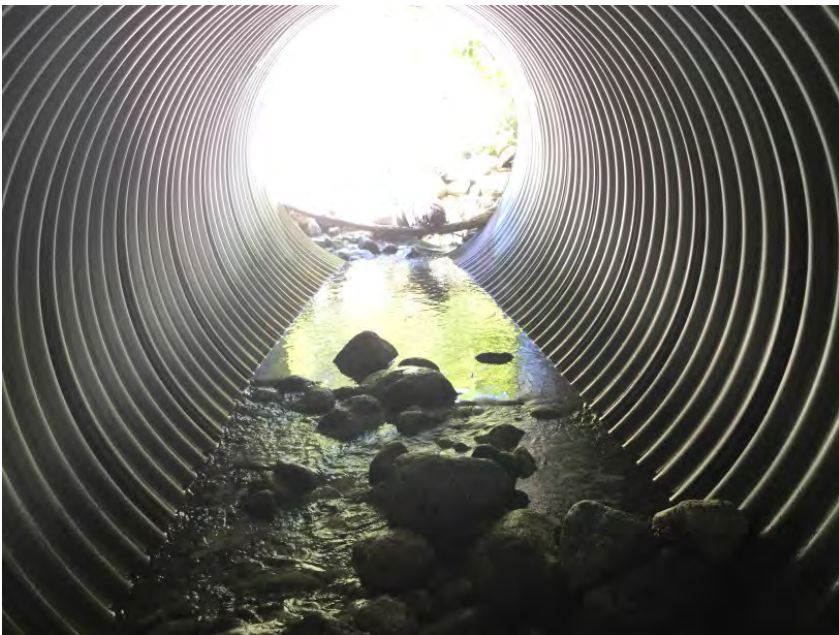
| Floor | Fair | Limited amount visible due to rocks on floor of culvert. |

Typical Culvert Barrel Condition

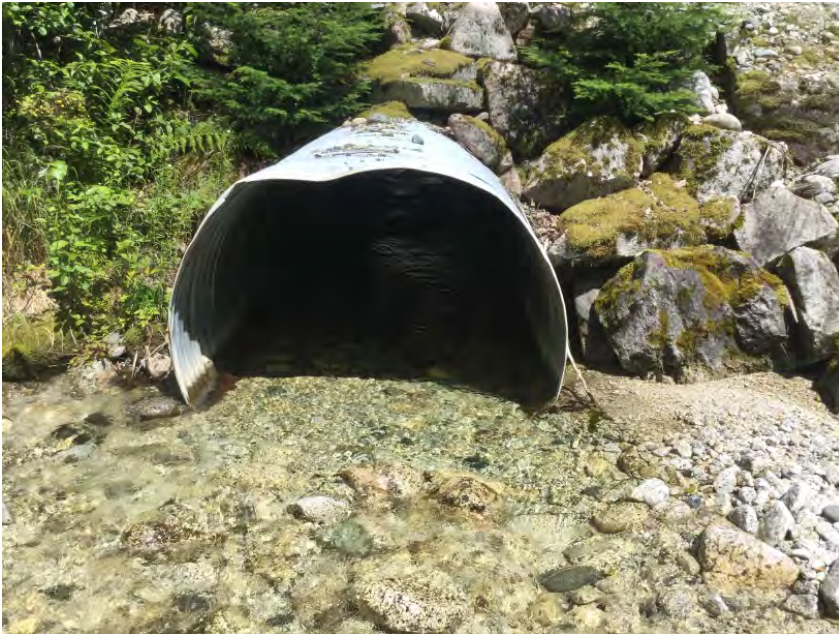
| Outlet | Fair | Minor damage to outlet of culverts 2. River deposits have reduced Culvert 3 outlet to 1.4 m. |

Outlet 2

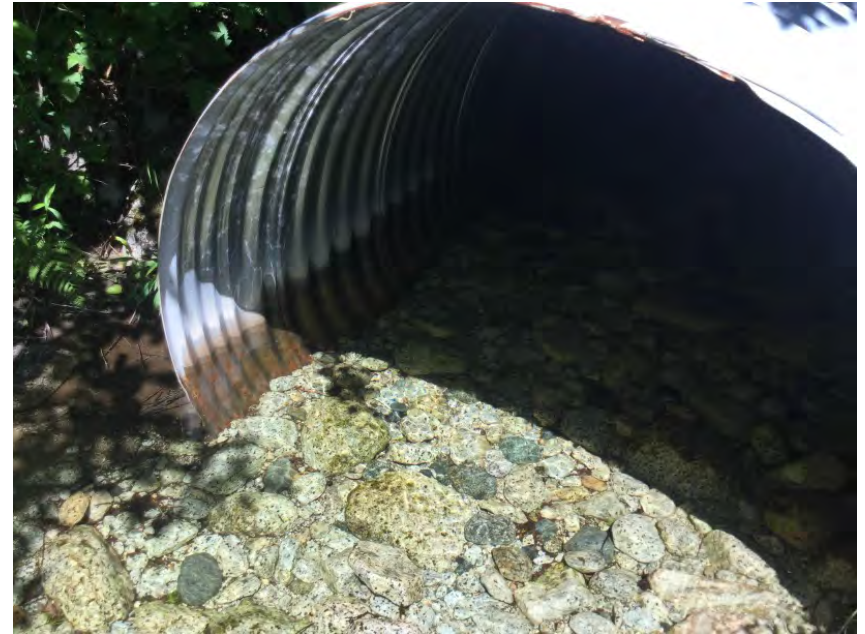
| Coating | Fair | Loss of coating where visible at waterline. |

Typical Coating Condition

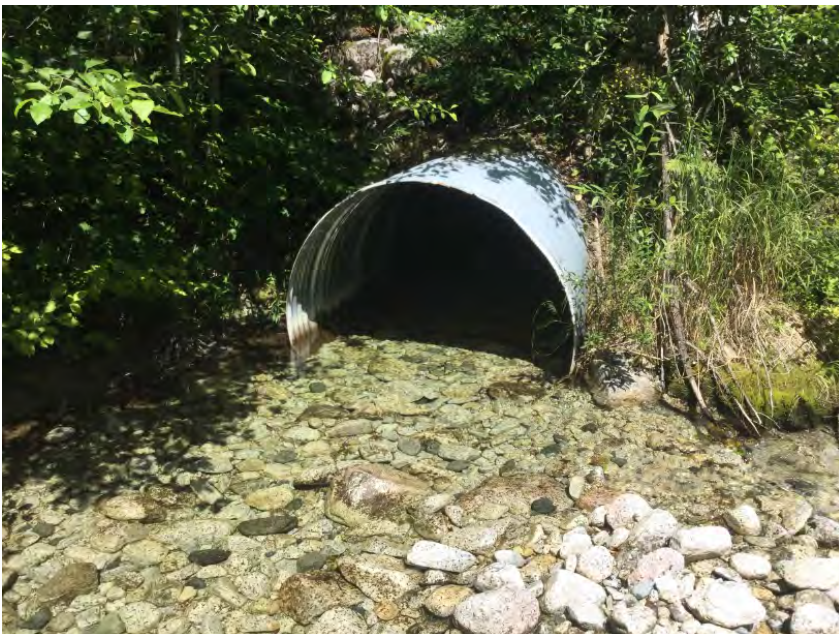
Outlet 3

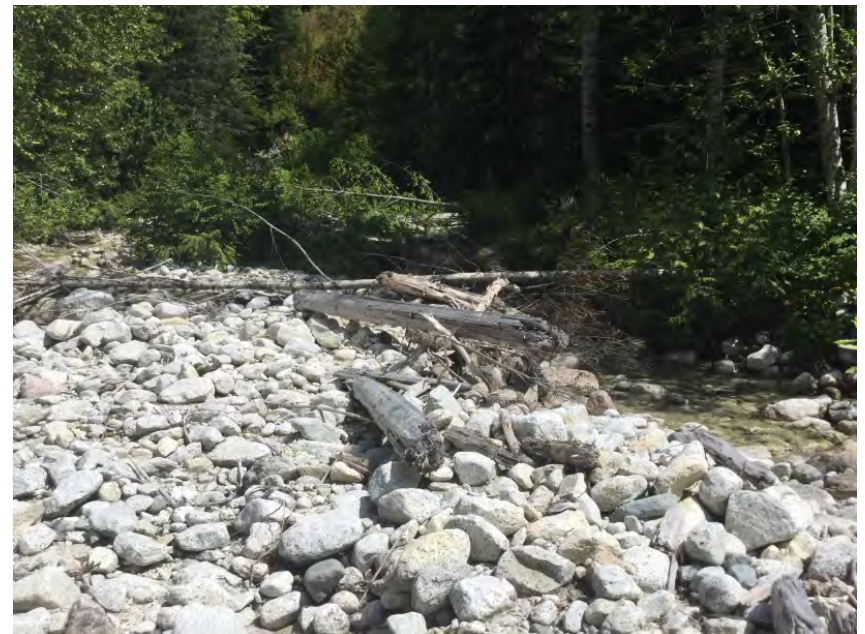
Comments Large woody debris noted upstream, some woody debris in mouth of culvert.

Large Woody Debris Upstream

Monitor debris upstream from the culvert inlets. Consider installing a large sump at the inlet. Present load rating of L75 or 68 tonnes to continue.

| Item | Monitor Description | Frequency |
|---|---|---|
| 1 | Monitor movement of upstream woody debris. Material may catch in mouth of culvert and cause blockage. | Anually |
