CK-2277

WINSLOW CREEK 0.9km

2016 Inspection

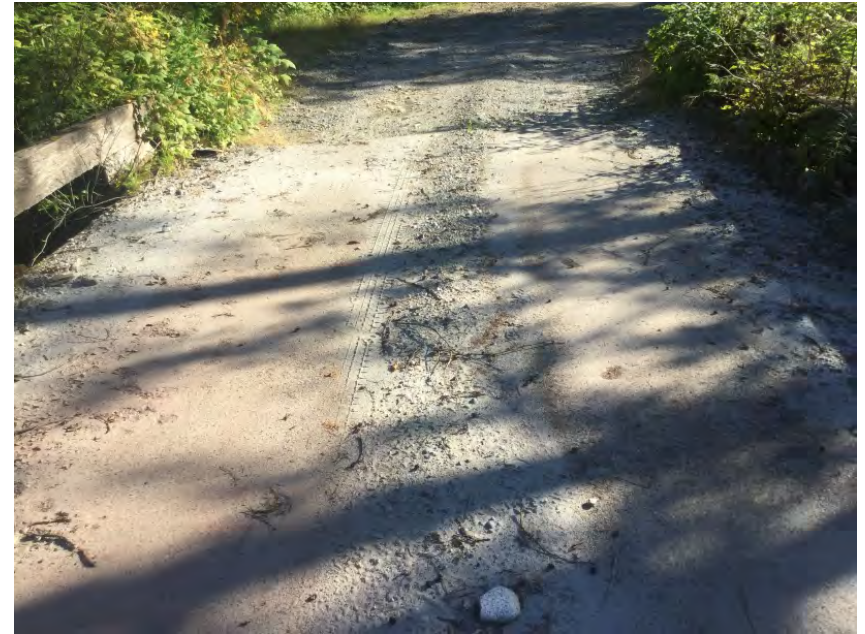
| Concrete Deck | Fair | Covered in debris, limited visible deck. |

| Item | Priority | Repair Description |
|---|---|---|
| 2 | Medium | Post bridge ahead signs, install delineators, brush approaches, realign fenders, clear debris from deck, repair ends of slab girders, and grade approaches before industrial activity. |

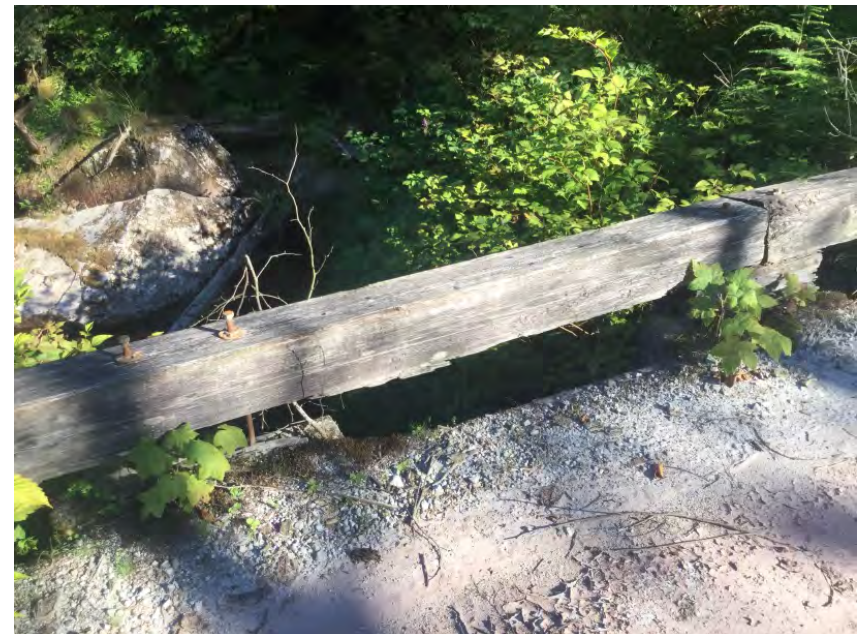
| Curb Rail/Blocks/Posts | Poor | All guardrail components are rotten. |

Guard Rail

| Item | Priority | Repair Description |
|---|---|---|
| 1 | High | Replace guardrails, riser and blocking prior to industrial or recreational activity. Requires: 18 m of 250x250 mm guardrail sections, 8 650x250x250 mm risers, 8 900x250x250 mm blocking, and necessary hardware. |

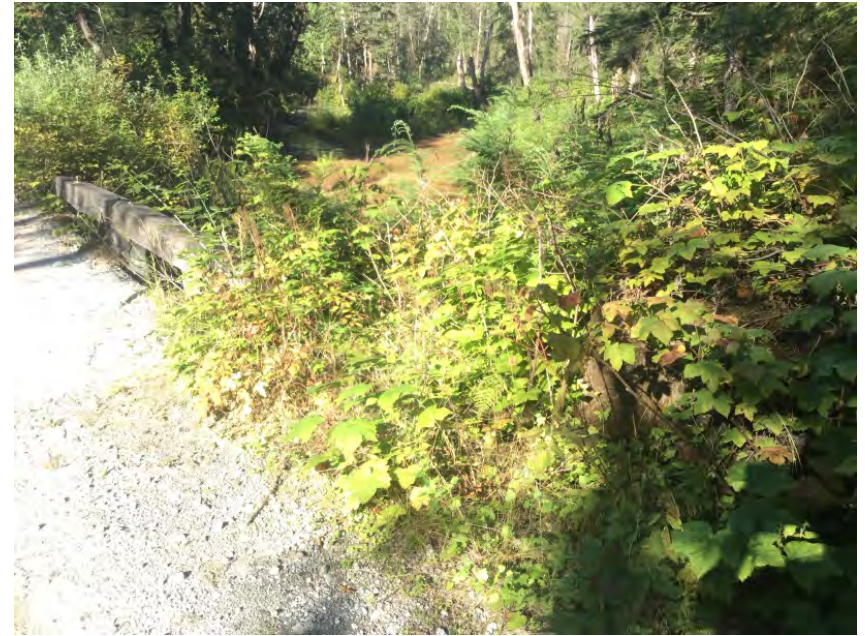
Overgrown, large gap between fender and guardrail at left approach upstream corner.

Left Approach Upstream Corner Gap between Fender & Guardrail

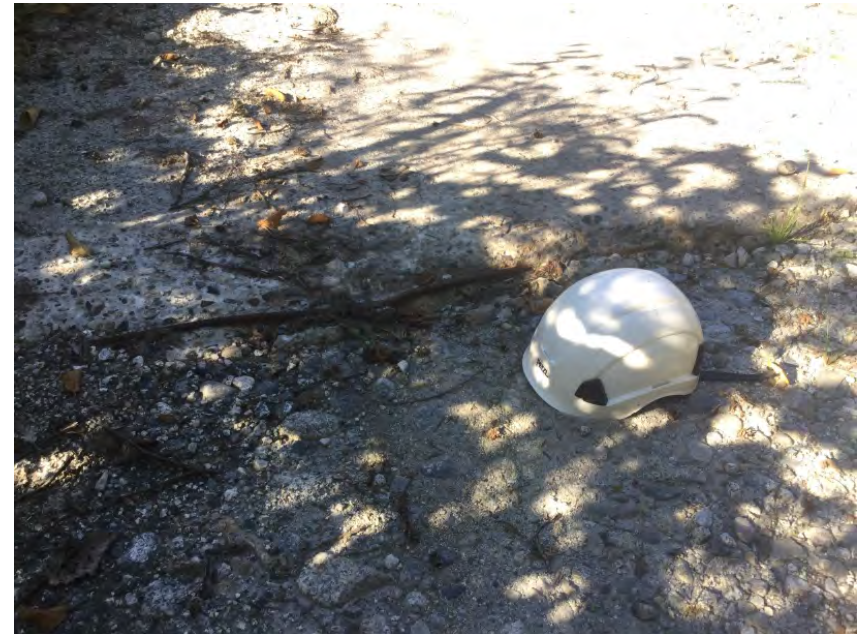
Significant difference in grade between bridge deck and approach, resulting in damage to slabs.

Lack of embankment fill at the left abutment has resulted in settlement of the approach fill and damage to girders.

Left Approach Grade Differential & Damage to Slab

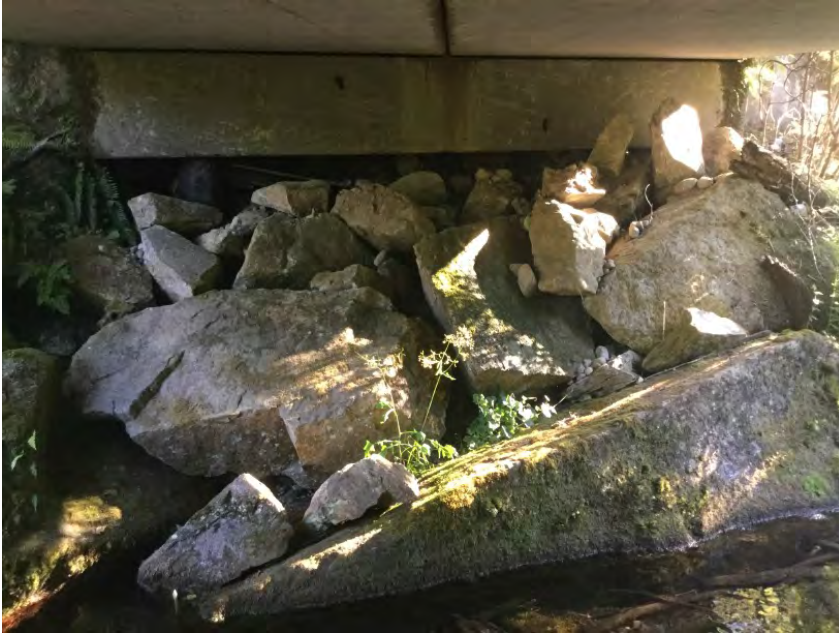
Left Bank Abutment

Moss growth, water staining.

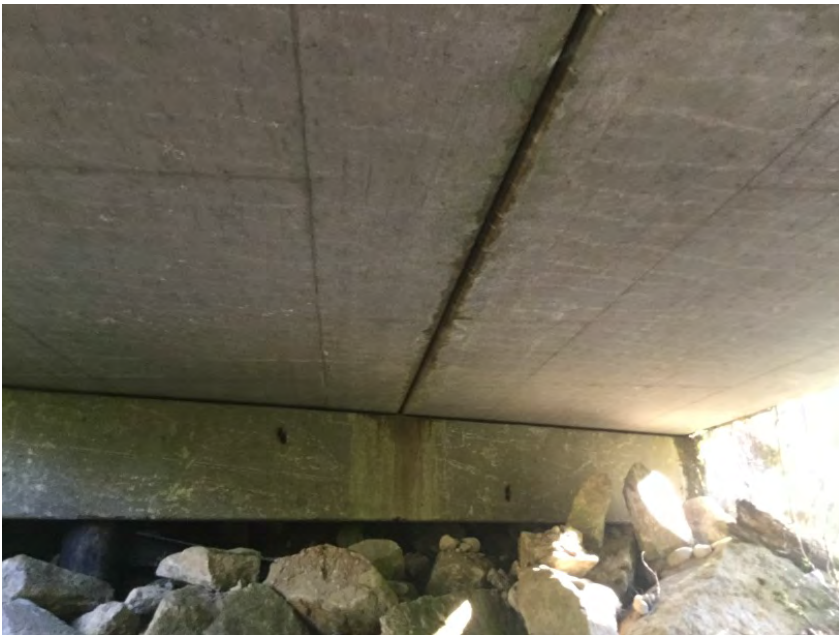
Slab Girders

Spalling and exposed rebar at girder end.

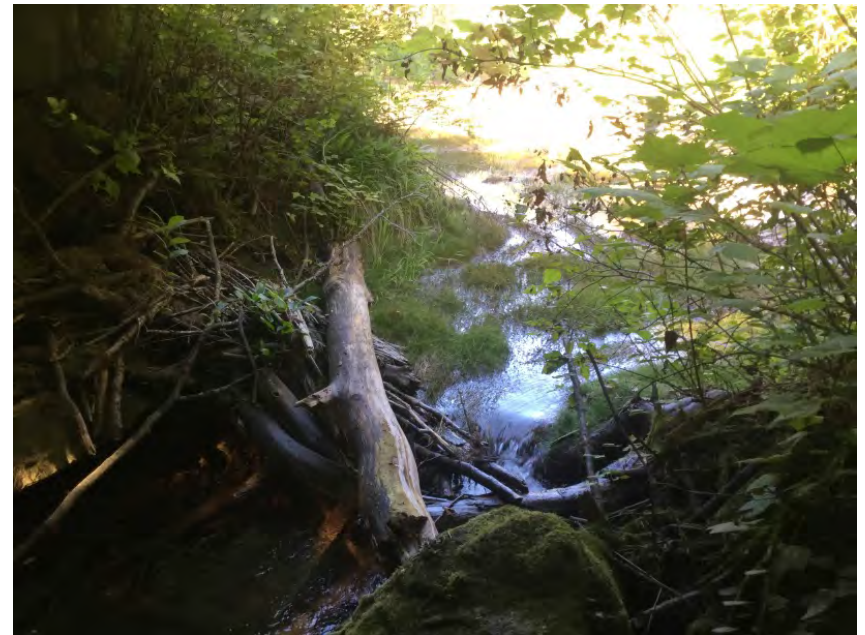
Comments Partially constructed beaver dam at upstream end of bridge.

Beaver Dam at Upstream Side of Bridge

| Item | Priority | Repair Description |
|---|---|---|
| 3 | Medium | Remove beaver dam. |

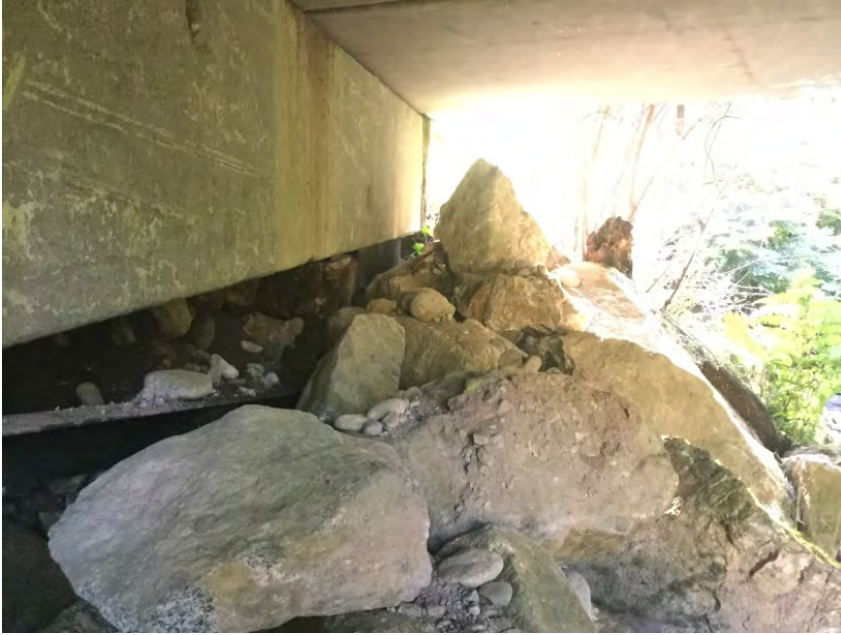
Gap between the cap and riprap has resulted in settlement of the approaches and damage to the ends of girders.

Gap between Riprap & Cap
