CK-2285

TSILEUH CREEK 12.1km

2016 Inspection

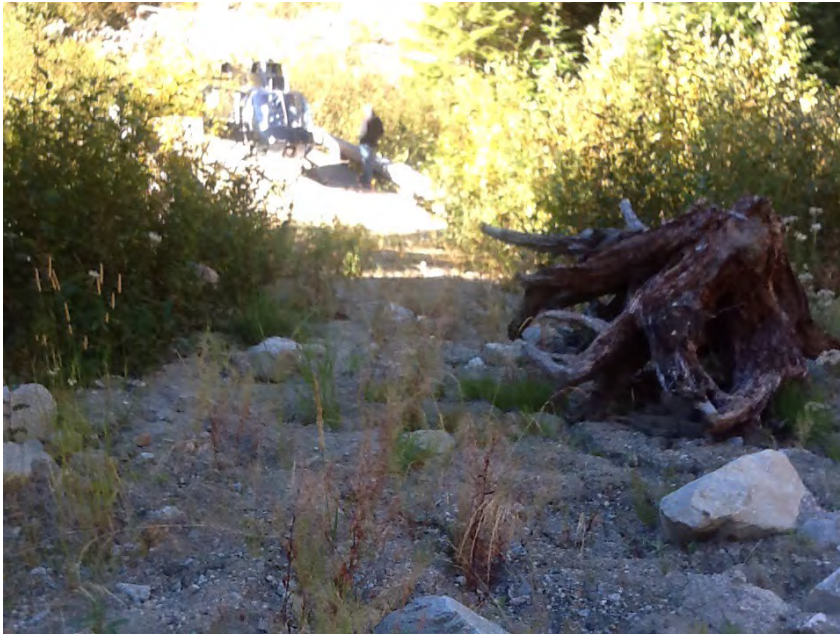
Left approach facing structure

A large slope failure on the left approach has blocked the road.

| Repair Item | Priority | Repair Description |
|---|---|---|
| 1 | High | 1. Repair left bridge approach. |

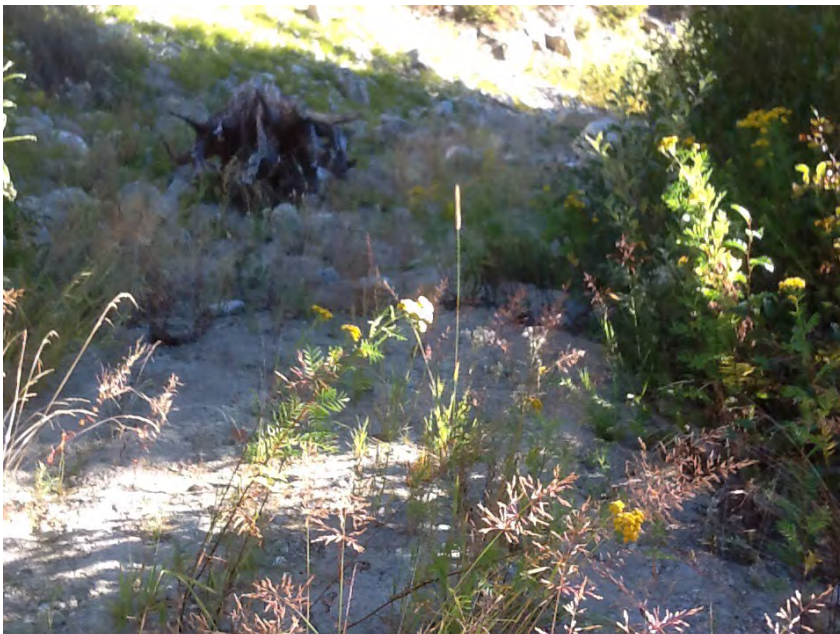
Left approach facing away from structure

Has a 5 percent gradient on left approach as well as a curve.

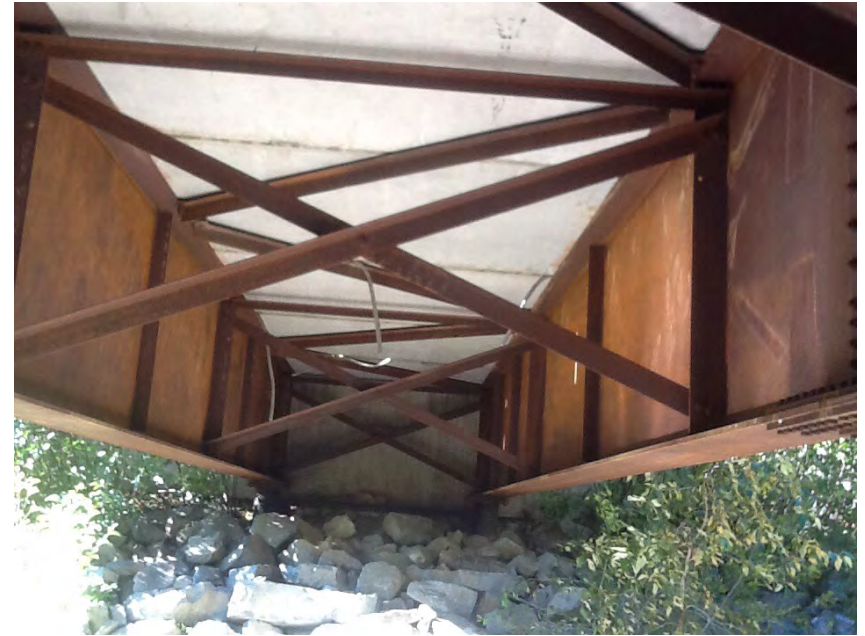
Underside of bridge

Girders Fair Light rusting
