CK-2286

TSILEUH CREEK 17.7km

2016 Inspection

| Crossing Name | South Fork Tsileuh Creek | | |

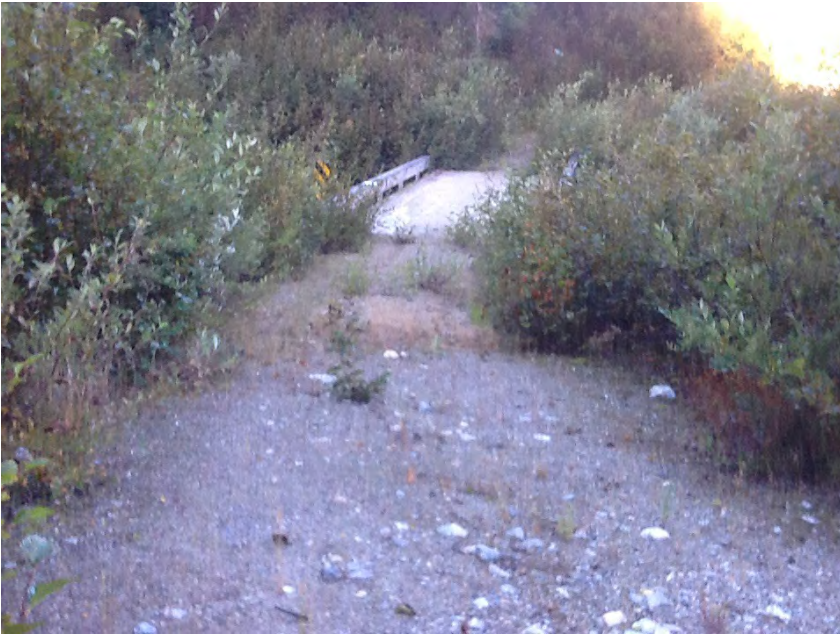
Right approach facing structure

Gradient on right approach. Curve on each end.

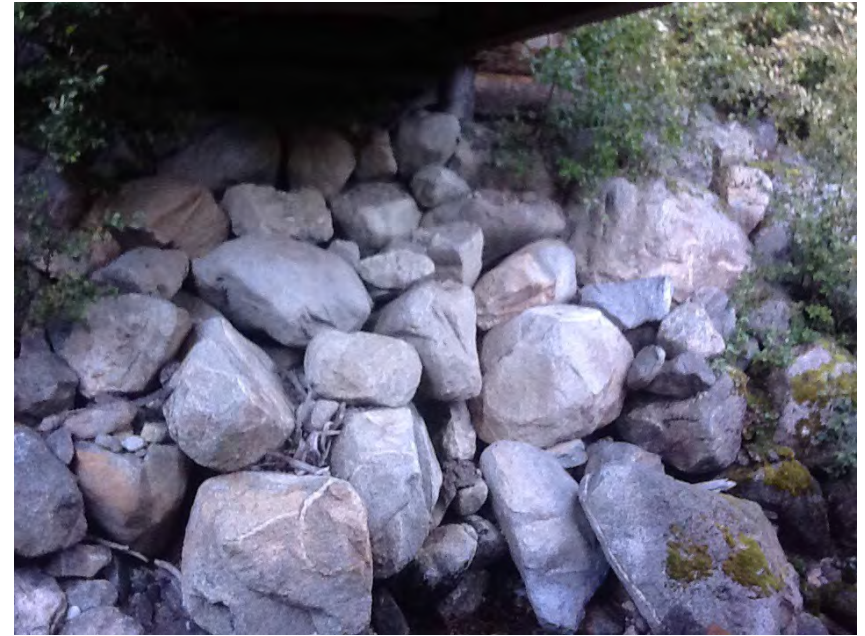
Left Bank Abutment when facing downstream

Both walls are cedar logs. On the left the top log is rotten and on the right there is generally 50mm of sap rot with 150mm pockets of rot in the top log.

Slight subsidence about 6cm and a small scour hole were noted on the left fill.

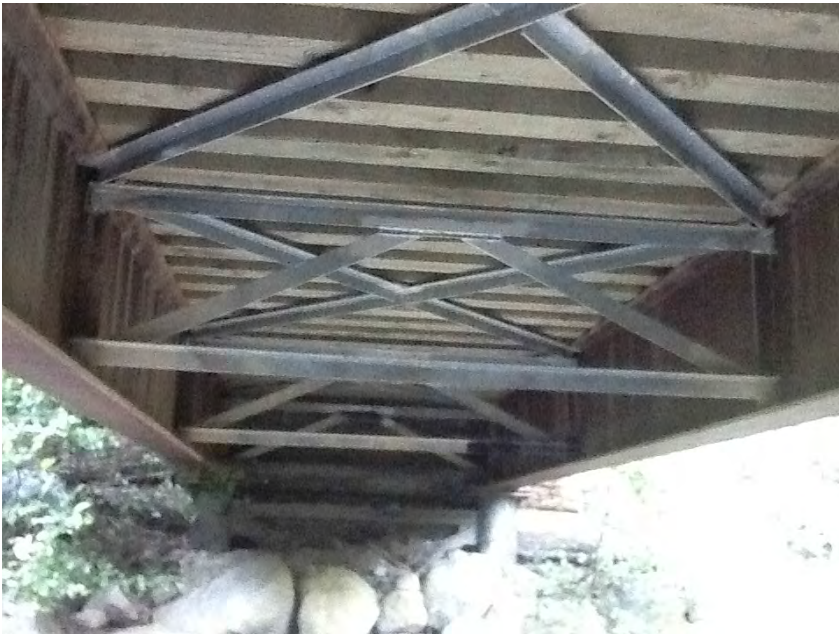
Underside of bridge

Girders Fair Light rust
