CK-2287

SILVERHOPE 0.6km

2016 Inspection

| Crossing Name | Silverhope Creek (structure # |

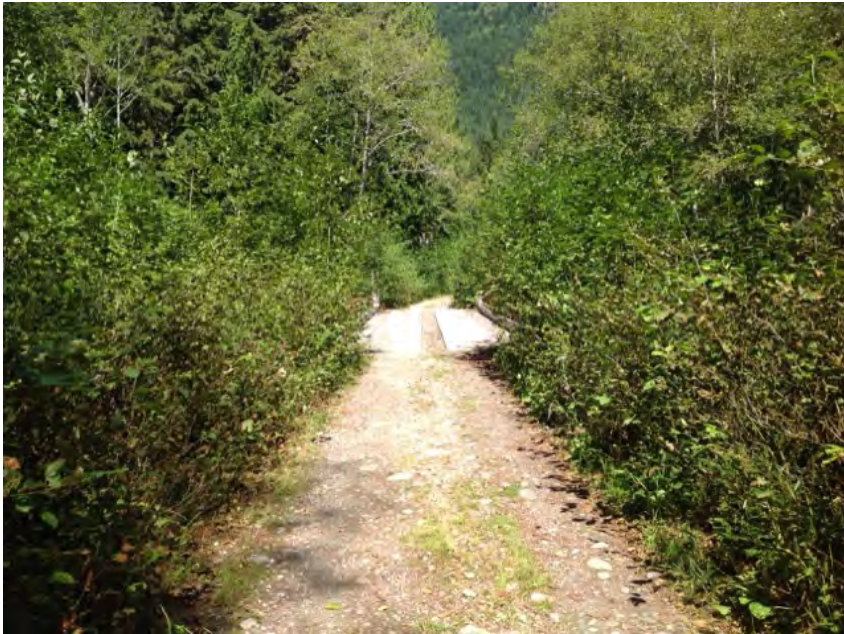
Approach from Left Bank when facing downstream

Bridge Ahead Signs  
Missing ☐ 0 ☐ 1 ☒ 2

Delineator Missing  
Left ☐ 0 ☒ 1 ☐ 2Delineator Missing  
Right ☐ 0 ☒ 1 ☐ 2

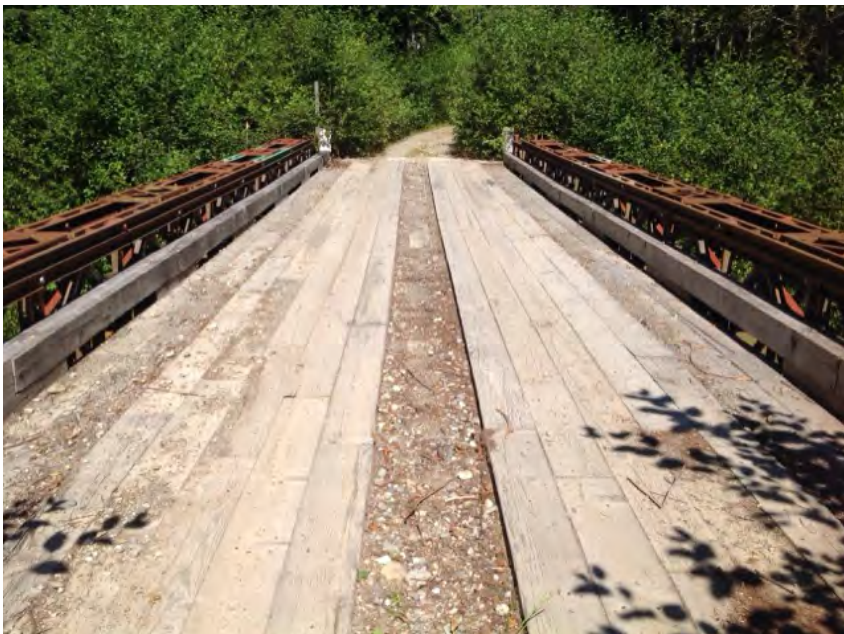
| Running Surface | N/A | grown over |
| Sub Deck | Poor | rotting |
| Ties | Poor | rotting |
| Overall Deck Condition | Poor | due to sub deck and ties |

Replace entire deck system; post bridge ahead signs, replace missing delineators and brush approaches prior to industrial use. Limit loading to 40 tonnes until the work has been completed. Post load rating sign.

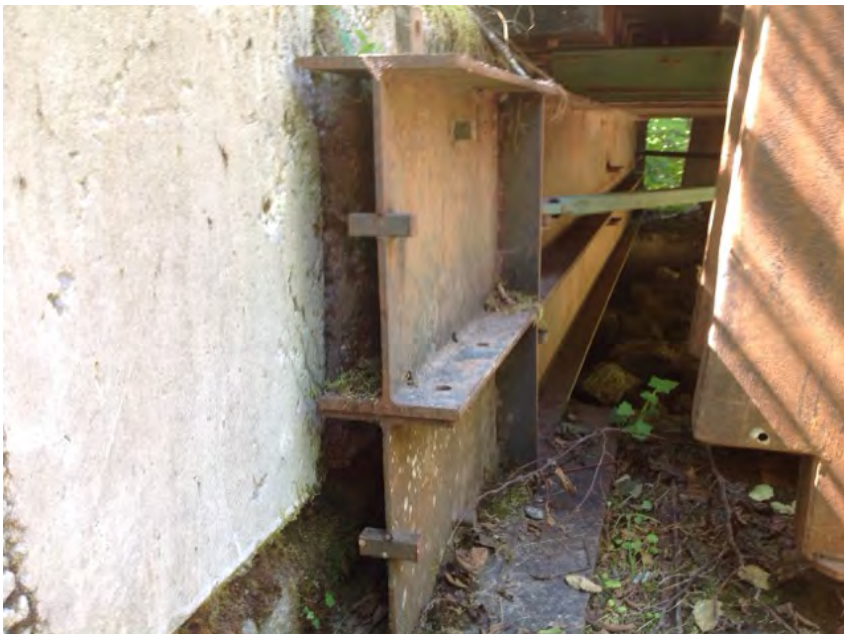
Ballast Wall Fair

ballast wall - typical both sides
