CK-2289

UZTLIUS CREEK 8.7km

2016 Inspection

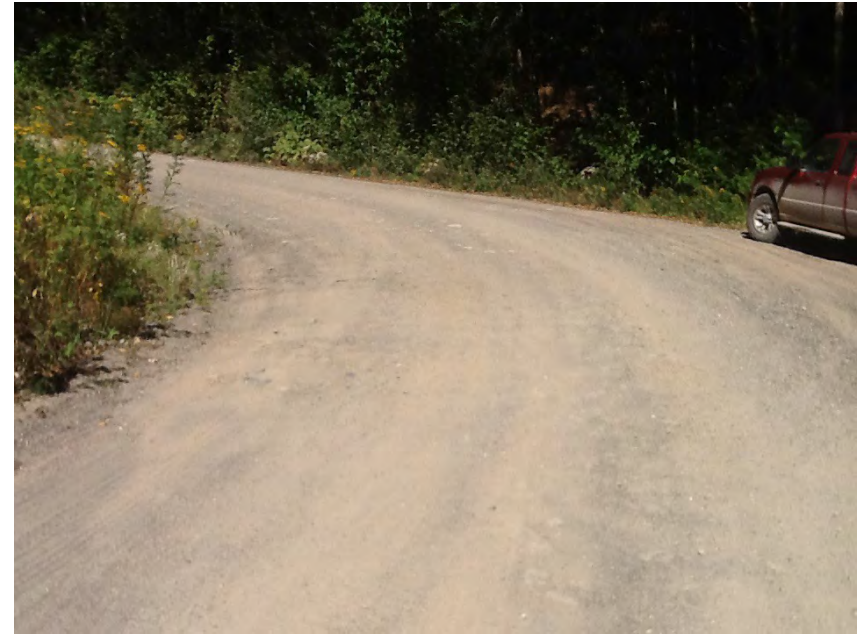
Right approach facing away from structure

Right approach has tight curve and 7% grade. Downstream curb has been damaged.

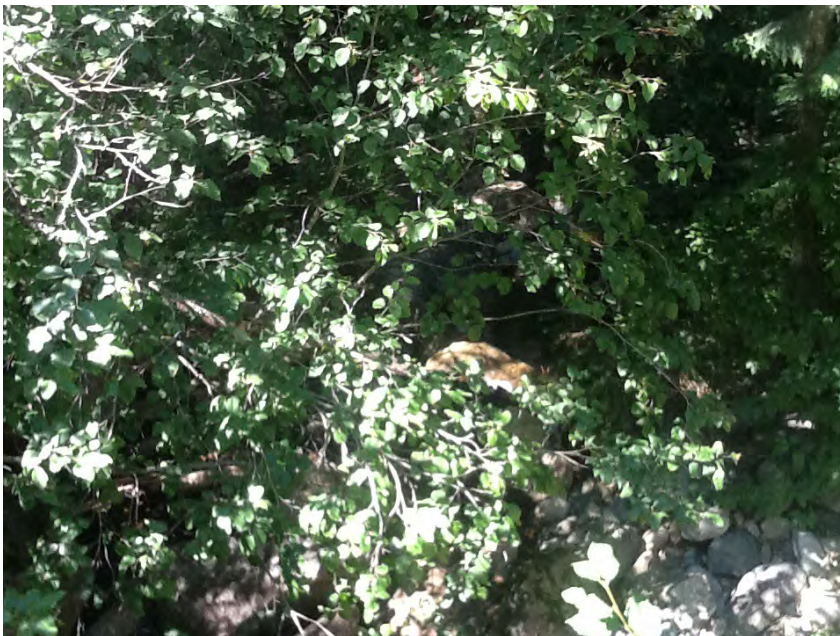
Downstream from Crossing

Eroded downstream but little apparent change from last inspection.

| Item | Monitor Description | Frequency |
|---|---|---|
| 1 | Monitor DSRB riprap scour. | |

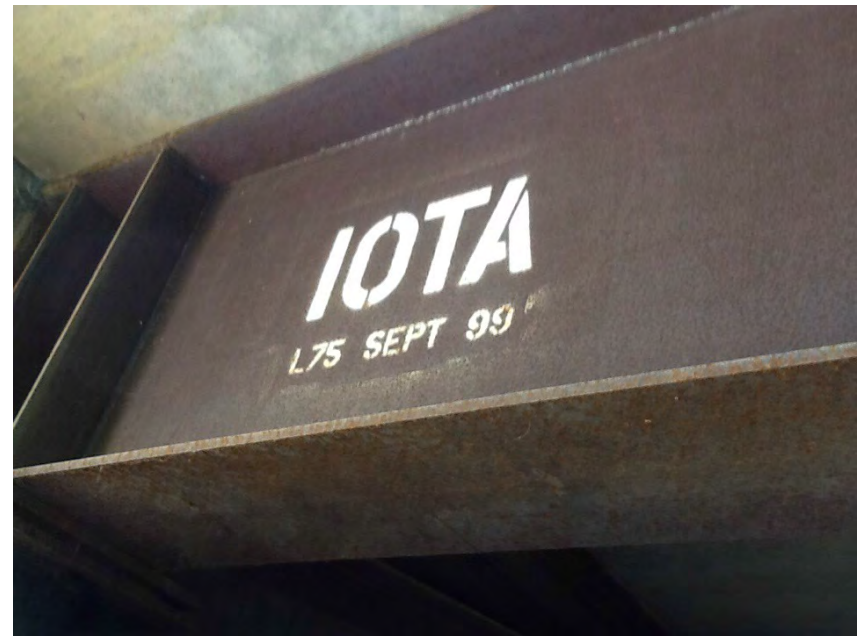
Structure ID

Serial/ID Plate IOTA L75 SEPT 99
