CK-2290

UZTLIUS CREEK 16.7km

2016 Inspection

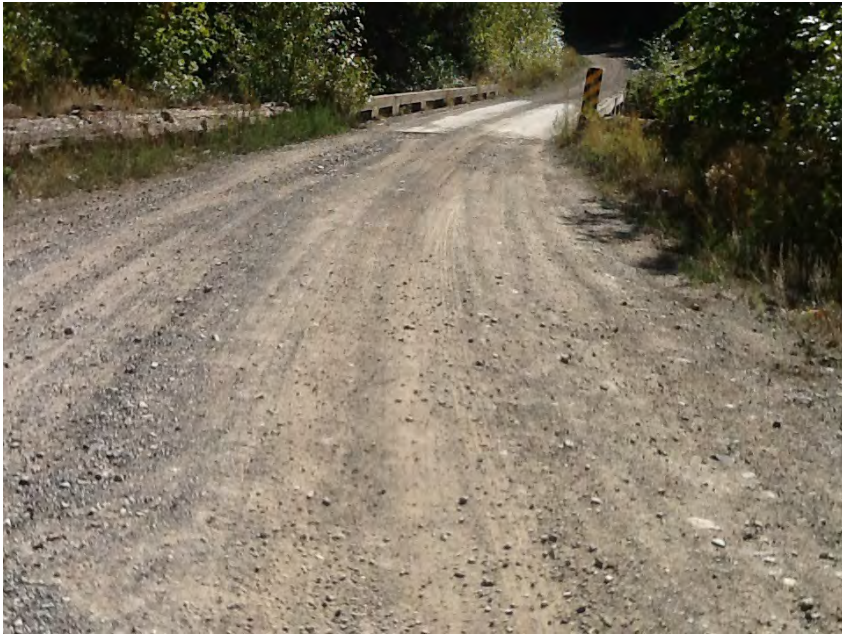
Right approach facing structure

Curve on right approach.

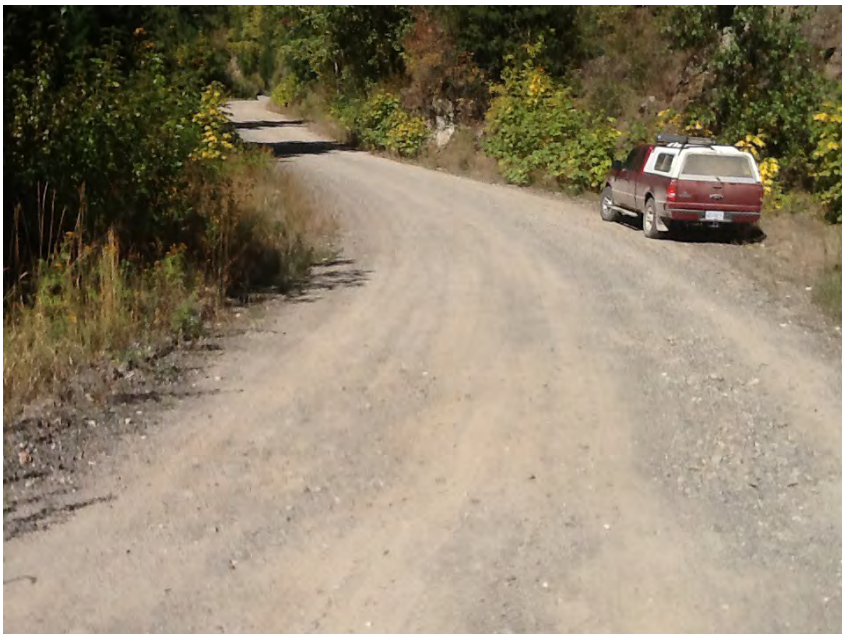
Right approach facing away from structure

Potholes on right end.

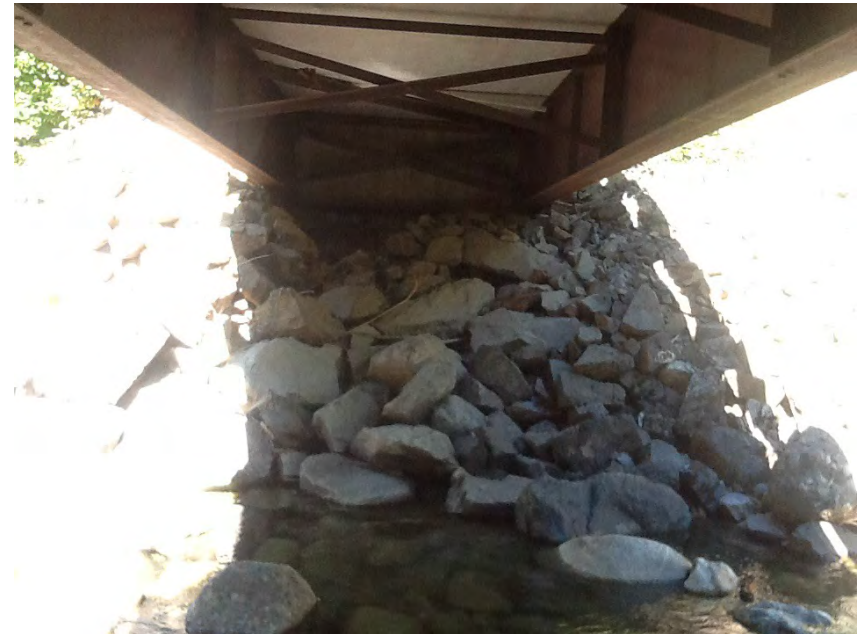
Right Bank Abutment when facing downstream

A 5cm +/- metal pipe goes over riprap on USRB from ballast wall to the stream.

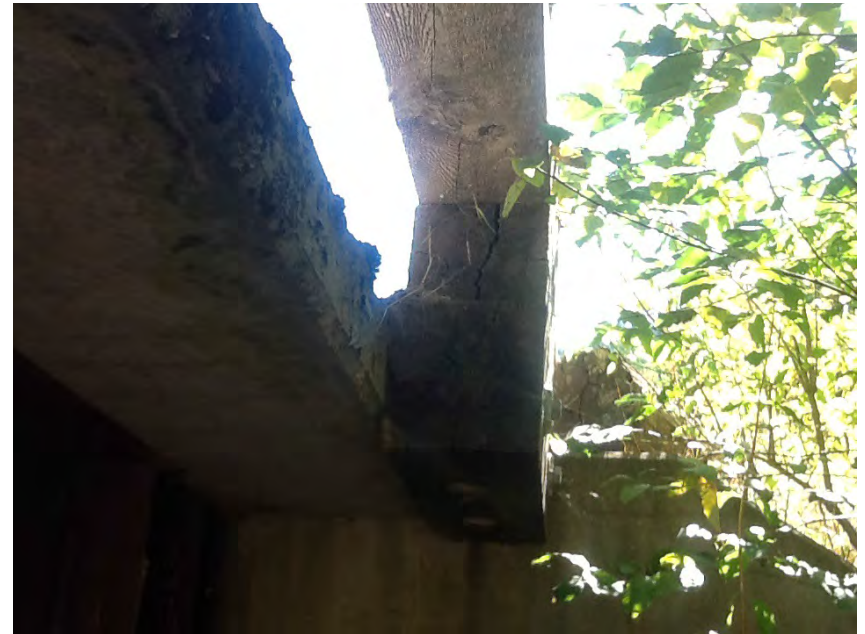
Guard Rail

Coordinates confirmed by GPS.  
Curbs need replacement for industrial use.

| Curb Rail/Blocks/Posts | Poor | Risers and blocks are rotten. Rails are fair to poor and curbs are loose. |
| Overall Deck Condition | Poor | Due to loose and rotten curbs. |

| Item | Priority | Repair Description |
|---|---|---|
| 1 | Medium | Replace curbs. Rails 250x250mm x 21.3m x 2. Blocks 250x250x80cm x 18 pieces. Risers 250x250x60cm x 18 pieces. |

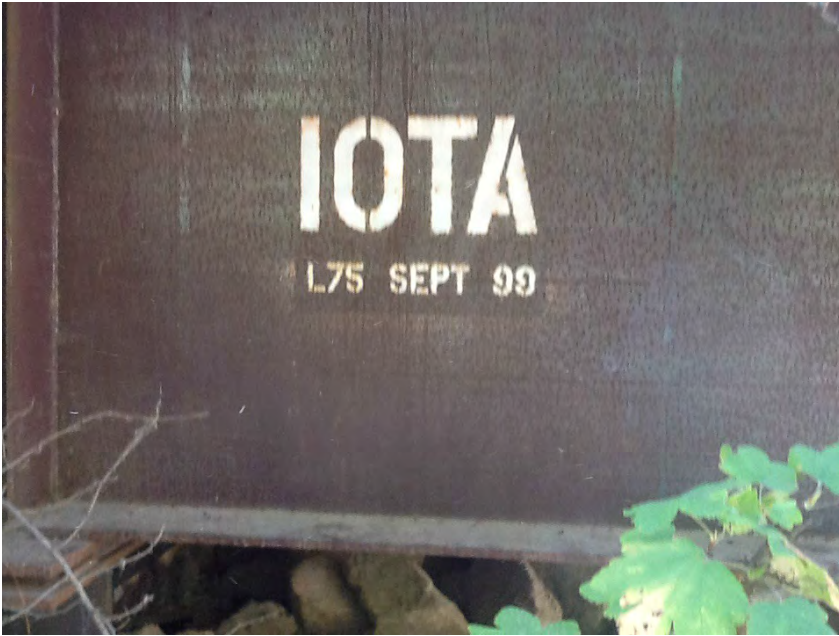
Structure ID

Serial/ID Plate IOTA L75 SEPT 99
