CK-2291

UZTLIUS CREEK 17.7km

2016 Inspection

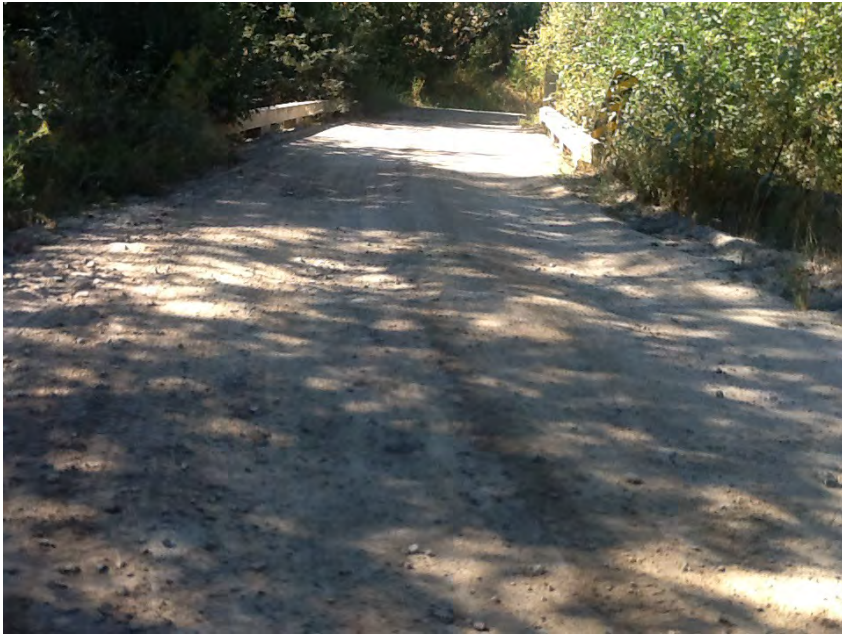
Right approach facing structure

Silty soils and mud track onto deck. Potholes on each end.

| Item | Priority | Repair Description |
|---|---|---|
| 3 | Medium | Grade and shape right approach to direct flow of sediments away from deck. |

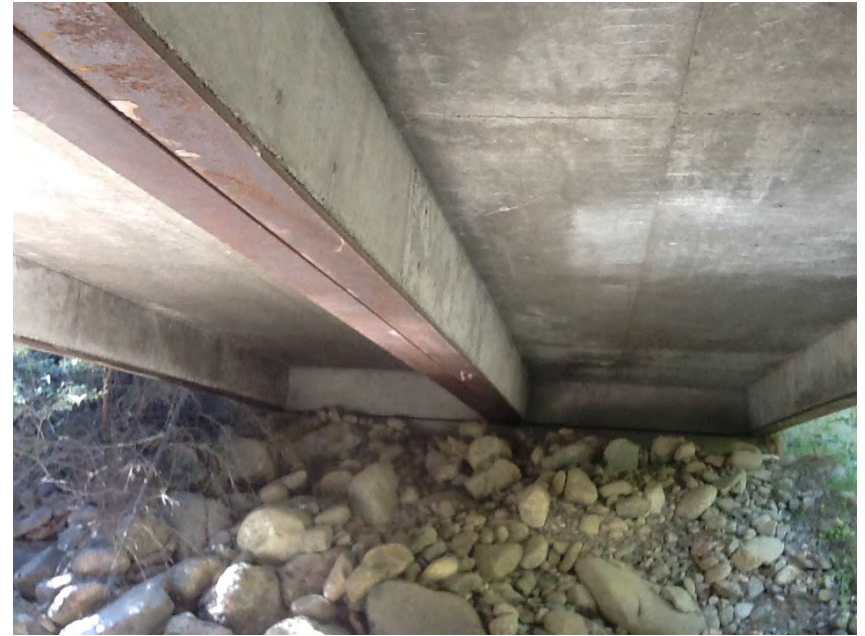
Underside of bridge

2 composite inverted channel beams with welded shear plates  
inspect again next year as they were not rated
