CK-2292

UZTLIUS CREEK 18.5km

2016 Inspection

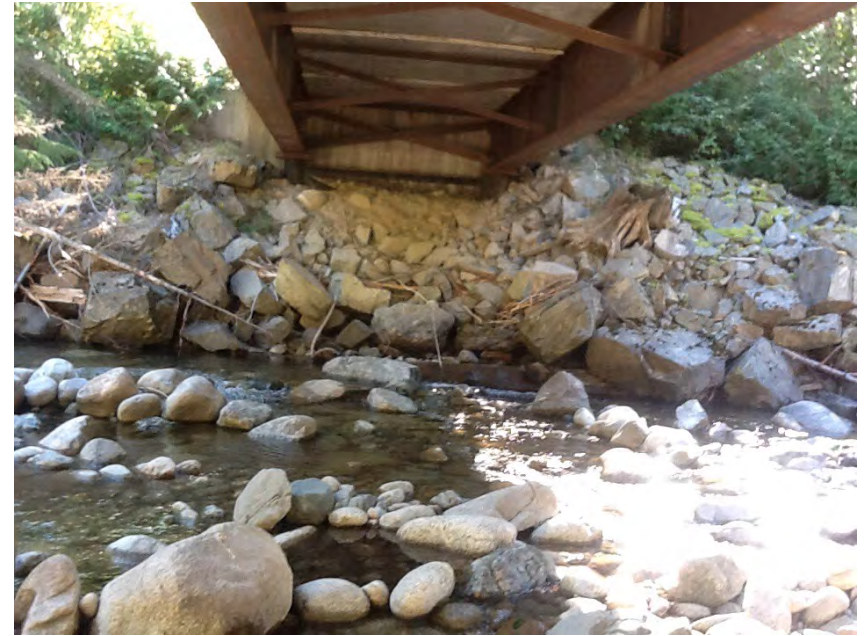
Left Bank Abutment when facing downstream

Riprap Fair Left side is very sparse at high water level and both sides seem prone to scour.

Comments Major failure and bank instability 100m upstream a source of large woody debris which would flow to the bridge in high water. Riprap may be scouring at high water on left abutment.

| Item | Monitor Description | Frequency |
|---|---|---|
| 1 | Monitor riprap on left for scour. | Routine Inspection |

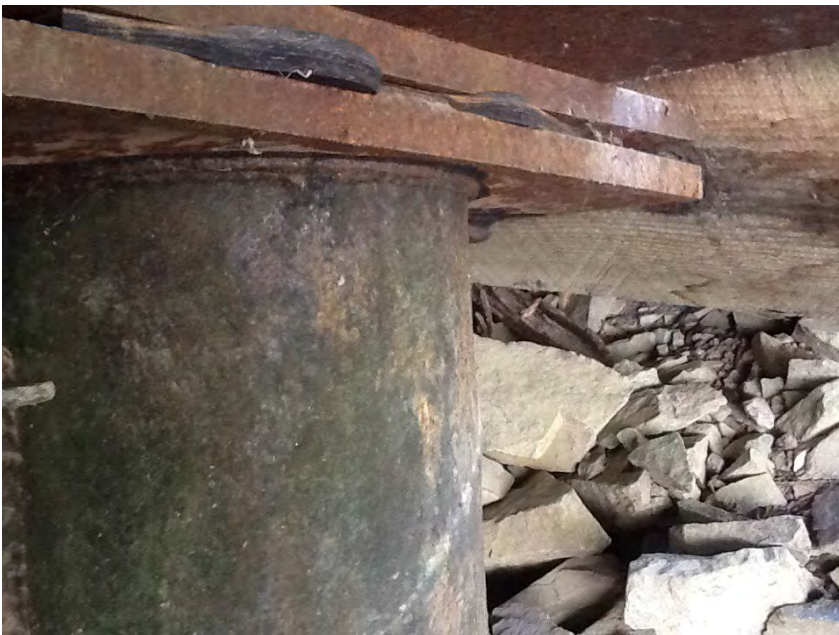
Left Bank Abutment when facing downstream

Caps or Sills Fair DSLB rubber pad is bulged out 20mm, see photo

Bearings Fair Bulging pads on left abutment.
