CK-2293

UZTLIUS CREEK 19km

2016 Inspection

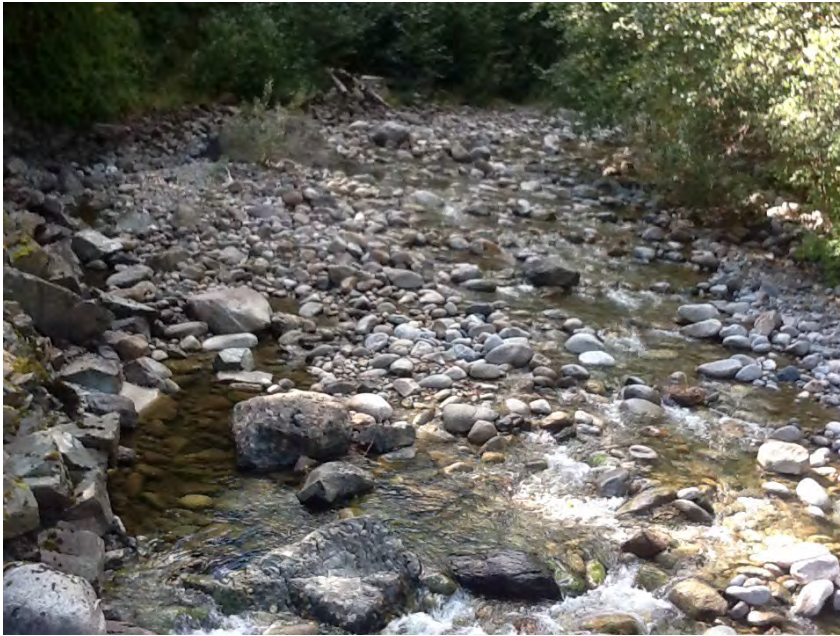
Upstream from Crossing

Comments Large log hung up on girder upstream right bank.

| 1 | High | Remove large log debris. |
