CK-2295

UZTLIUS CREEK 21.9km

2016 Inspection

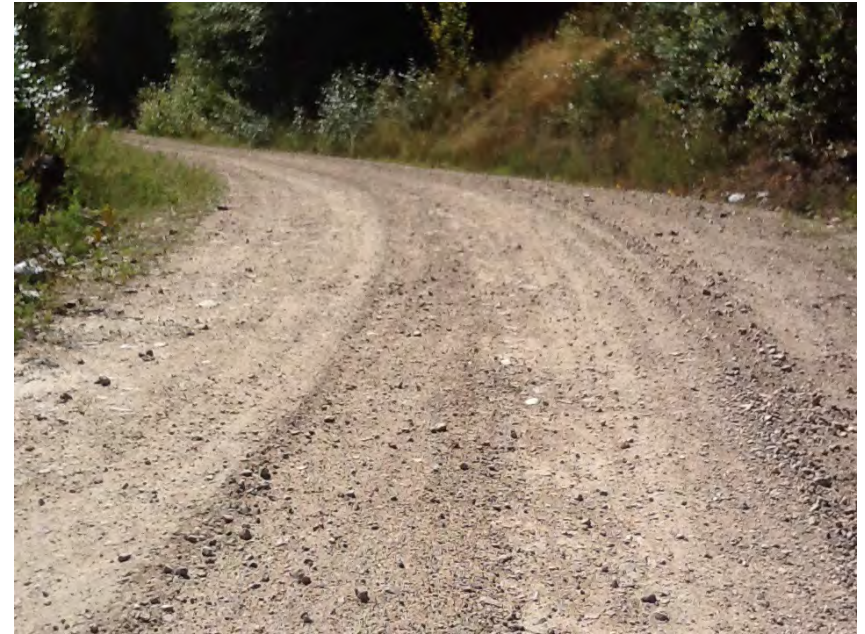
Right approach facing away from structure

Curve on right approach.

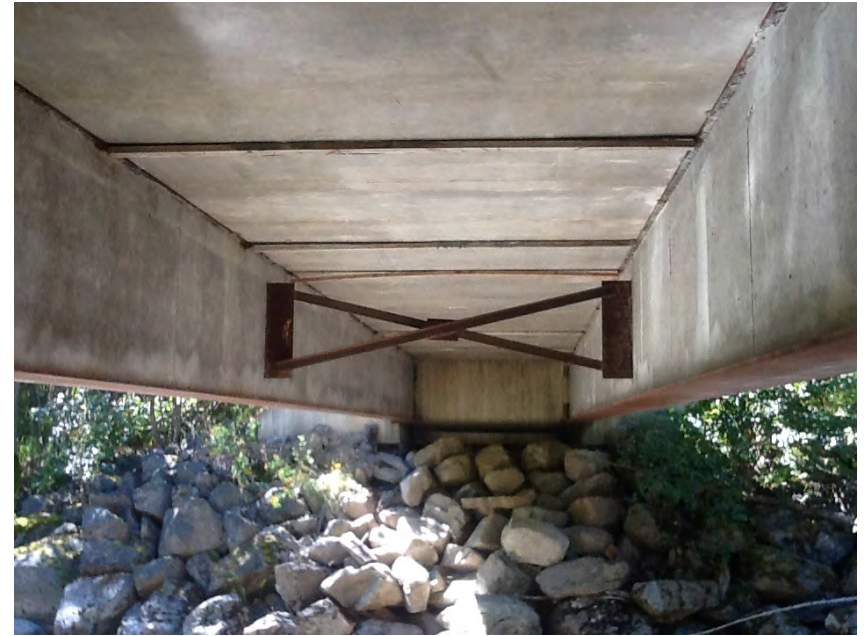
Underside of bridge

| Concrete Deck | Fair | Concrete is wearing and is pitted by tracks. The bottom of the end of the first panel on the right has had minor damage (previously noted). |

Repair damage to the first panel on the right bank (underneath); post bridge ahead signs. Present load rating of L75 or 68 tonnes to continue.

| 1 | Monitor damaged end of deck panel. | |
