CK-2298

UZTLIUS CREEK 27.5km

2016 Inspection

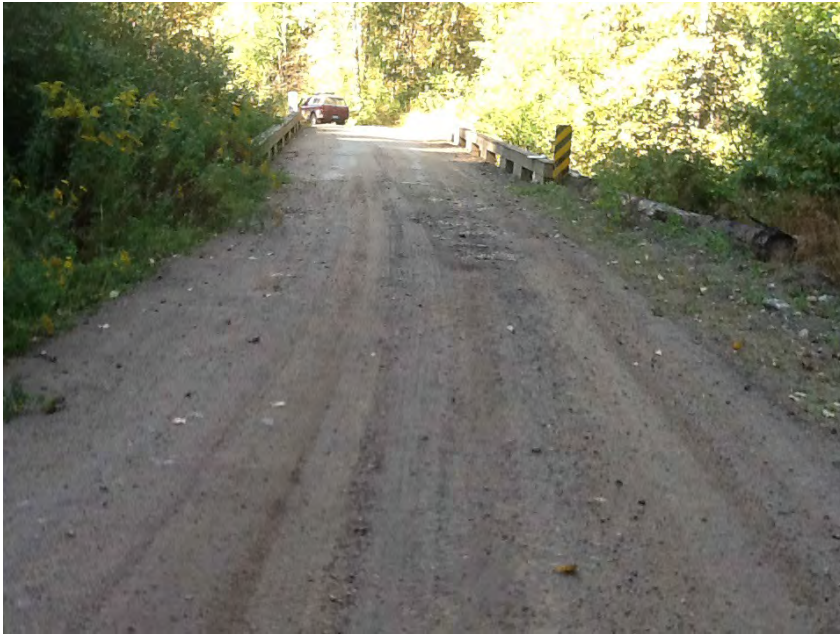
Left approach facing structure

Fender Condition Poor

Small loose logs

| Item | Priority | Repair Description |
|---|---|---|
| 2 | Medium | Place fenders or concrete no post barriers at approaches. |

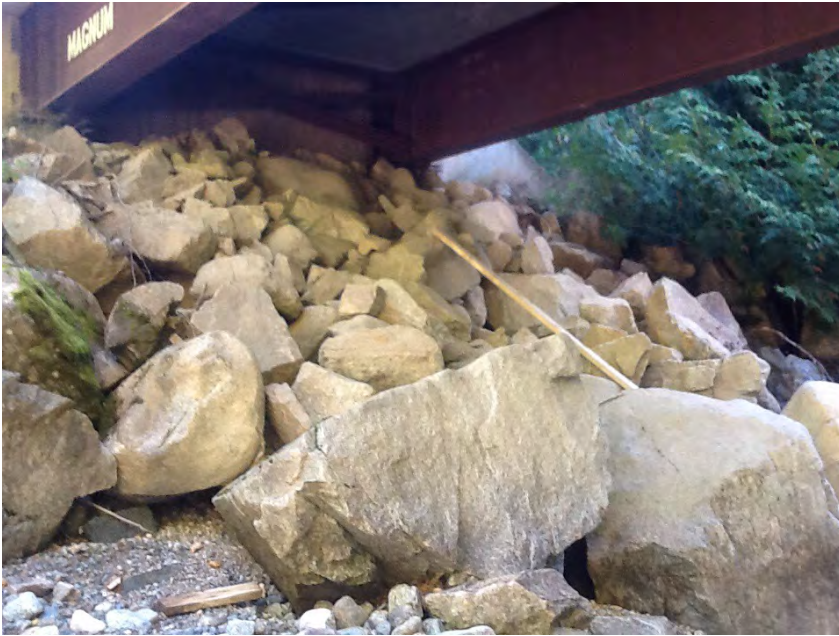
Left Bank Abutment when facing downstream

Left upstream scouring under riprap.

Comments Riprap on upstream left abutment is being undermined and this could result in toppling of boulders.

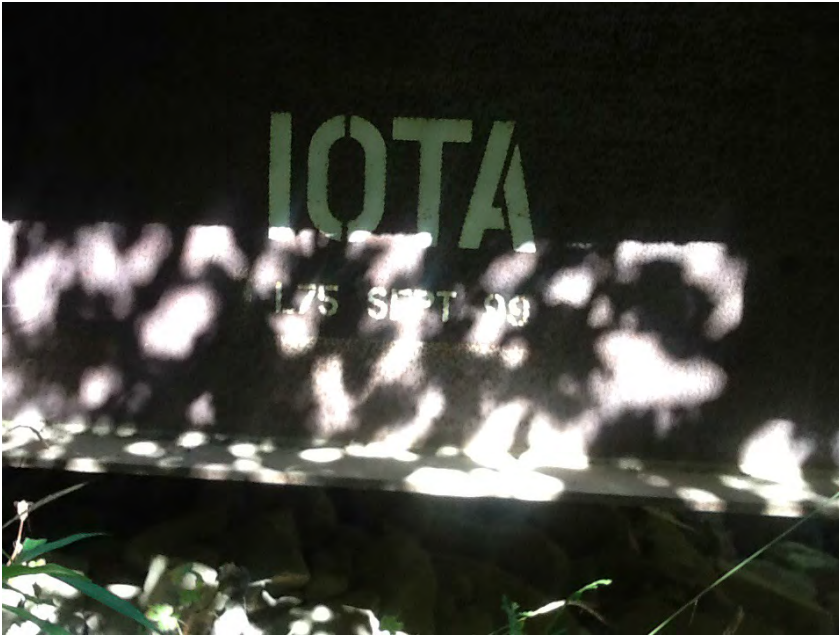
Structure ID

Serial/ID Plate Iota L75 Sept 99
