CK-2300

UZTLIUS CREEK 13.4km

2016 Inspection

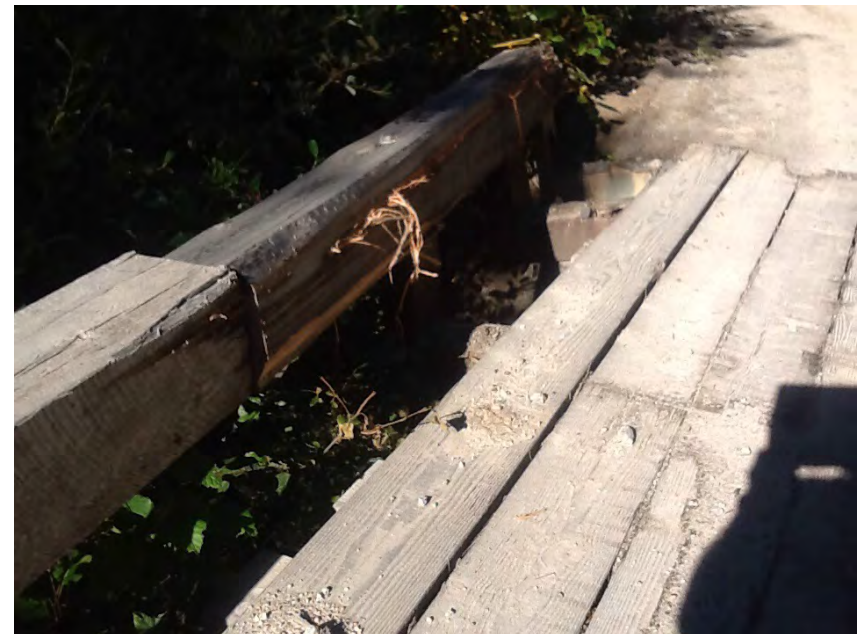
Guard Rail

| Curb Rail/Blocks/Posts | Fair | DSRB curb rail has been struck and damaged and a tie has broken. Needs replacement. |

| Item | Priority | Repair Description |
|---|---|---|
| 3 | Medium | Replace damaged curb rail and cross tie on DSRB. |

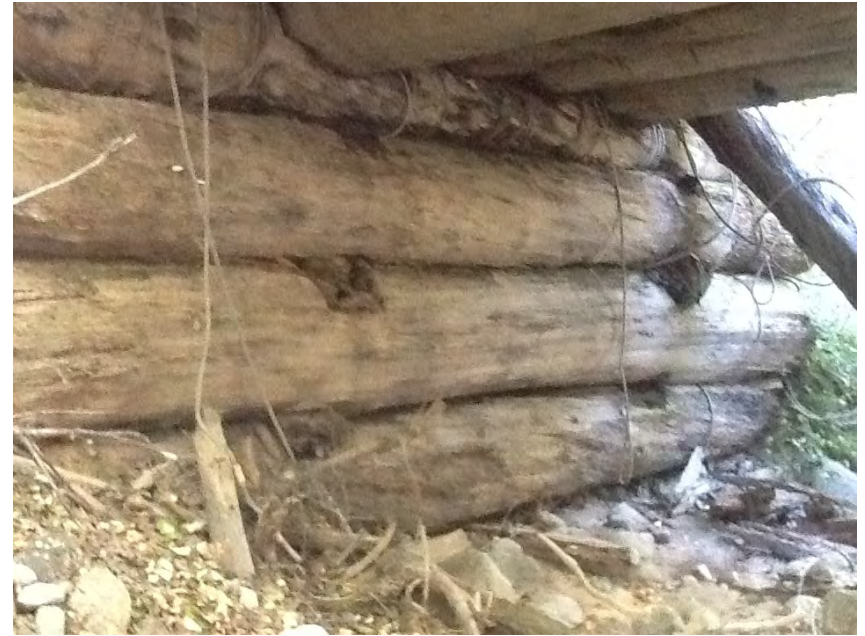
Left Bank Abutment when facing downstream

Left log sill for girder is rotten. Right sill is deeply buried in dirt and could not be assessed.

Left fill has hole at end of deck. Minor scour. Left downstream corner.

Girder is bearing on rotten and/or uncertain materials.

| Item | Priority | Repair Description |
|---|---|---|
| 1 | High | Remove the old log structure from under the steel girders and rebuild the abutments or replace the sills for the girders. Instal fenders. |

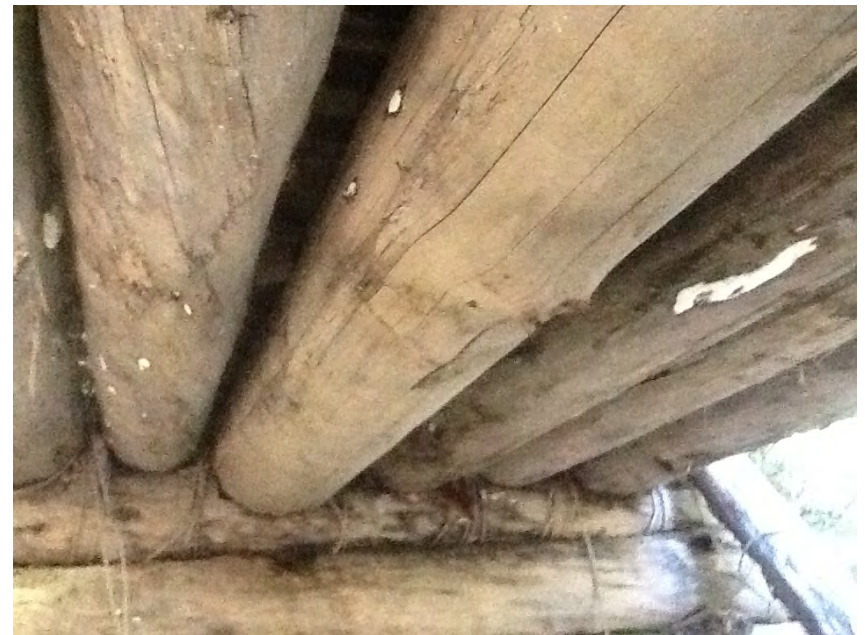
Stringers

6 old stringers poor.

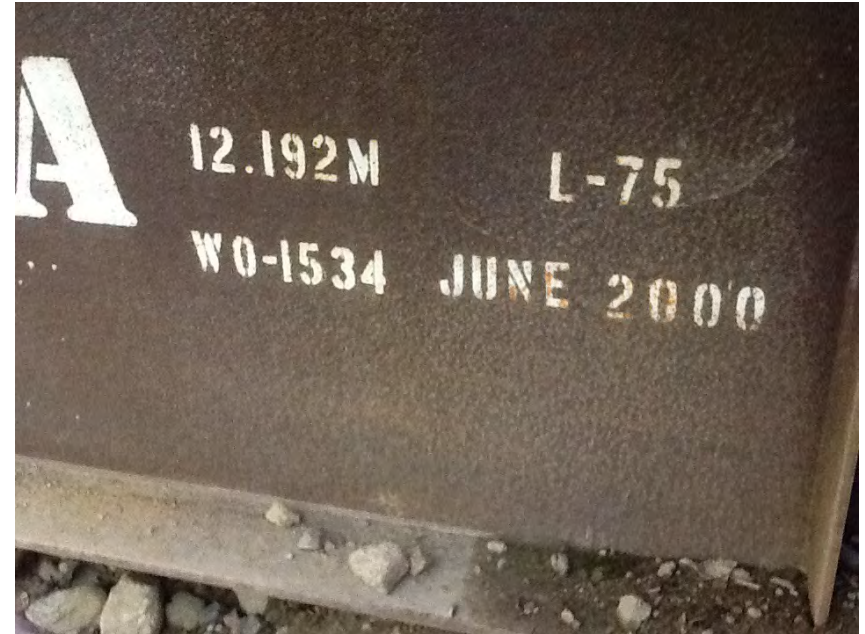
Structure ID

Serial/ID Plate IOTA. WO-1534. June 2000. L-75. 12.192m
