CK-2304

UZTLIUS-E ANDERSON 6.6km

2016 Inspection

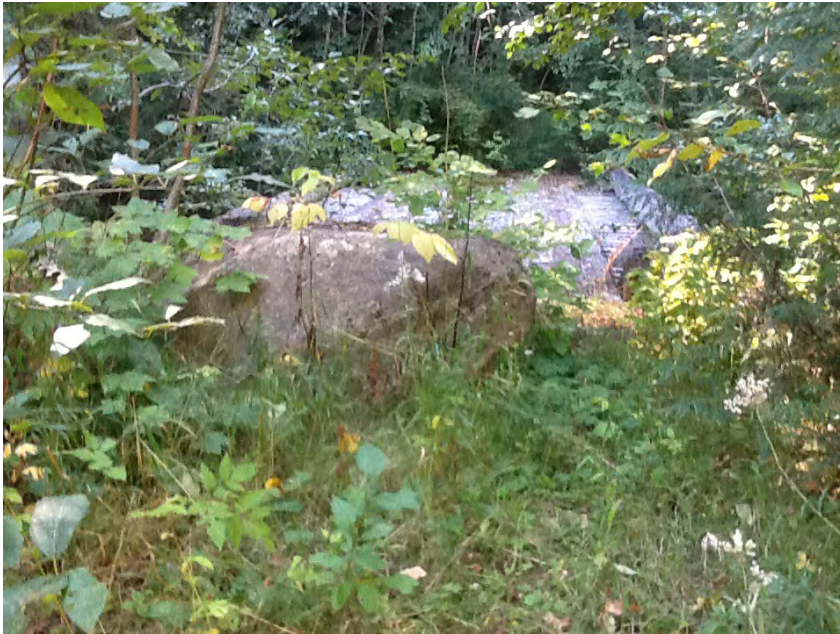
Right approach facing structure

Not posted but has Boulder barrier.

0 tonnes load rating. Post load rating sign and consider blocking access more securely or removing the entire structure. This structure is not on the existing 7972.02 branch, and rather appears to be on a non-status road. Consider removing this structure from inventory.

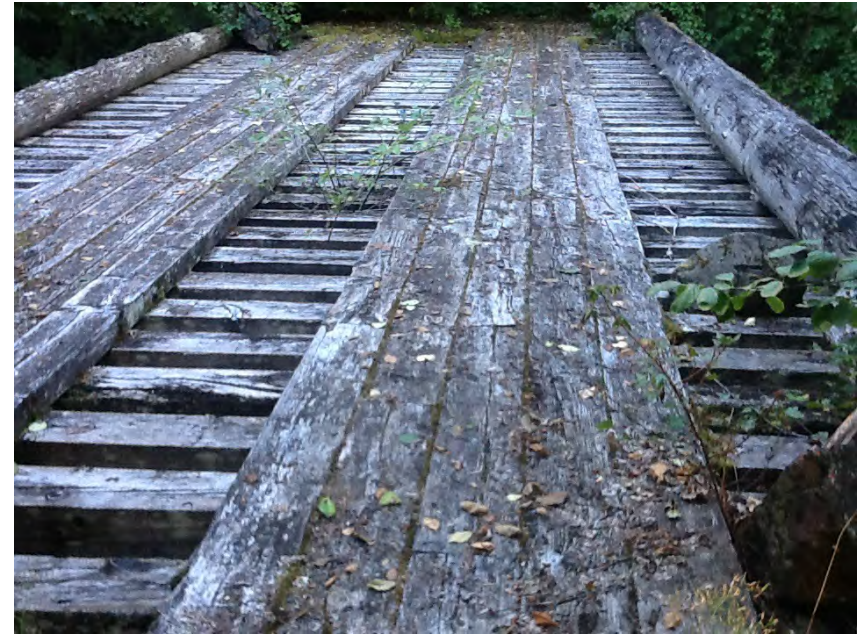
| Running Planks | Poor | Rotten |
| Ties | Poor | Rotten |
| Curb Rail/Blocks/Posts | Poor | Blocks and rails rotten. |
| Overall Deck Condition | Poor | All deck components are rotting and poor. |

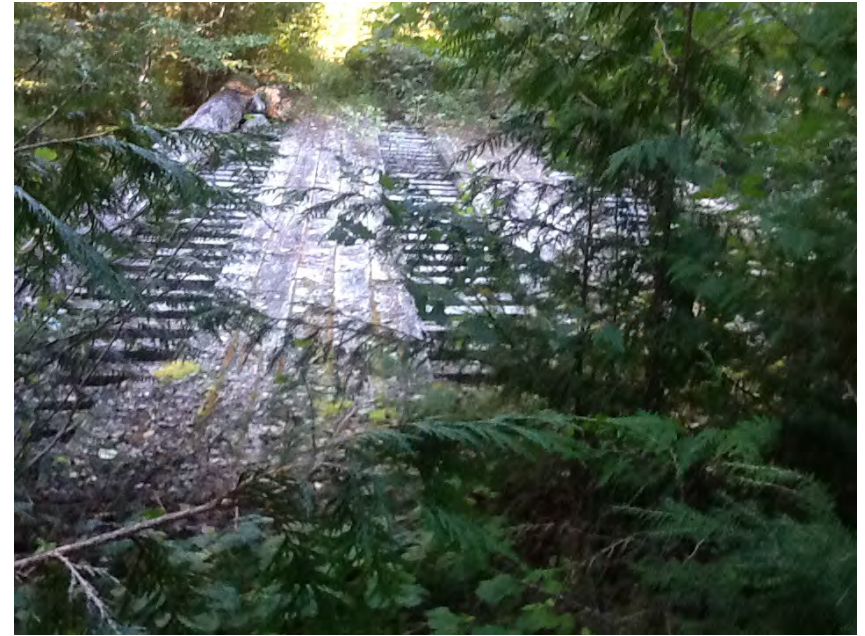
Left approach facing structure

Left approach has tight curve

Very heavy brush on road and structure.

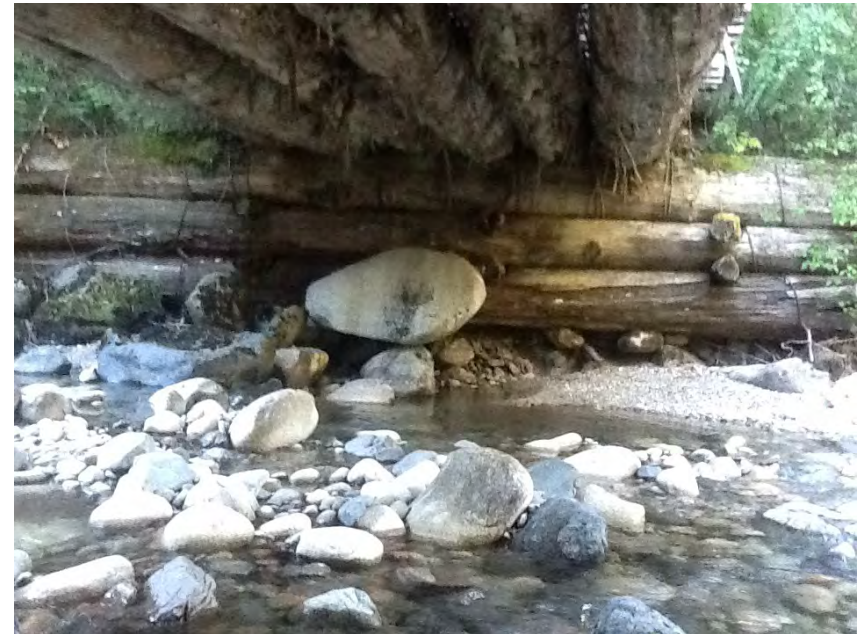
Left Bank Abutment when facing downstream

Saprot but appear sound inside. Scouring on both for full length of bottom sill.

Rotten

There is only a remnant of riprap left, on the USLB.

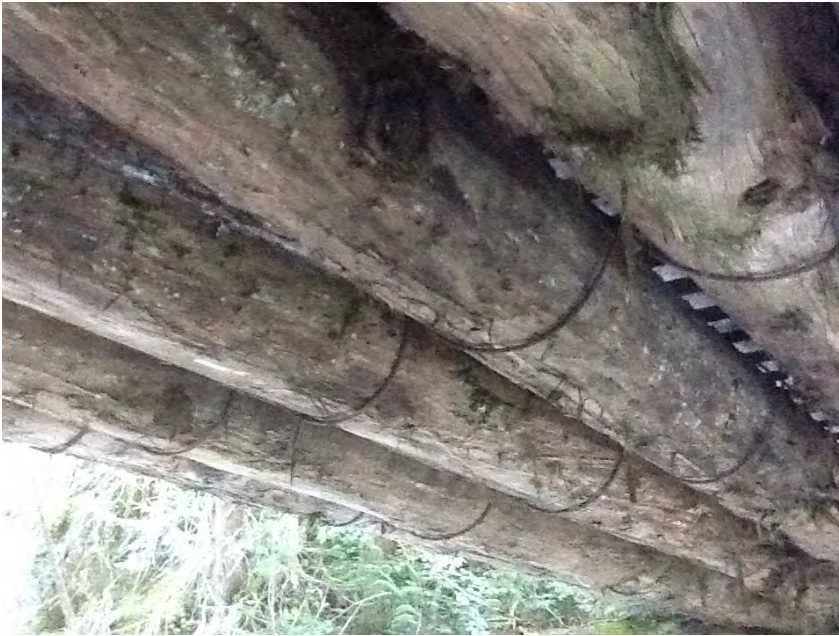
Stringers

No drilling done but past inspections indicate

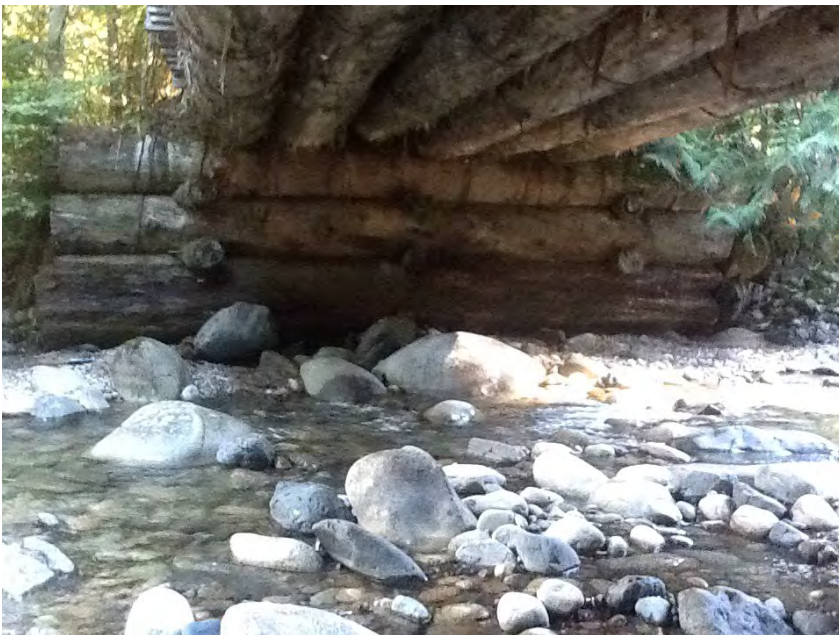
Right Bank Abutment when facing downstream

Right bottom sill log scoured for full length and right sill scoured on downstream half.
