CK-2305

UZTLIUS-E ANDERSON 11.7km

2016 Inspection

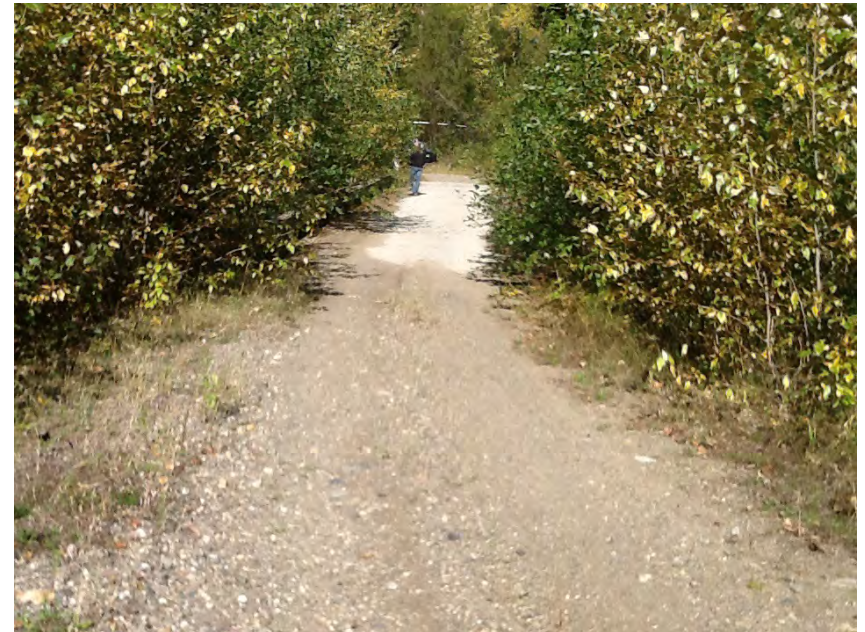
Left approach facing structure

Sediment running onto left end of deck.

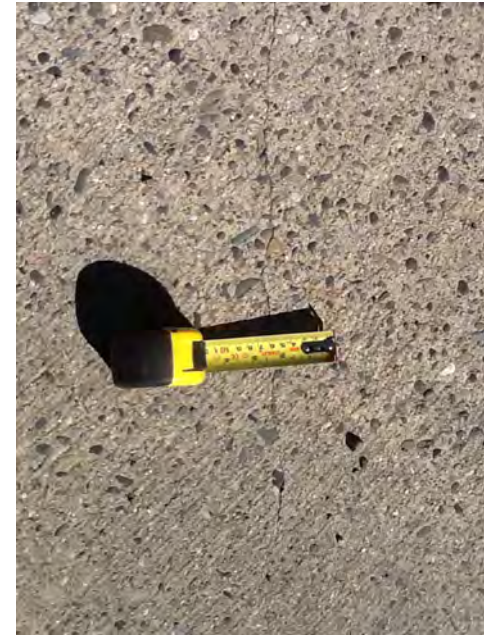
Bridge needs new curbs and brushing before industrial use. The 4th and 5th panels from the left end have diagonal cracks 3.3m long on the surface but they are not on the bottoms of the panels. Deck is worn and pitted. On the right end of the right panel the bottom edge of the panel is heavily chipped with a piece 80x20cm removed, exposing rusting metal rebar. Monitor panels. See photos.

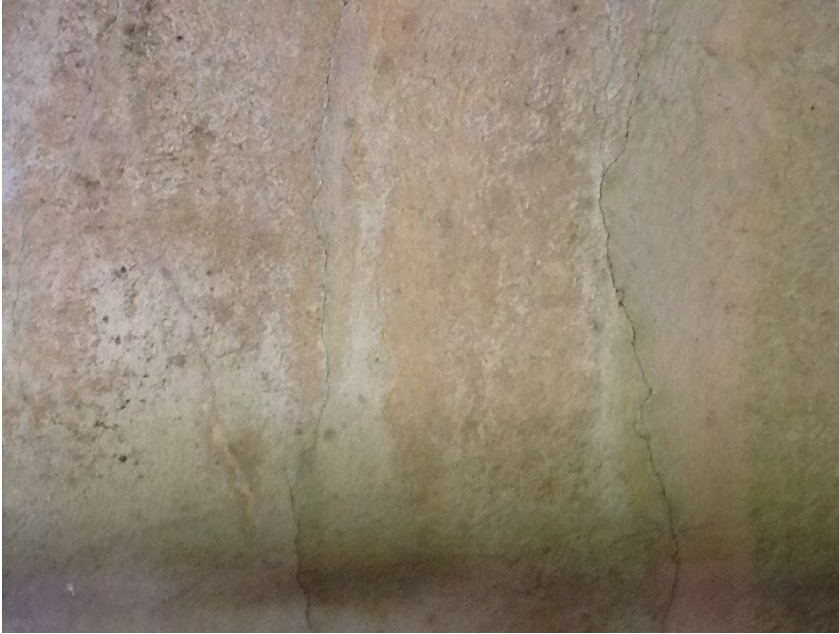
Right Bank Abutment when facing downstream

The right ballast wall has a network of cracks with 4 cracks in the centre portion of the wall. One set of 2 cracks extends from top to bottom. Crack width is 1mm. See photo.

| Item | Monitor Description | Frequency |
|---|---|---|
| 1 | Monitor cracks in right ballast wall and in 4th and 5th deck panels. | Routine Inspection |
