CK-2306

UZTLIUS-E ANDERSON 27.2km

2016 Inspection

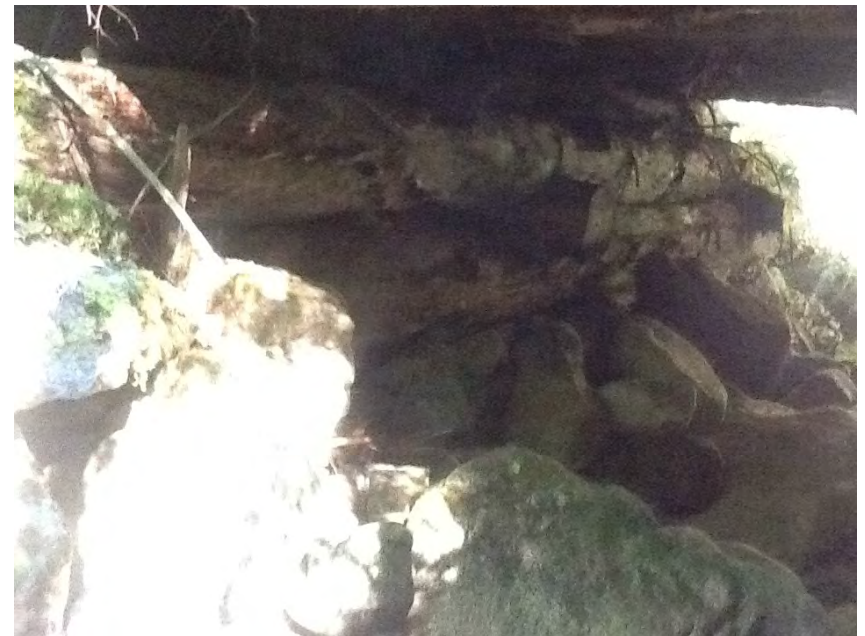
Left Bank Abutment when facing downstream

Log/Timber Cribs Poor The right crib has significant scour. The cribs act to hold fill for the sill logs and do not support the stringers. Both have sap rot up to 50mm.

Caps or Sills Poor Sill logs are just behind the top crib logs. Left has 25mm of rot. Right side could not be reached but has scour under half its length.

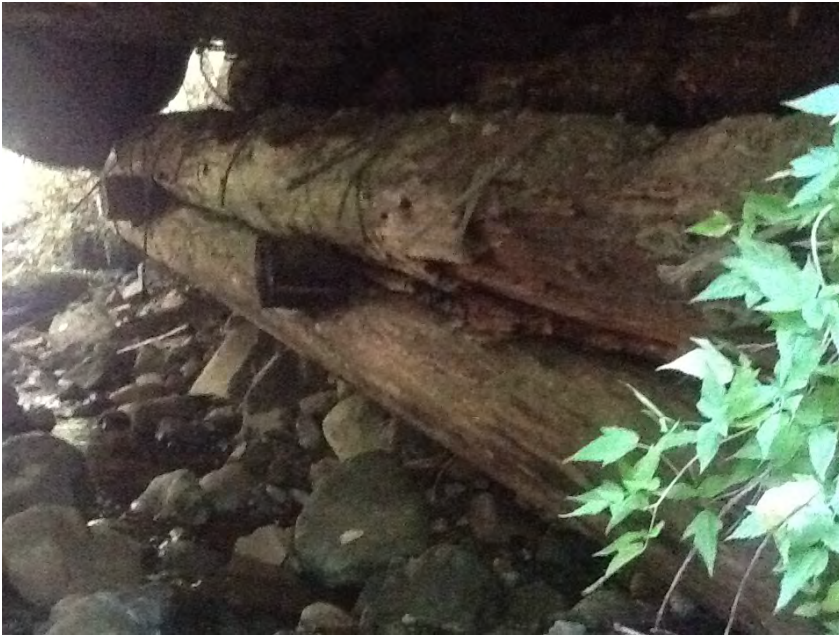
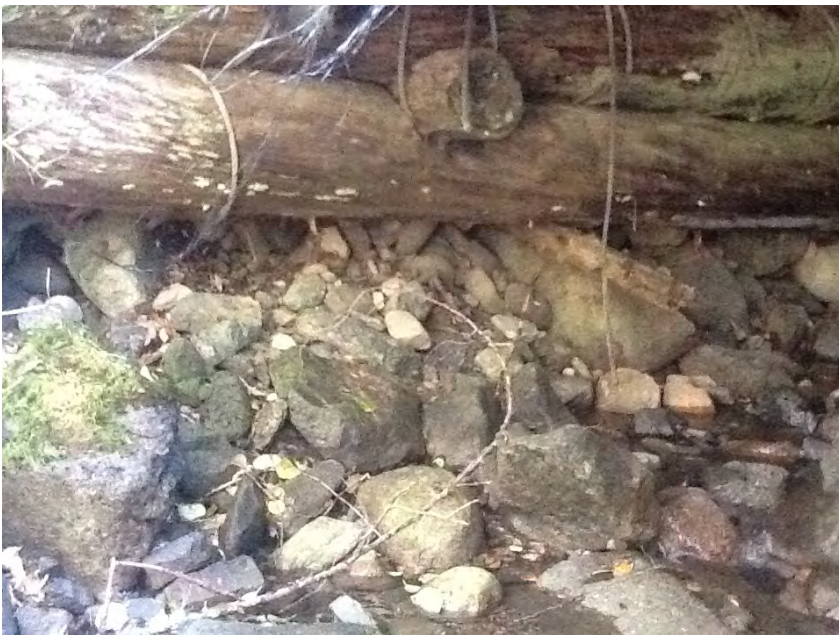
Right Bank Abutment when facing downstream

Bearings Poor Due to undermined sill on right bank.

Comments    Scour under right abutment. This may be affecting the scour under the right sill log.

| Item | Monitor Description | Frequency |
|---|---|---|
| 1 | Monitor for continued scour under right sill and crib. | Routine Inspection |

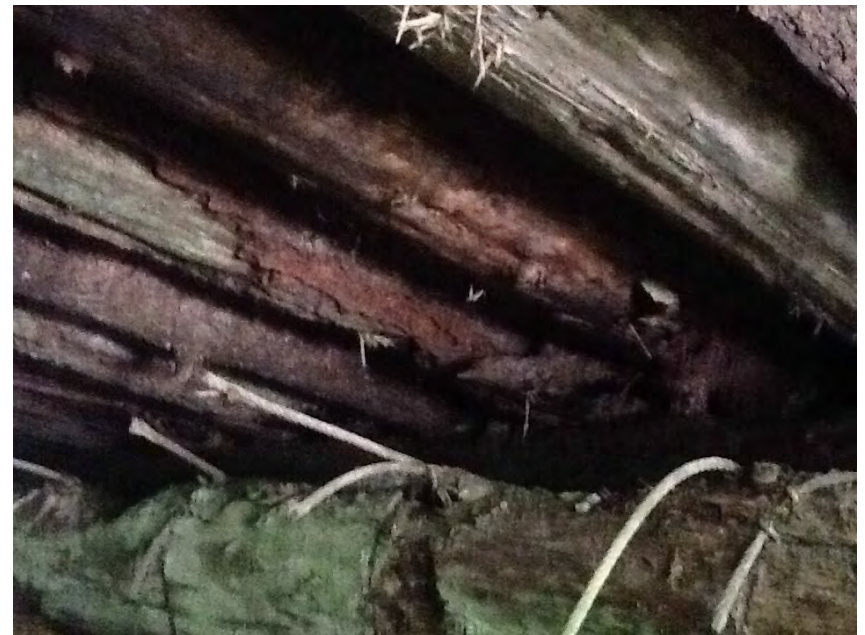
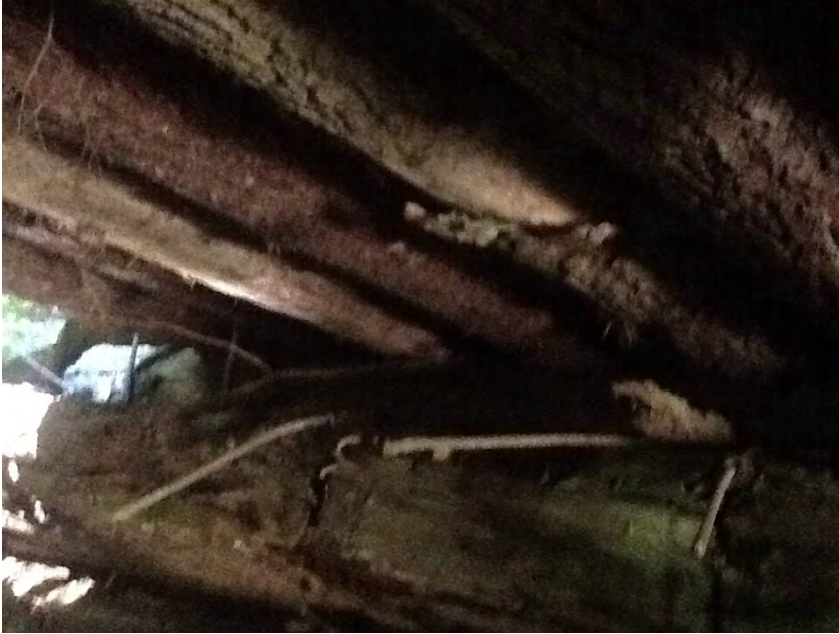
Stringers appear to be reasonably sound for 10 tonnes rating. Replace structure for industrial use due to poor right abutment and reduced capacity of stringers. Note that coring was only possible on the left end of stringers.
