CK-2308

UZTLIUS-E ANDERSON 29.3km

2016 Inspection

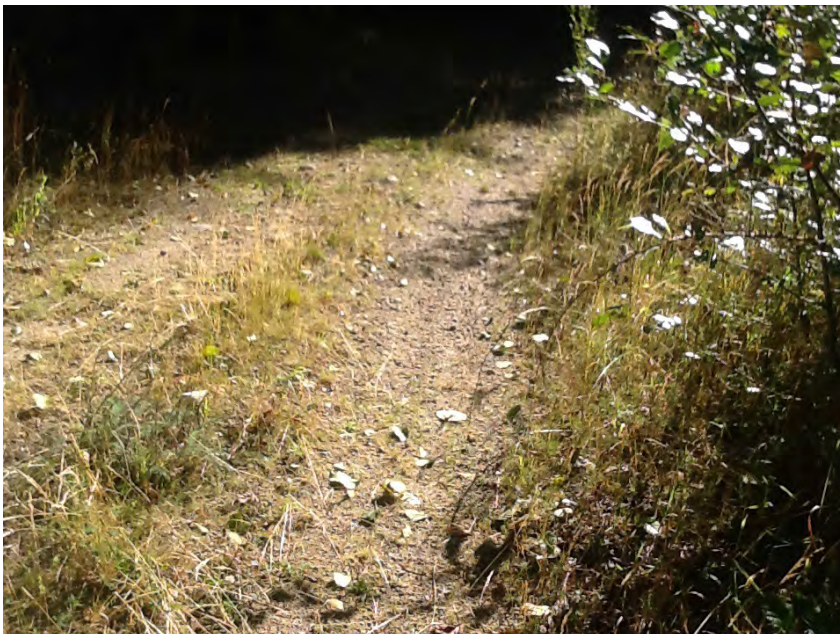
Left approach facing away from structure

Left approach has curve and gradient of 7%.

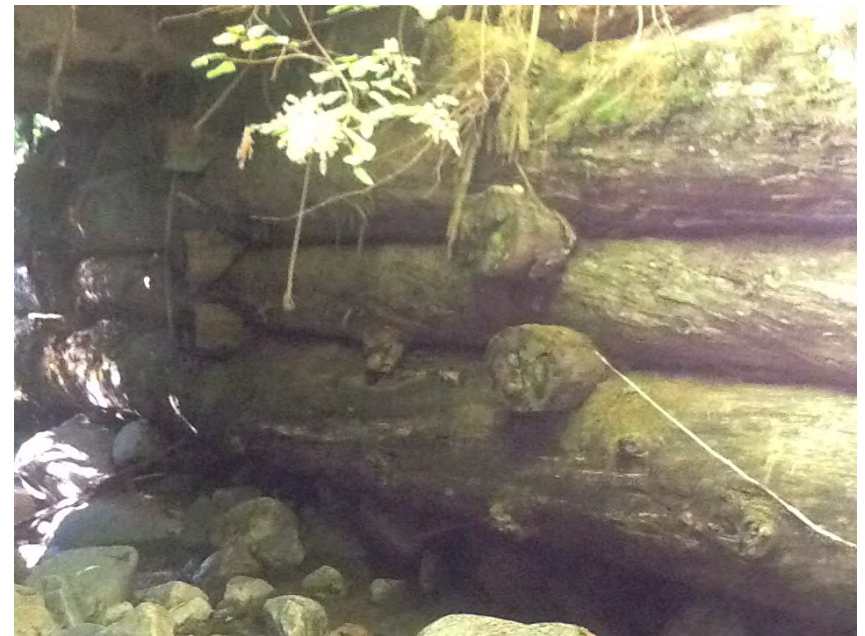
Right Bank Abutment when facing downstream

The old crib is used to contain fill that supports the sills for the steel girders. The crib is rotten but not failing. There is heavy scour under the right crib.

Sills have 100mm of rot. The right sill is heavily scoured on the upstream side.

Right sill is undermined on upstream end.

| Item | Monitor Description | Frequency |
|---|---|---|
| 2 | Monitor right sill for failure from scour. | Routine Inspection |

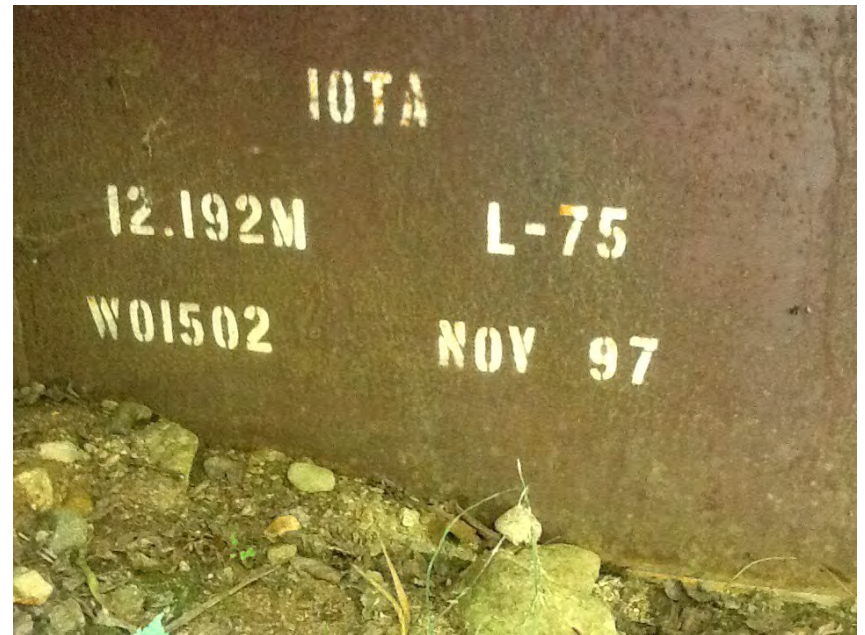
Structure ID

Serial/ID Plate IOTA 12.192m. L75. WO 1502. NOV 97
