CK-2327

STAVE RIVER 0km

2016 Inspection

| Road Name | STAVE RIVER | | |

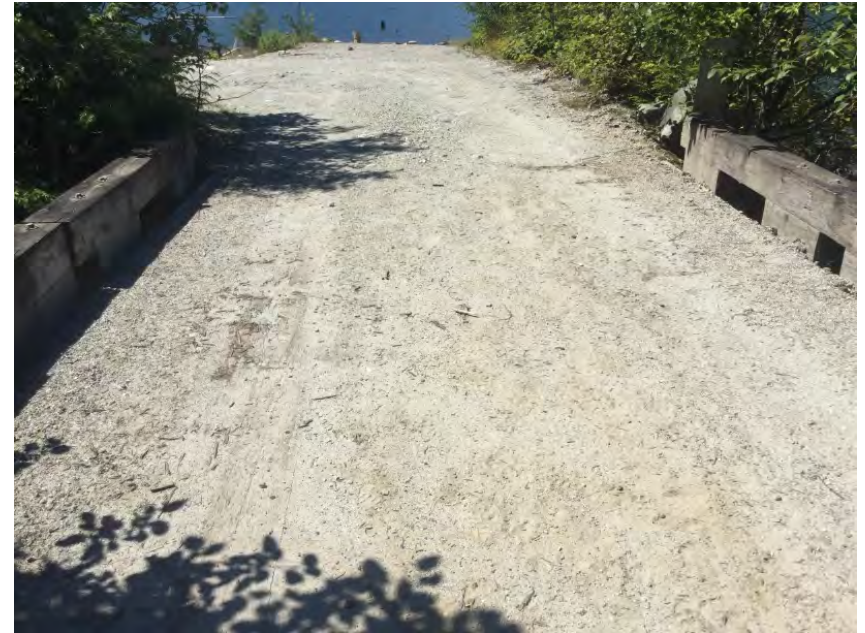
| Running Planks | Poor | Limited amount of deck visible due to debris accumulation. Heavily worn planks. |
| Overall Deck Condition | Poor | Heavily worn deck planks. |

| Item | Priority | Repair Description |
|---|---|---|
| 1 | High | Replace timber sills. Requires 2 4500x400x300 mm timbers. Replace ballast walls. Requires planks for 4500x650 ballast wall. Replace running planks. Requires 100 mm thick planks for 4.9 m wide, 7 m long deck. |

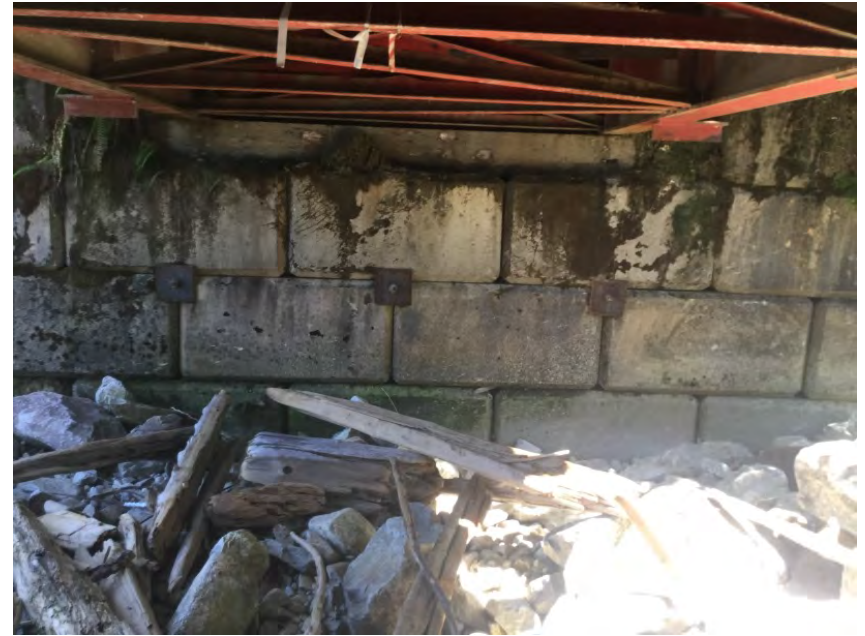
Right Bank Abutment

Right abutment downstream bottom lock block has spalled. It is outside the bearing area of the abutment and does not appear to have deteriorated since previous inspection.

| Item | Monitor Description | Frequency |
|---|---|---|
| 1 | Monitor spalling lock block at right abutment downstream corner. | Routine Inspection |

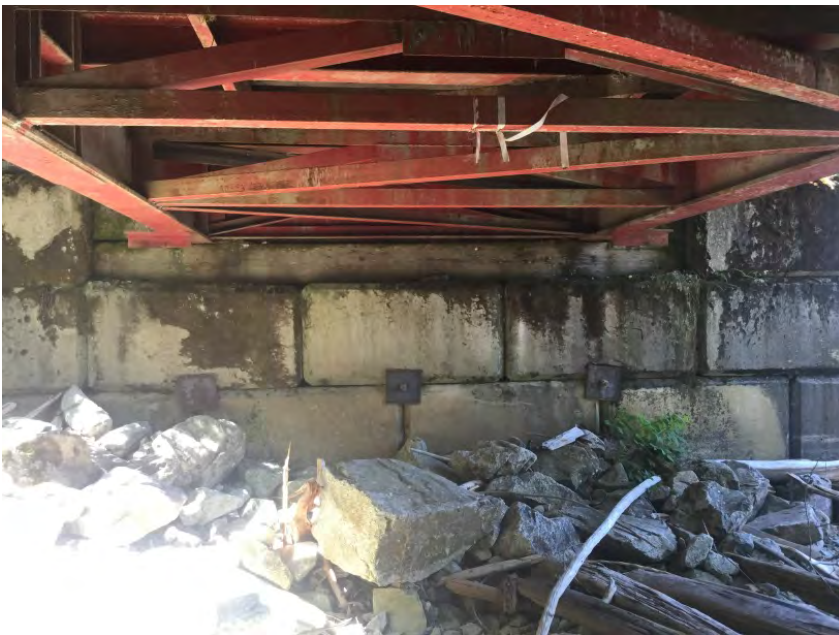
Left Bank Abutment

No access right abutment. Left abutment ballast wall is rotten.

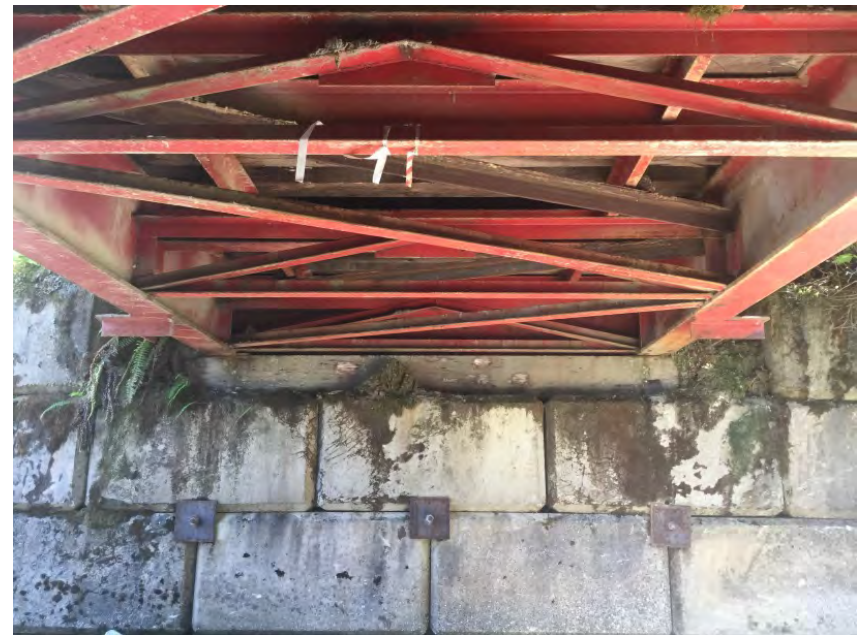
Girders Fair Light surface corrosion where paint has failed.

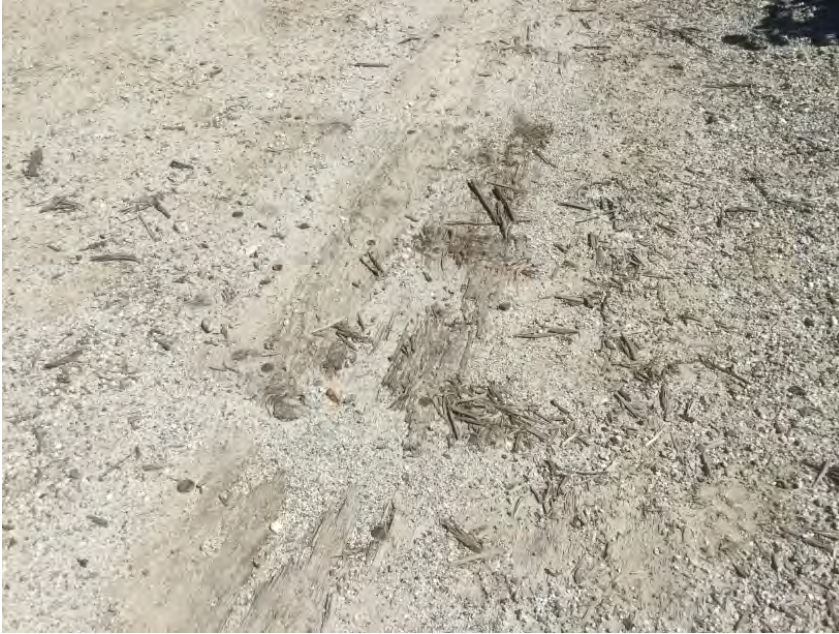
Deck Wear

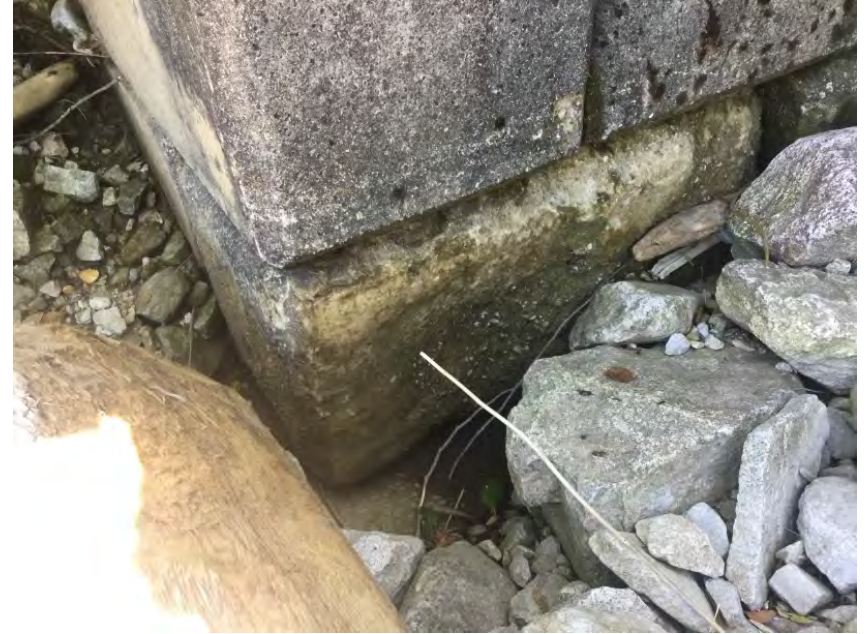
Spalling of Bottom Lock Block at Downstream Left Abutment

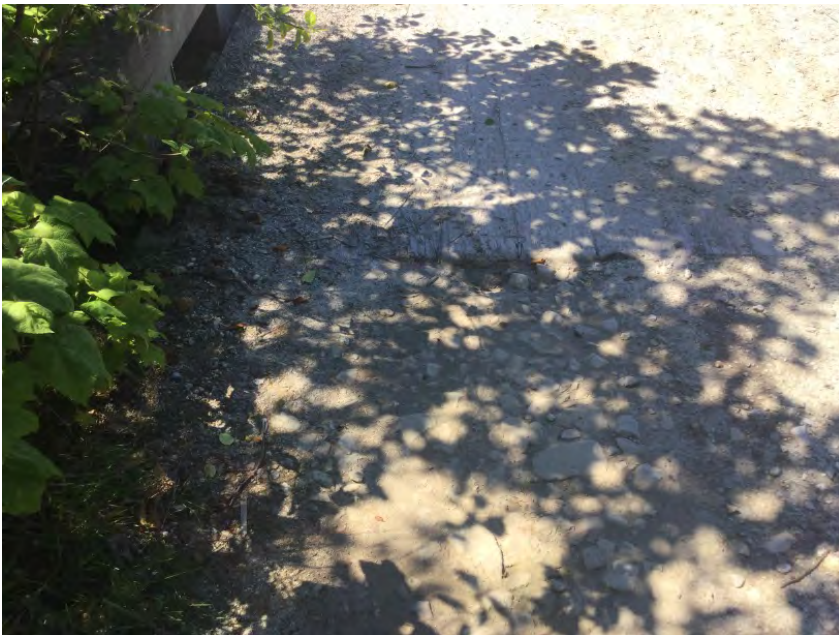
Potholes at approaches have resulted in heavy wear to deck ends.

Pothole in Approach with Worn Wearing Planks

| Item | Priority | Repair Description |
|---|---|---|
| 2 | Medium | Install fenders at all corners, post bridge ahead sign, and grade approaches. |

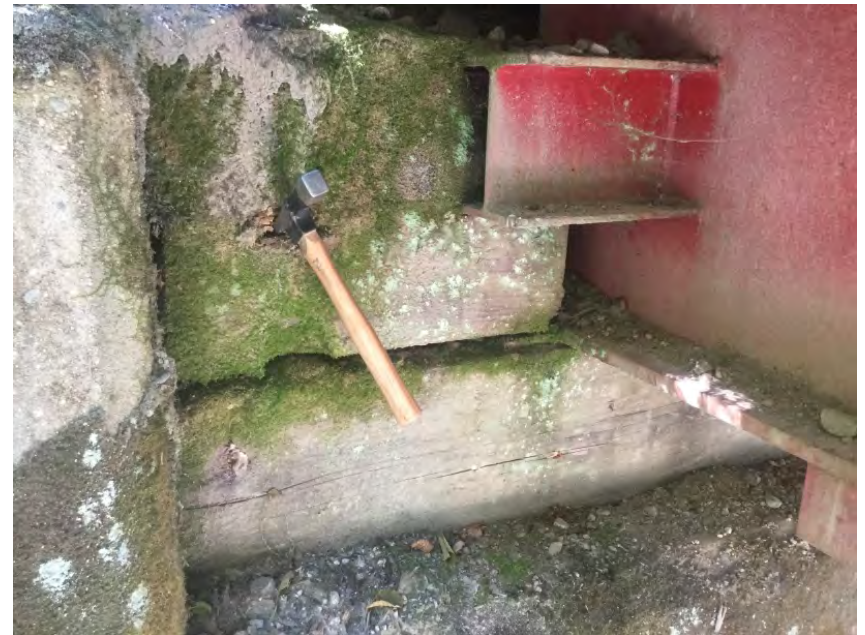
Left Abutment Rotten Ballast Wall

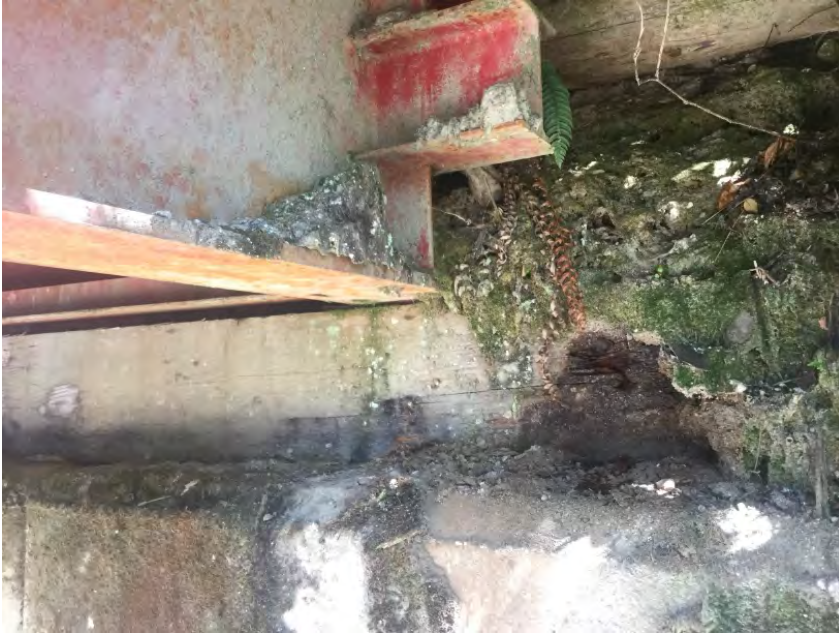
Timber sills. Pockets of rot 90 mm deep below upstream bearings in both sills.

Right Abutment Rotten Sill
