CK-2329

LOST-SOUTH 1.1km

2016 Inspection

| Structure Class | Major Culvert |

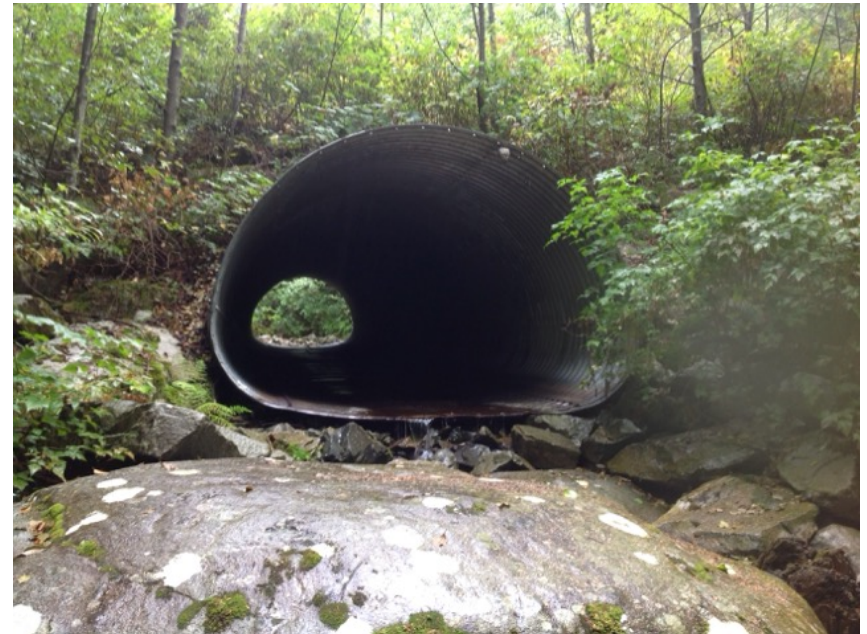
| Outlet | Fair | |

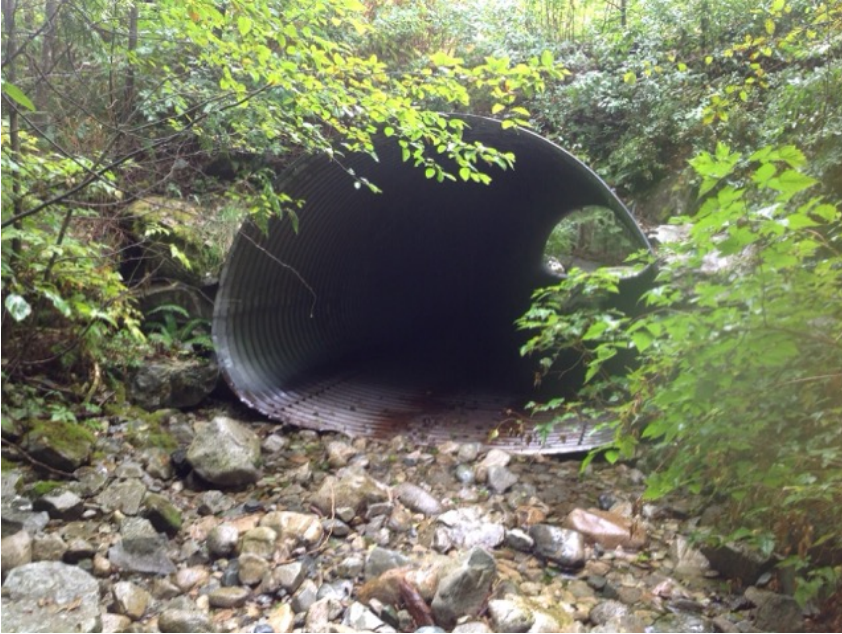
| Inlet | Good | |
