CK-2330

LOST-BLACKLOCK 1.3km

2016 Inspection

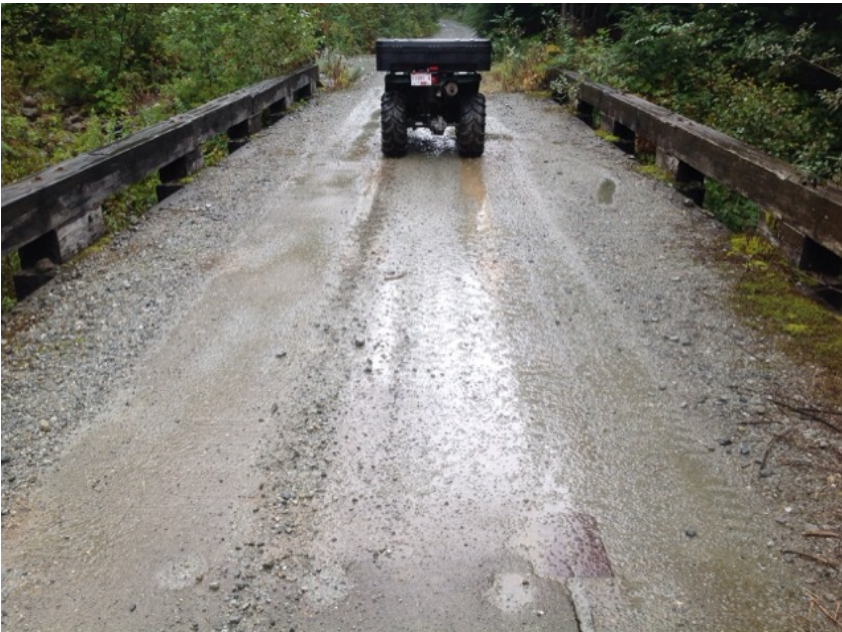
| Curb Rail/Blocks/Posts | Poor | rotten |
| Overall Deck Condition | Poor | due to rail condition |

| Repair Item | Priority | Repair Description |
|---|---|---|
| 1 | Medium | replace rail system prior to activity |
