CK-2331

STAVE RIVER 5.1km

2016 Inspection

| Crossing Name | Camp Creek | | |

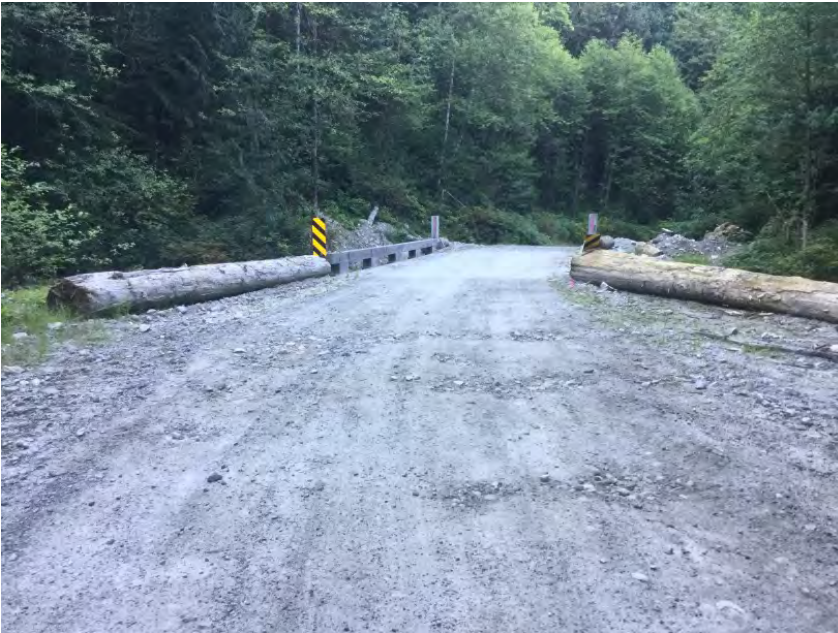
Right Approach Facing Bridge

Fair to poor. Potholes in approach and adjacent to deck end.

| Item | Priority | Repair Description |
|---|---|---|
| 1 | Medium | Install bridge ahead signs and delineator at right approach downstream corner. Grade approaches. Remove debris from deck. |

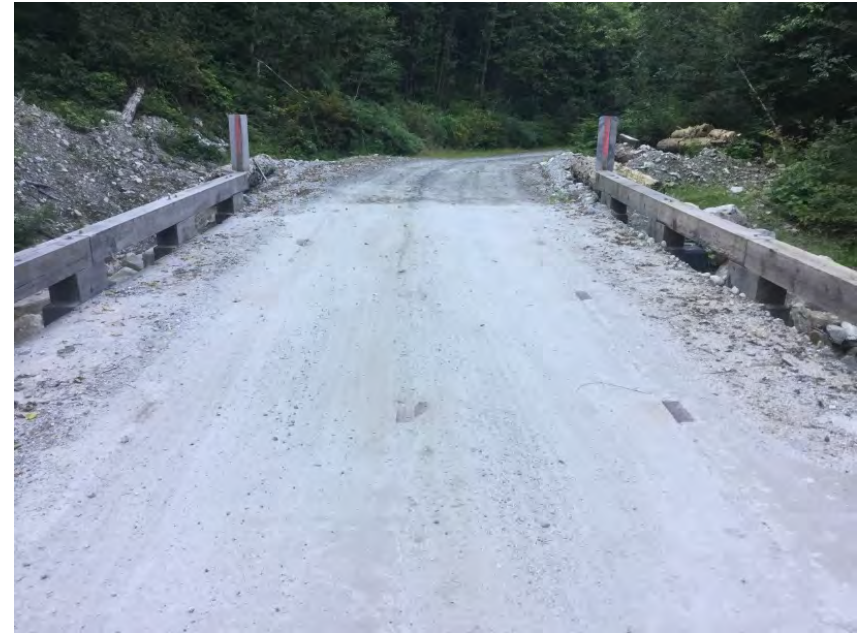
| Concrete Deck | Fair | Some minor tracked vehicle damage. |

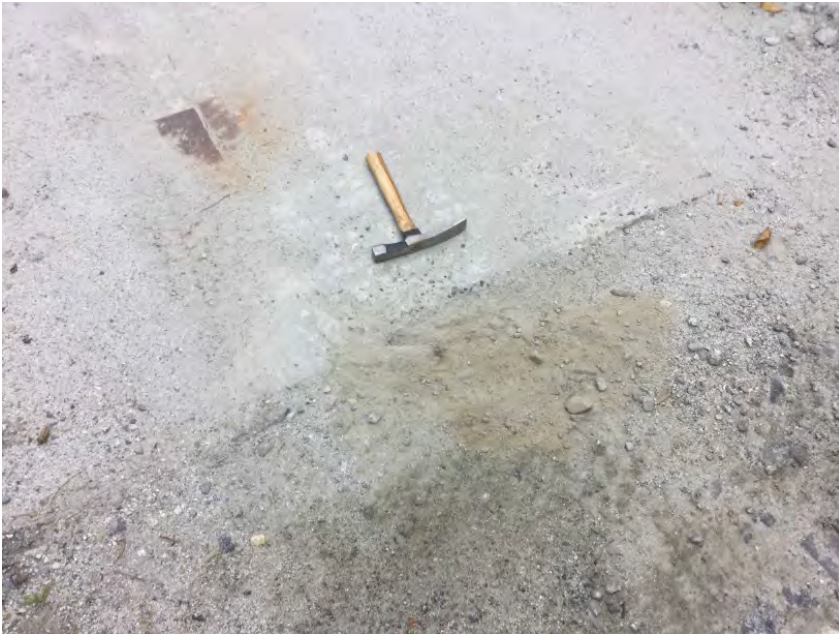
Recycled slab girders. Minor damage at ends, some spalling on edges, staining, moss growth.

Minor Damage to End of Slab at Approach

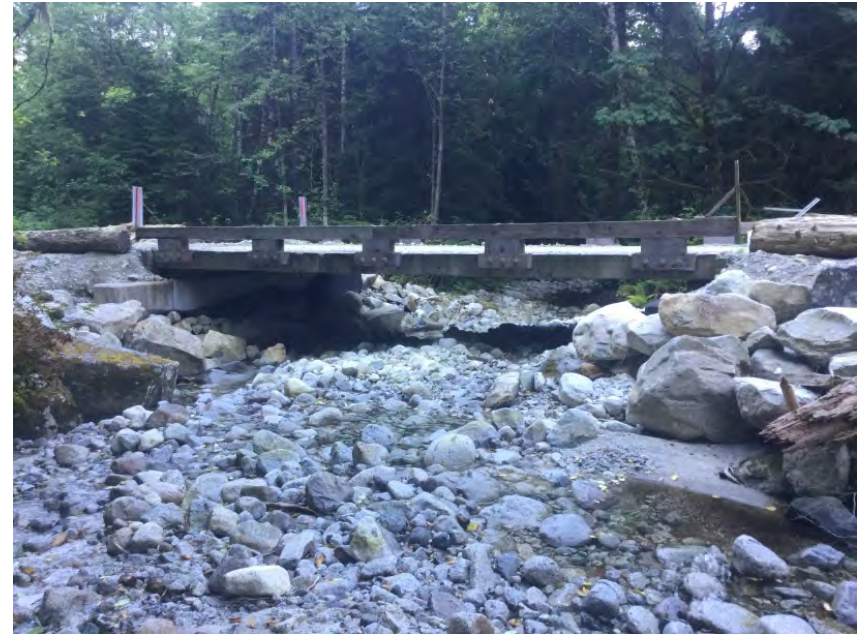
Upstream Elevation

Comments Bridge appears undersized for crossing. 1.4 m high opening with signs of water levels reaching near top of lock blocks. Large woody debris and dead fall upstream. Gravel bars upstream and starting to form under bridge.

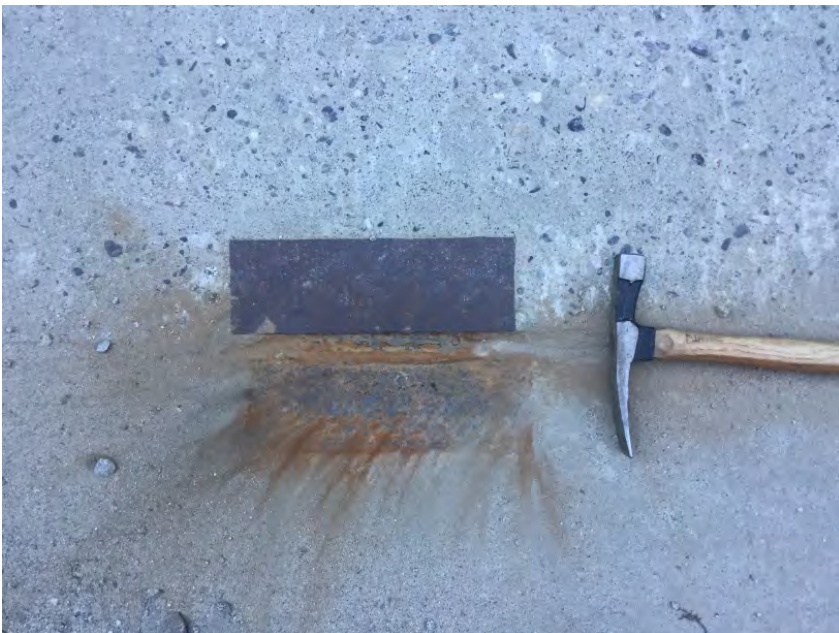
Slight misalignment of welded shear connector. Gap between slabs has been grouted.

Minor Misalignment of Shear Connector

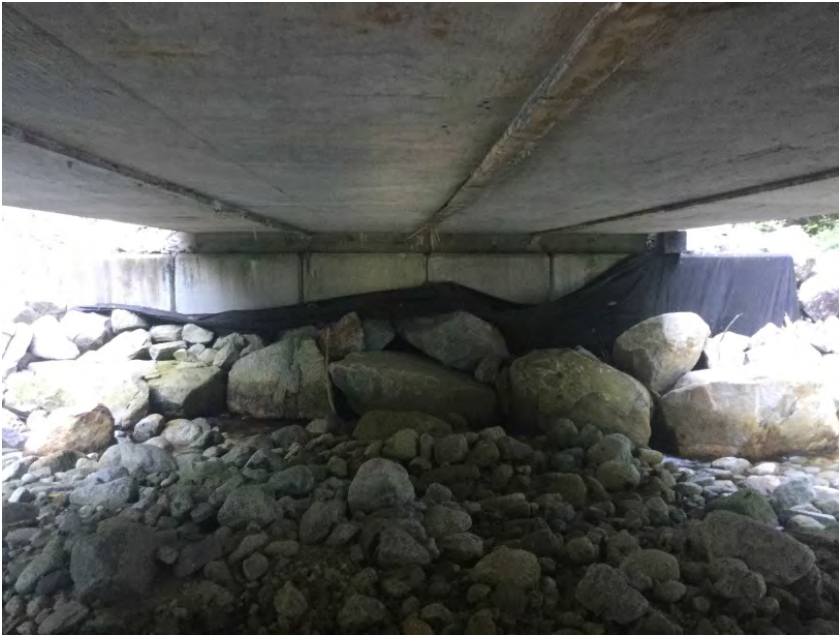
Left Bank Abutment

Lock block abutments.

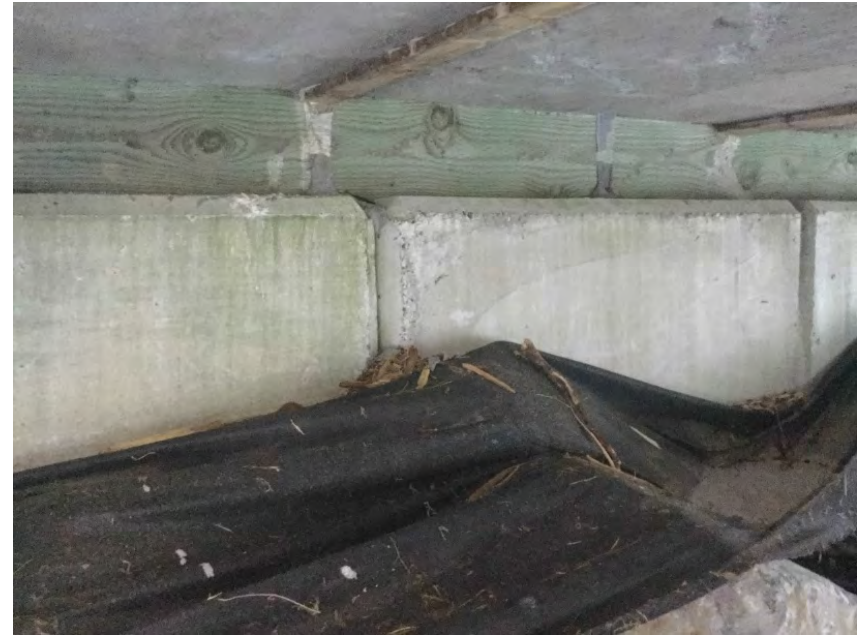
Woody Debris Deposits from High Water
