CK-2333

STAVE RIVER 3km

2016 Inspection

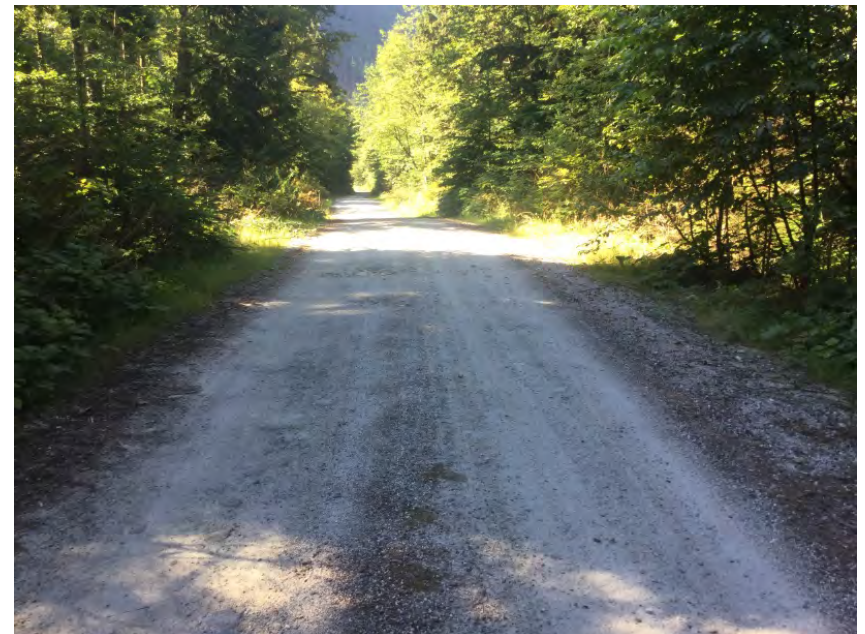
Right Approach Facing Culvert

Road Surface Fair Pothole in approach.

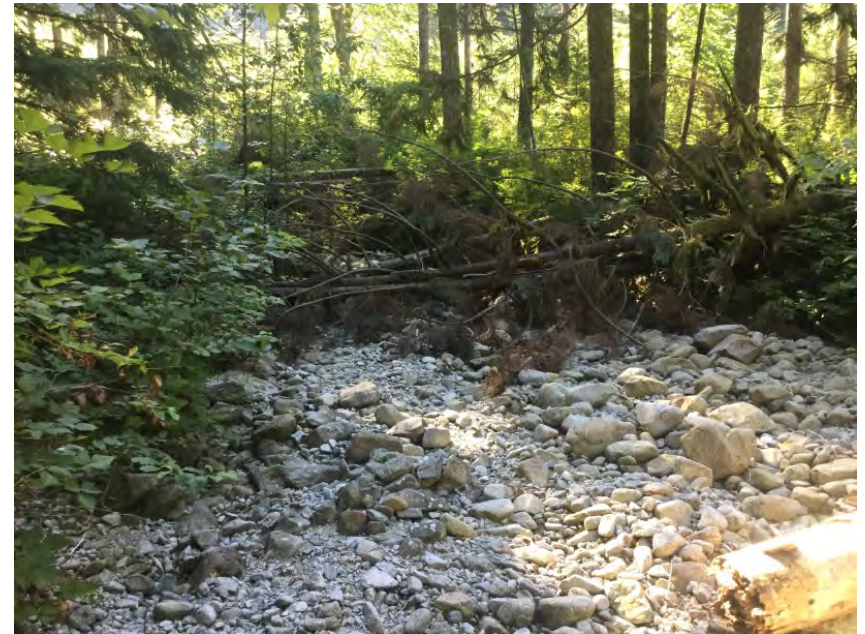
Comments Bed load deposits in culvert 2. Woody debris and fallen trees upstream.

Dead Fall Upstream

1 Monitor woody debris getting caught at inlets and bed deposits in culverts.

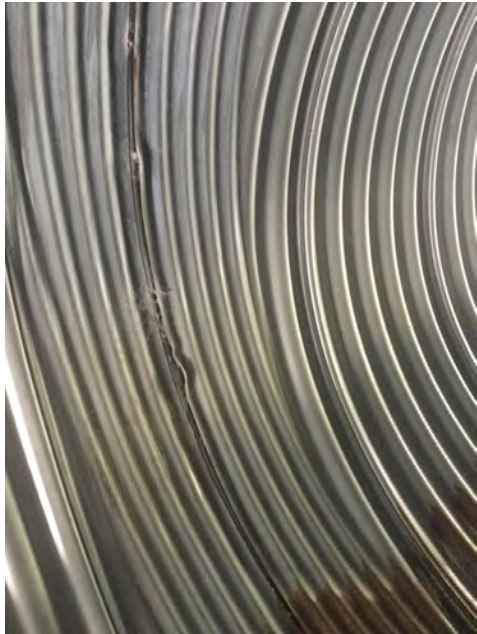
Typical Coupler

| Coupled Connections | Good | |

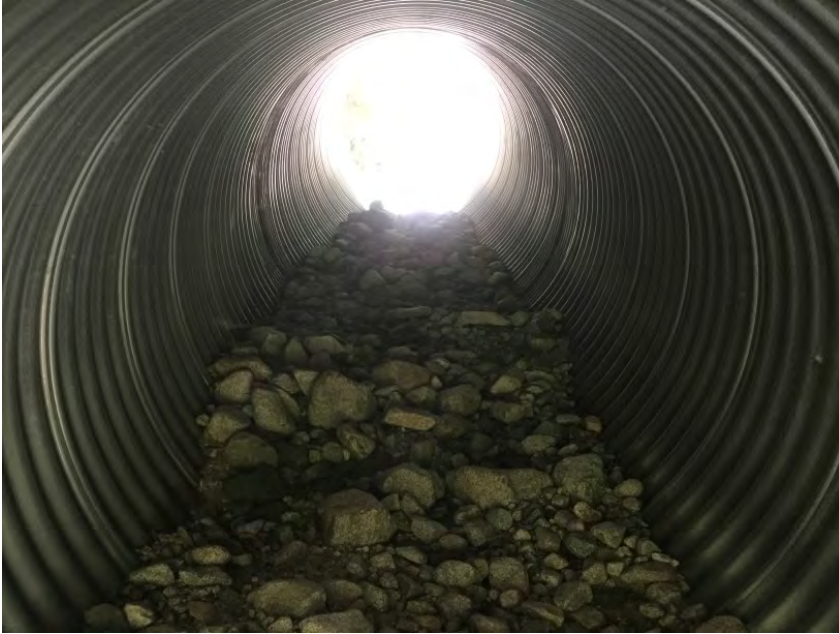
Barrel of Culvert 2

| Floor | Fair | Bed load deposits on floor of culvert 2, limiting inspection of floor. Light flaking on floor of culvert where inspectable. |

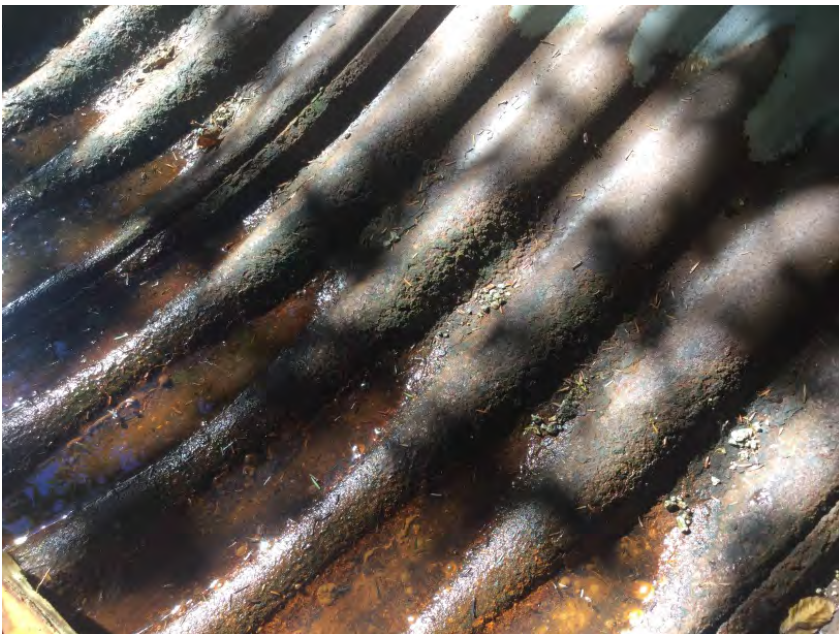
| Coating | Fair | Corrosion on floor of culvert. |

Typical Culvert Floor Corrosion
