CK-2334

STAVE RIVER 4.4km

2016 Inspection

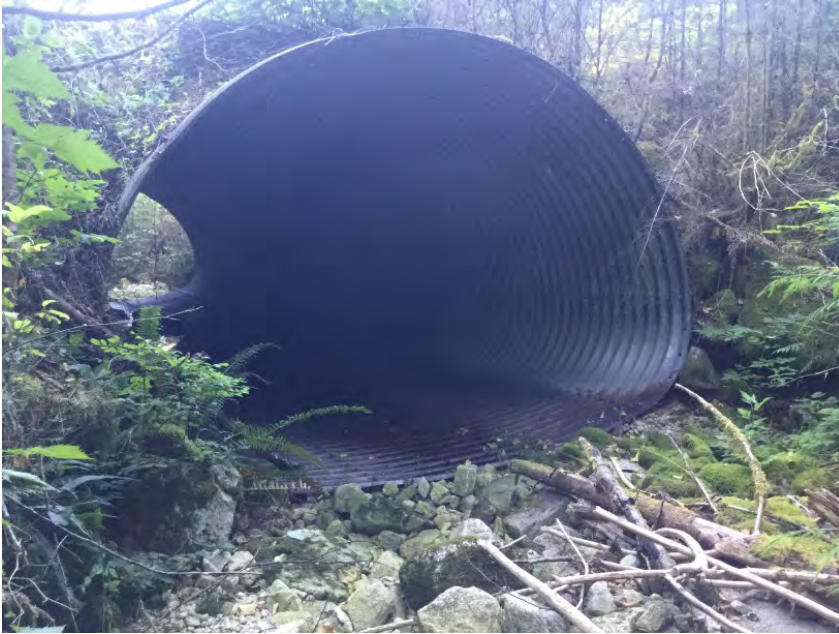
| Inlet | Fair | Light corrosion on top of inlets. |

Inlet 1

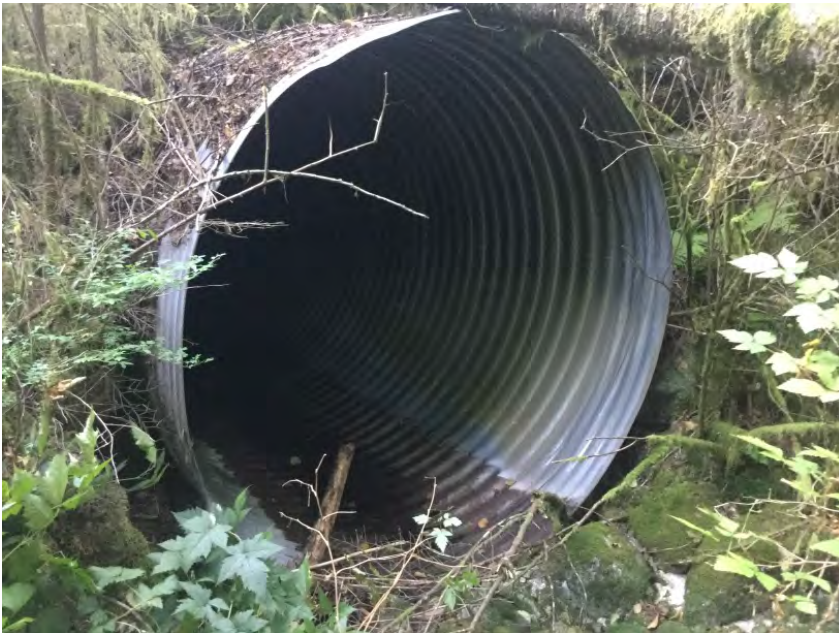
Inlet 2

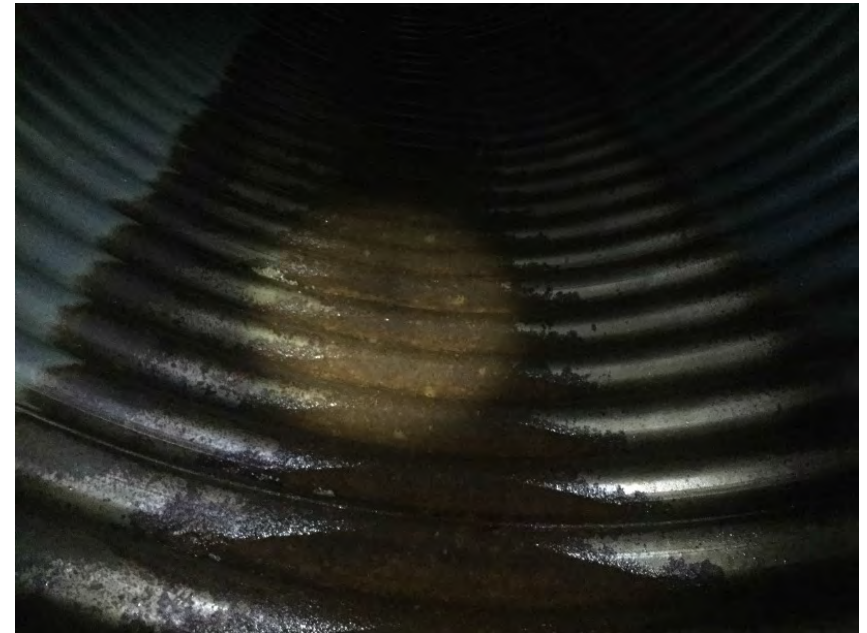
| Floor | Fair | Light minor corrosion on floor of both culverts. |

Floor of Culvert 2

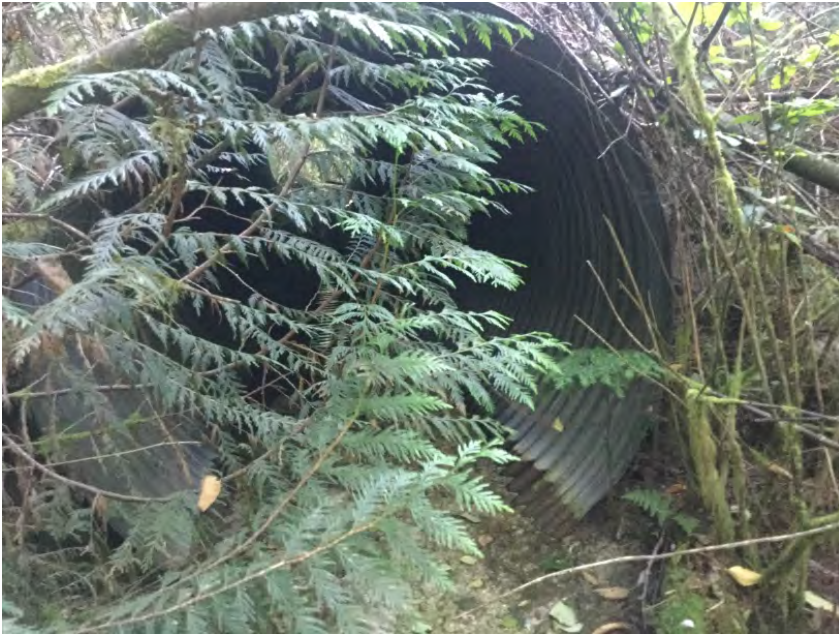
| Outlet | Fair | Light corrosion on top of outlets. |

Outlet Culvert 2

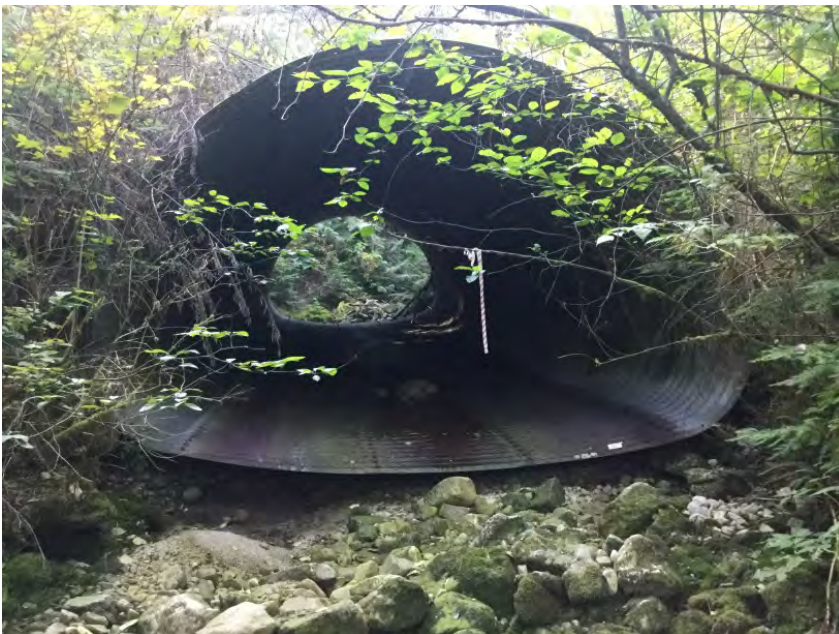
Outlet 1

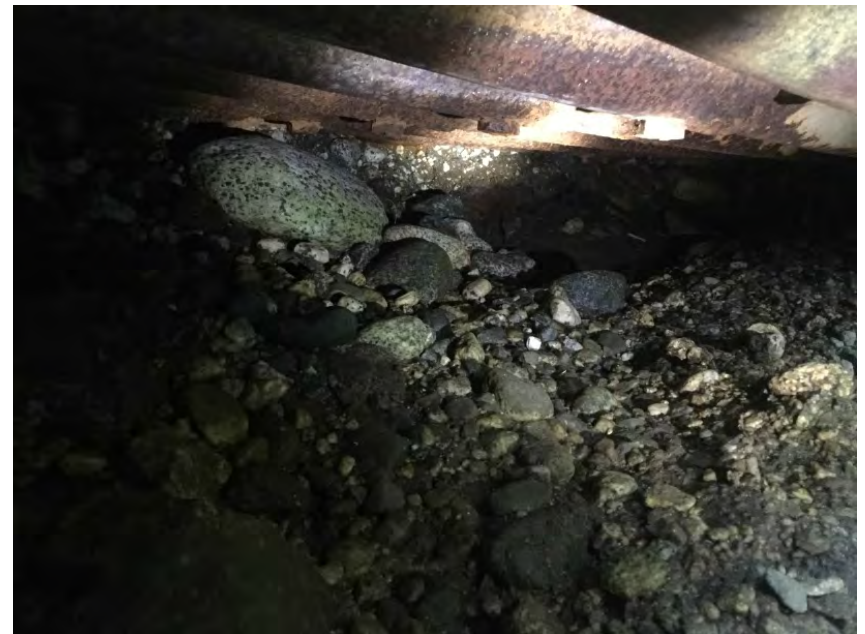
Crossing consists of a multi plate pipe arch and a CSP culvert. 1 m deep scour hole below floor of culvert 1 outlet requires repair and the addition of riprap. Updated user km to 3.7 based on road km markings. Structure appears to be the same as CK-2349, based on photos from 2013 and 2014 inspections, and as stated in 2013 inspection. Edit CBR accordingly.

Comments Dry channel. 1 m deep scour below floor of culvert 1 outlet.

Scour Under Outlet 1

Fill scour under mutliplate at the outlet. Present load rating of L75 or 68 tonnes to continue.

| Item | Priority | Repair Description |
|---|---|---|
| 1 | Medium | Fill scour hole below floor of culvert 1 outlet and place riprap. |

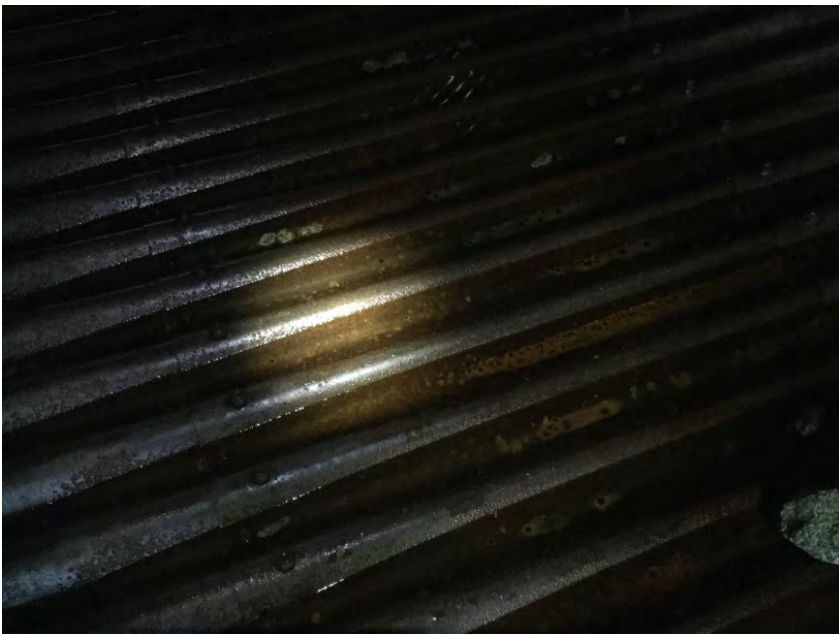
| Bolted Connections | Fair | Light minor corrosion of bolts on floor of culvert 1. |

Floor of Culvert 1
