CK-2335

STAVE RIVER 7.2km

2016 Inspection

| Structure Class | Major Culvert |

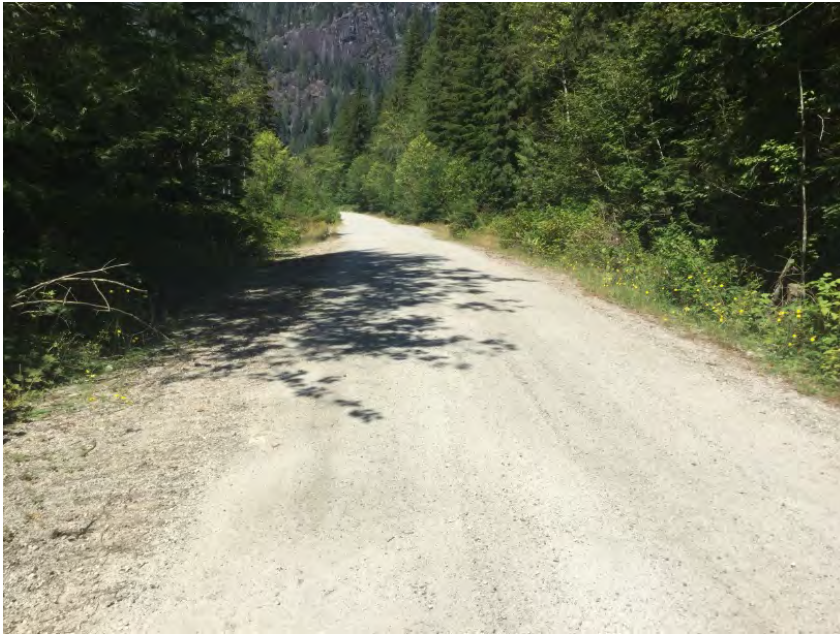
Left Approach Facing Culvert

Horizontal curve.

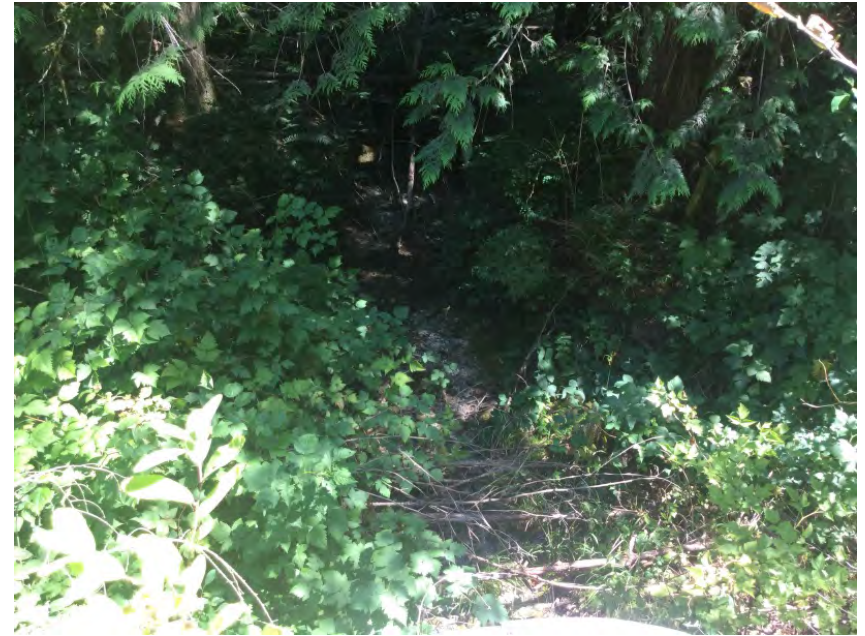
Looking Upstream

Comments    Dead fall covering the channel upstream.

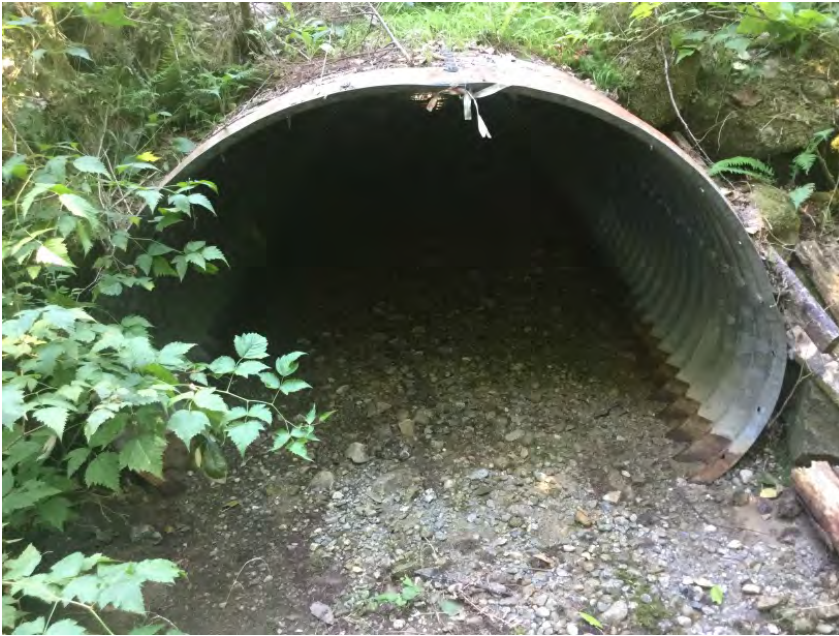
| Outlet | Fair | Light corrosion on top of outlet. |

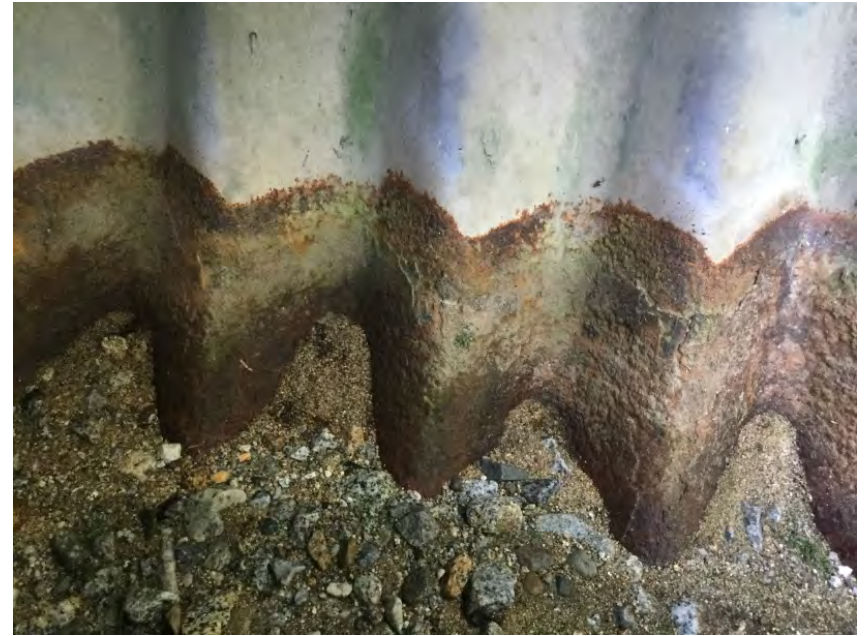
The culvert floor is flaking and pitting and should be monitored during future inspections. The culvert is at a higher chainage than CK-2336. Updated user km to 6.2 based on road km markings.

| Coating | Fair | Flaking and pitting in places on culvert floor. |
| Floor | Fair | Floor covered in debris. Flaking and pitting in places on culvert floor. No holes in visible parts of the floor. |

Pitting & Flaking of Culvert Floor

| Item | Monitor Description | Frequency |
|---|---|---|
| 1 | Monitor the corrosion of the culvert floor. | Routine Inspection |

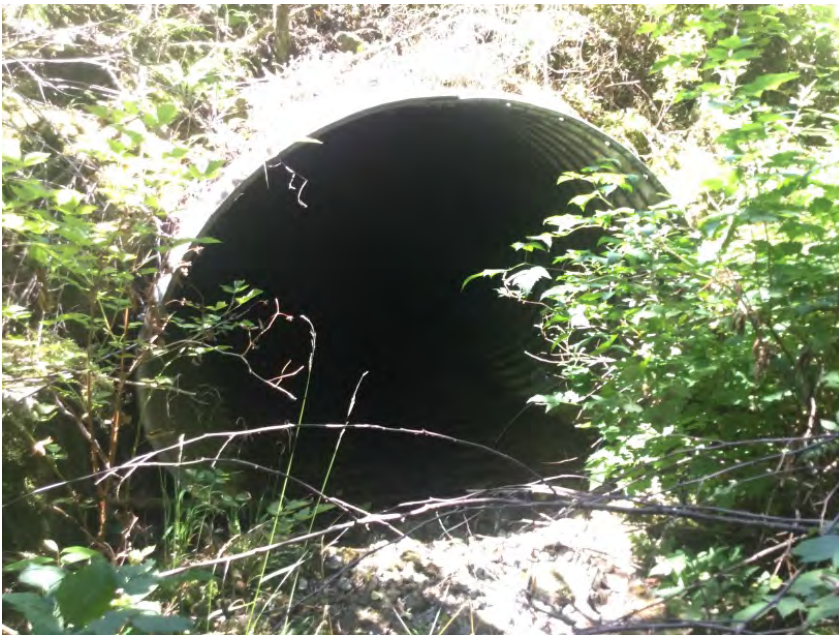
| Inlet | Fair | Light corrosion on top of inlet. |
