CK-2336

STAVE RIVER 7.2km

2016 Inspection

| Structure Class | Major Culvert |

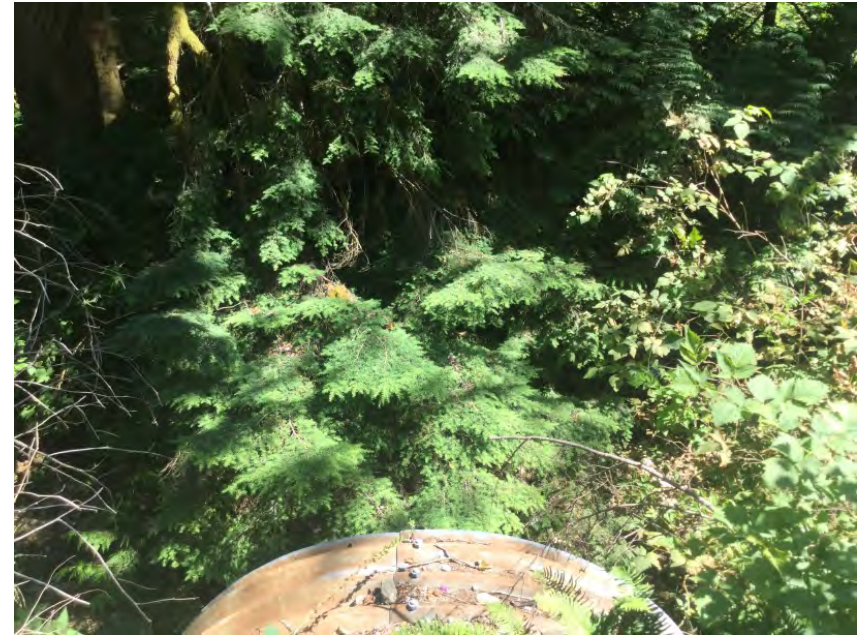
Looking Upstream

Comments Culvert drains channel adjacent to road. Fallen trees in channel upstream.

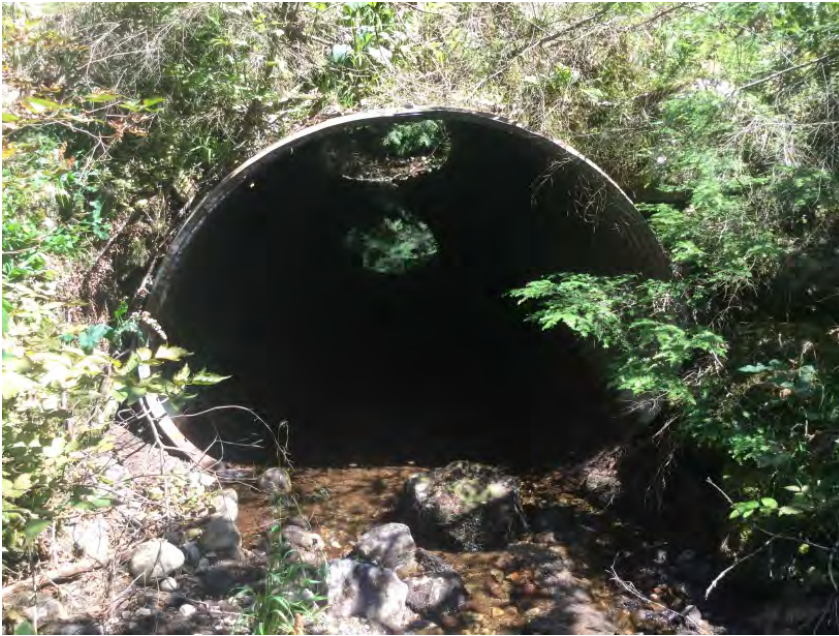
| Outlet | Fair | Light corrosion on top of outlet. |

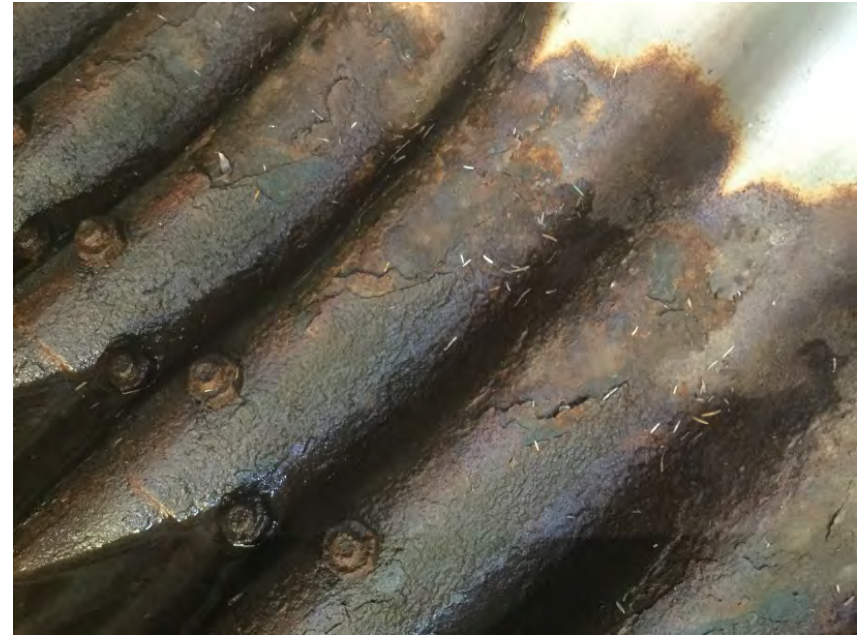
| Bolted Connections | Fair | Corrosion of bolts on floor. |
| Coating | Fair | Corrosion on floor. |
| Floor | Fair | Pitting and flaking on floor. No holes noted. |

Pitting & Flaking of Floor

| Item | Monitor Description | Frequency |
|---|---|---|
| 1 | Monitor corrosion of culvert floor. | Routine Inspection |

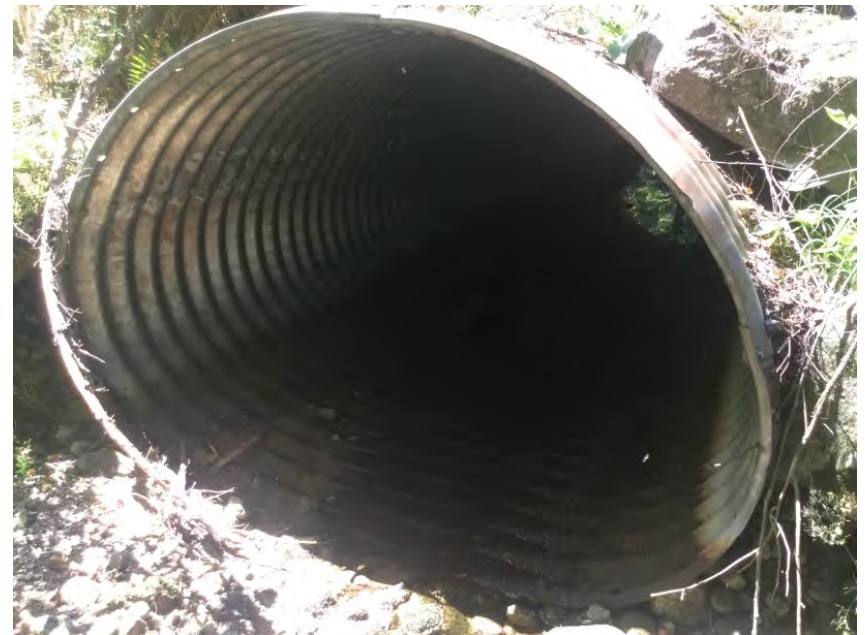
| Inlet | Fair | Light corrosion on top of inlet. |
