CK-2339

STAVE RIVER 13.6km

2016 Inspection

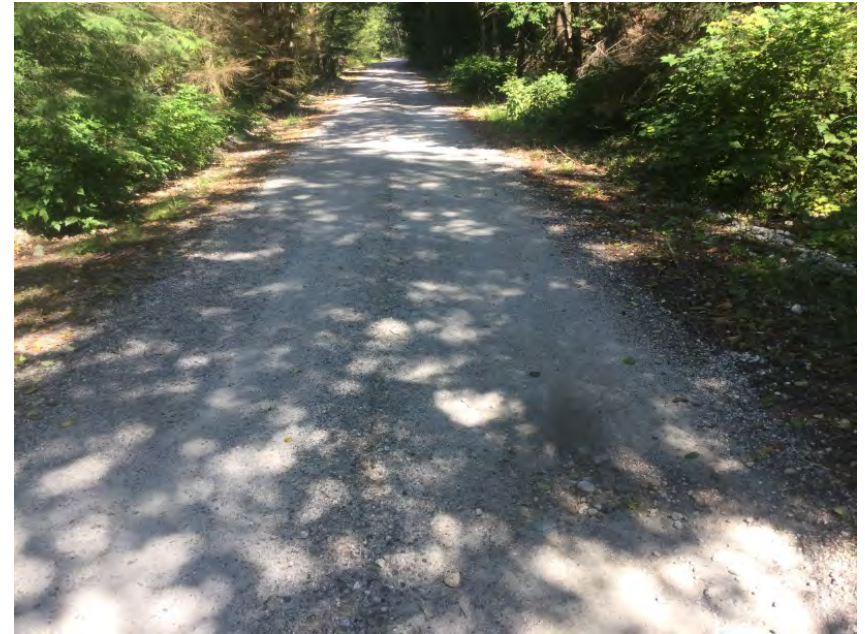
Roadway Over Culvert

Road Surface Fair Pothole.

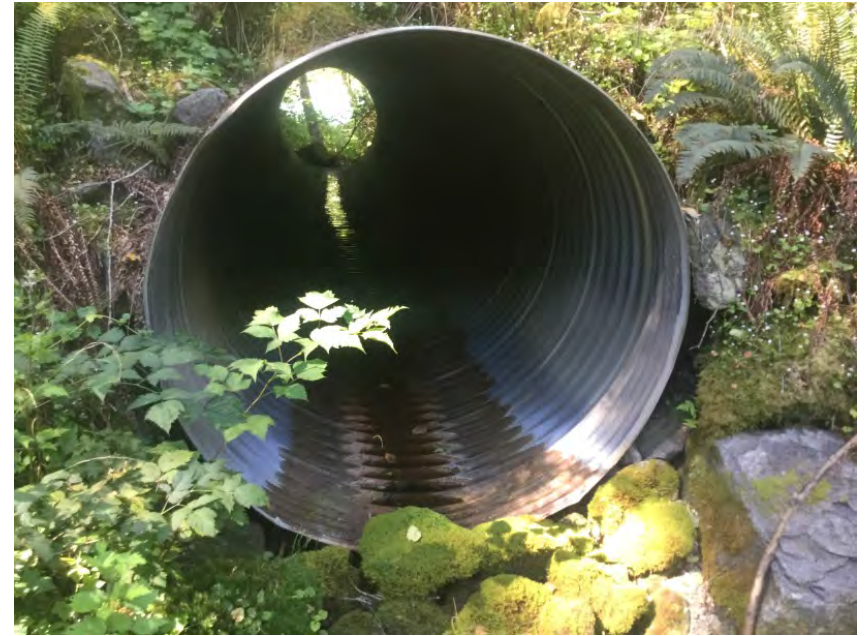
Inlet Good

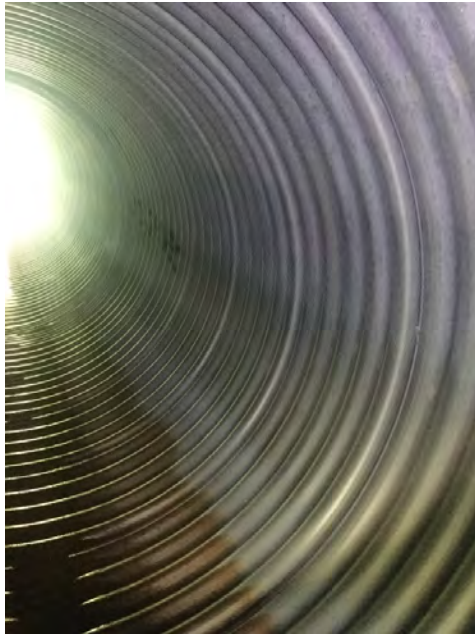
Barrel Condition

Roof Good

Sidewalls Good

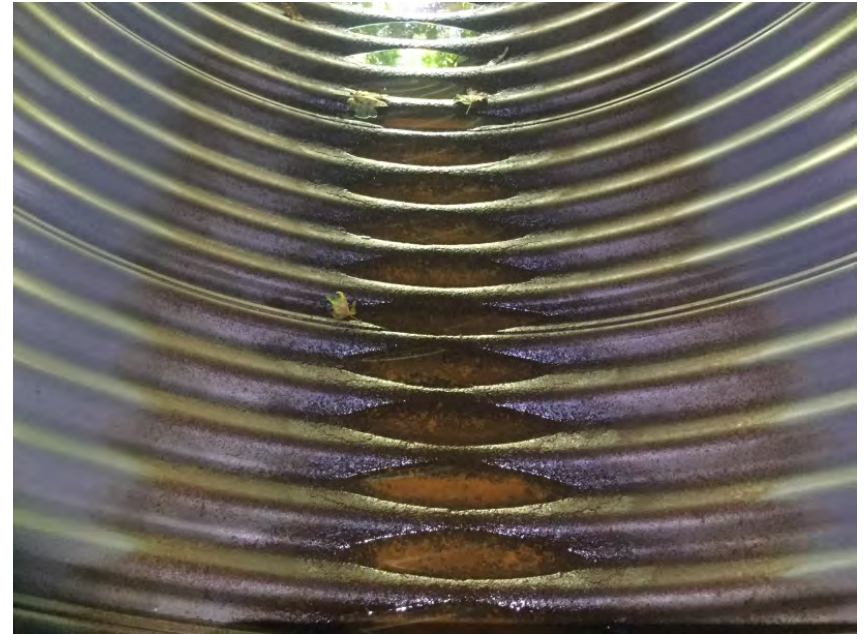
Floor Condition

Coating Fair Light corrosion on floor.

Floor Fair Light corrosion.

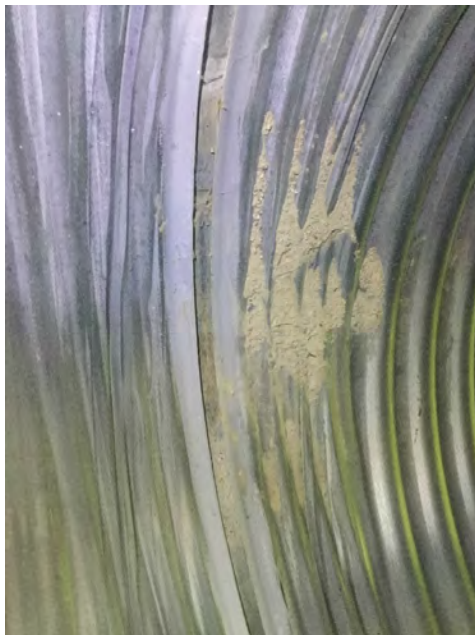
Coupler

Coupled Connections Good

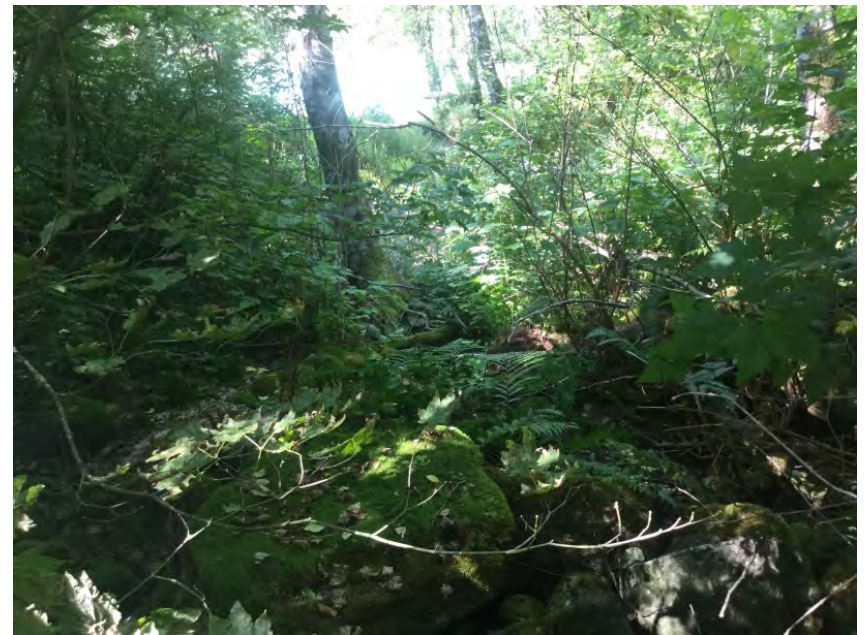
Looking Downstream

Comments Dry channel. Appears to drain road ditches.

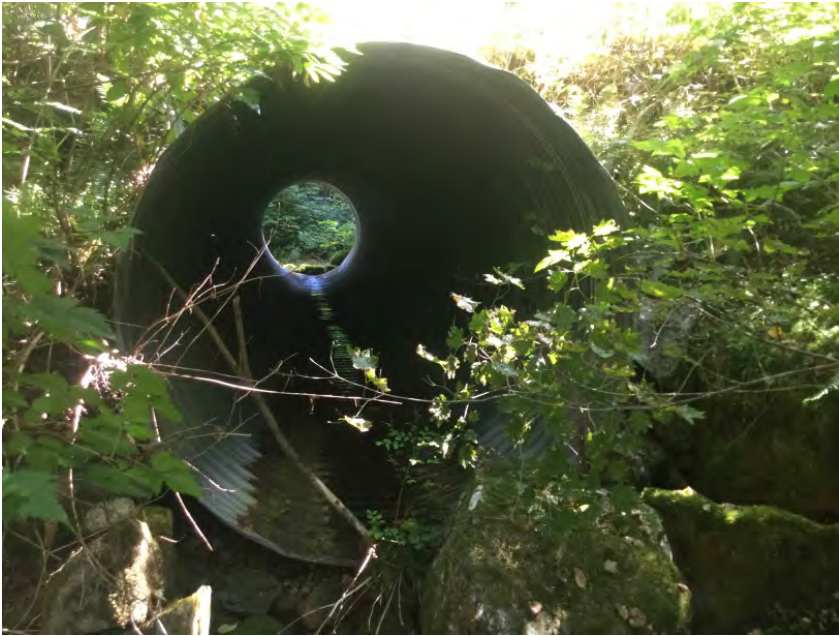
Outlet Fair Minor construction damage.
