CK-2343

STAVE RIVER 28.1km

2016 Inspection

| Structure Class | Major Culvert | | |

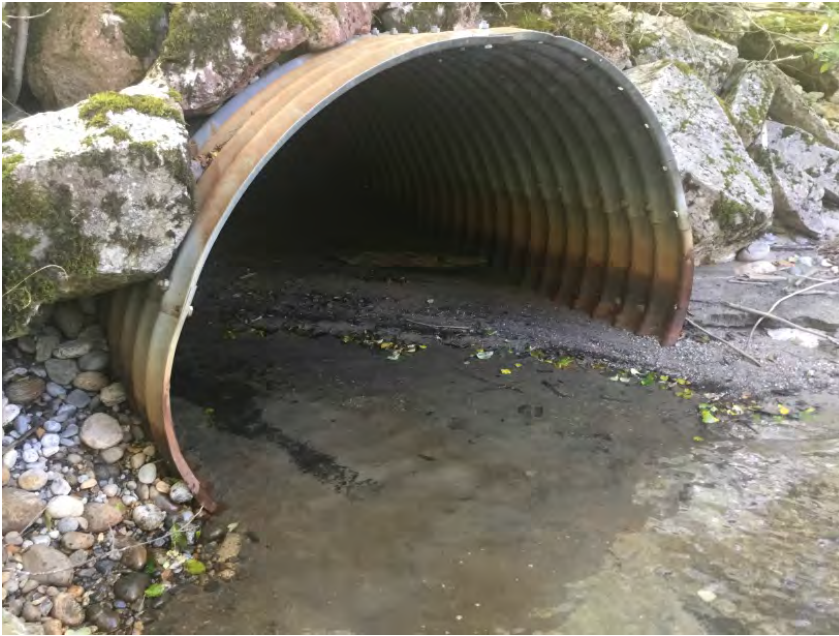
| Outlet | Fair | Light corrosion of outlet. |

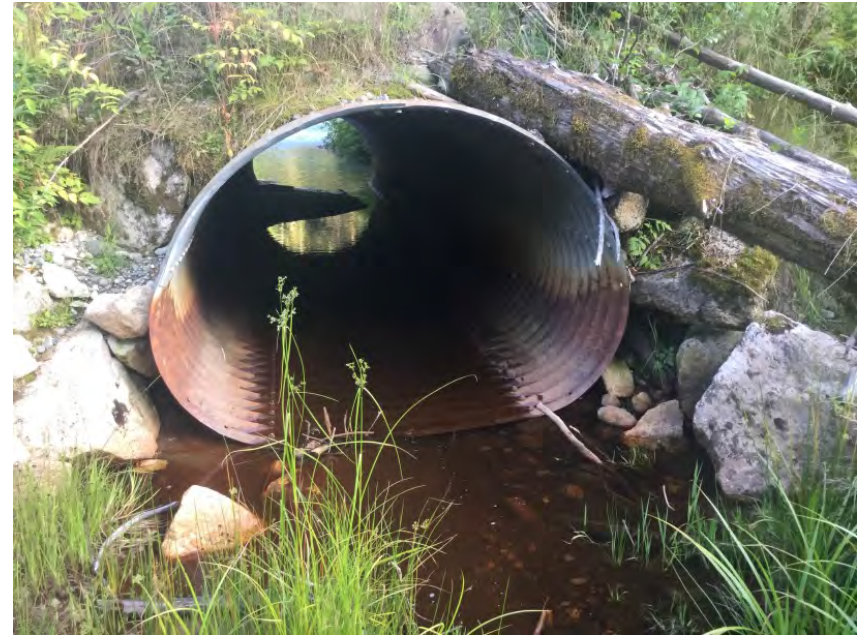
| Inlet | Fair | Light corrosion of inlet. |

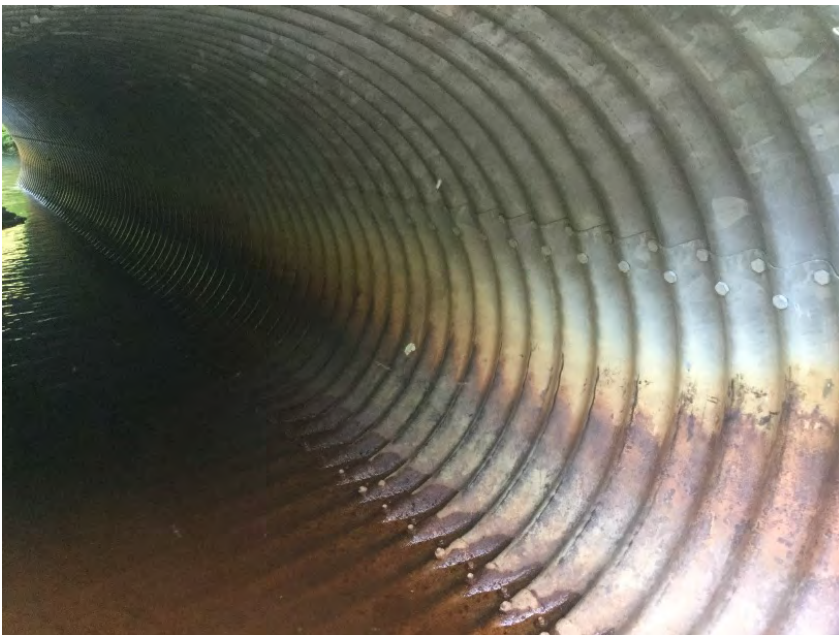
Culvert Barrel Condition

| Bolted Connections | Fair | Corrosion of bolts on floor of culvert. |
| Coating | Fair | Corrosion on floor of culvert. |
| Sidewalls | Fair | Light pitting on lower section of culvert walls. |
