CK-2345

WINSLOW CREEK 2.4km

2016 Inspection

| Crossing Name | Bradley Creek |

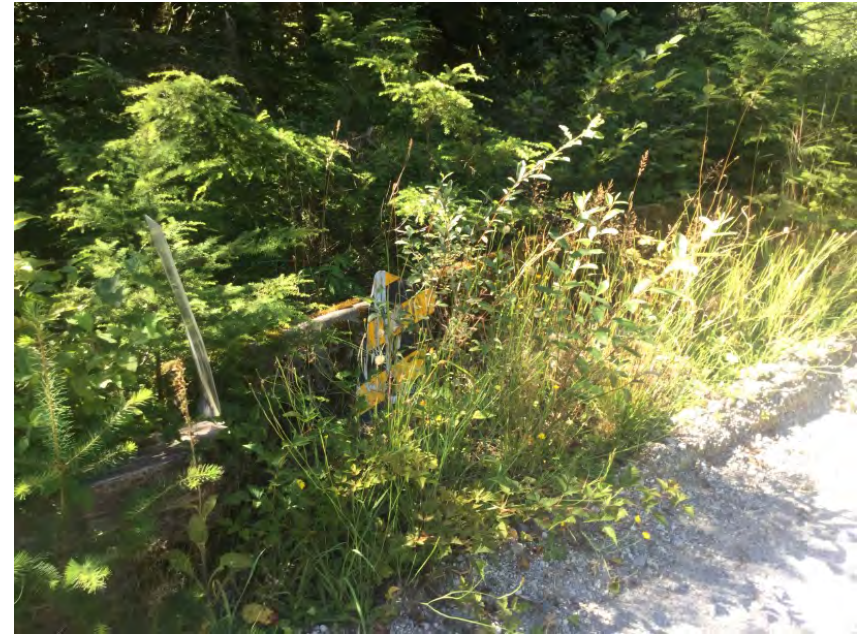
Right approach downstream CRB partially over turned.

Right Approach Downstream Fender Partially Overturned

| Item | Priority | Repair Description |
|---|---|---|
| 2 | Medium | Install bridge ahead signs, install delineator at right approach upstream corner, realign CRB at right approach downstream corner. Clear debris from deck. Brush approaches. |

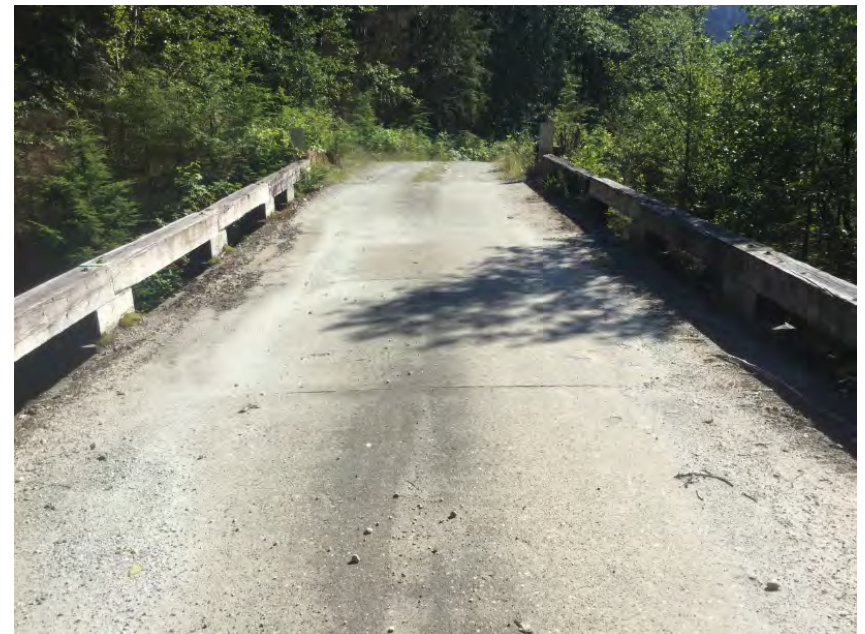
| Concrete Deck | Fair | Light wear in wheel tracks with some minor from damage excavator tracks. |
| Grout Pockets | Unrated | Debris on deck, not visible for inspection. |

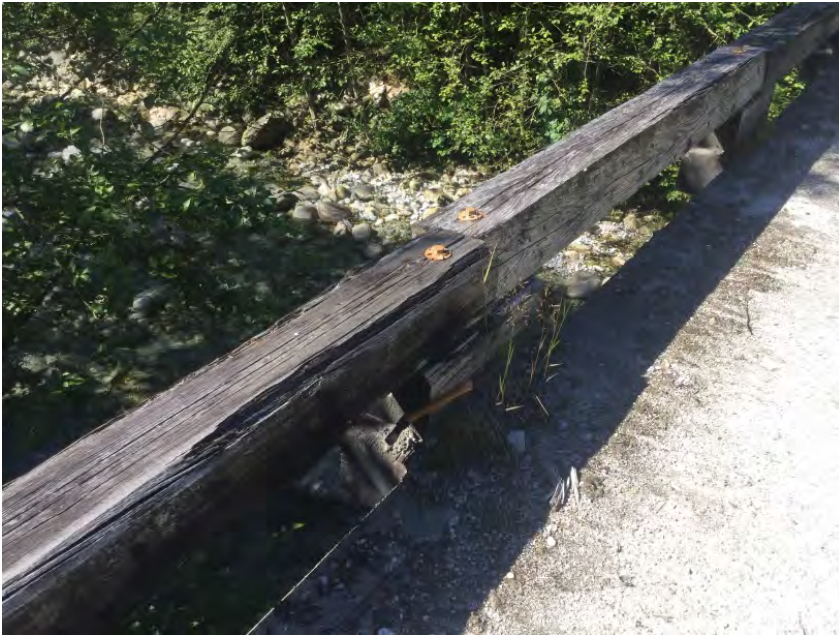
Road appears to be partially deactivated with some cross ditches and sees limited recreational use due to restricted access over Stave Lake. Guardrail is rotten and requires replacement prior to industrial or recreational activity, along with some routine maintenance.

| Curb Rail/Blocks/Posts | Poor | All guardrail components rotten and loose. |

Deteriorated Guardrail

Replace guardrail, risers and blocks; grade and brush approaches; post bridge ahead signs; replace missing delineators; realign the no post barriers where required and clean sediment from deck; all prior to industrial activity. Present load rating of L75 or 68 tonnes to continue.

| Item | Priority | Repair Description |
|---|---|---|
| 1 | High | Replace guardrail system prior to industrial activity. Requires: 44 m of 250x250 mm guardrail sections, 18 650x250x250 mm risers, 18 900x250x250 mm blocking. |

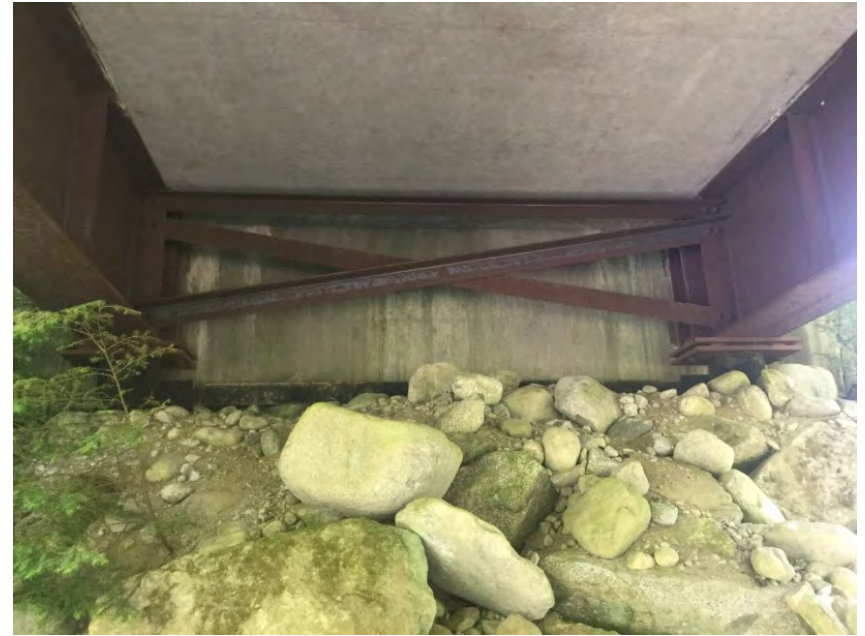
Typical Abutment Condition

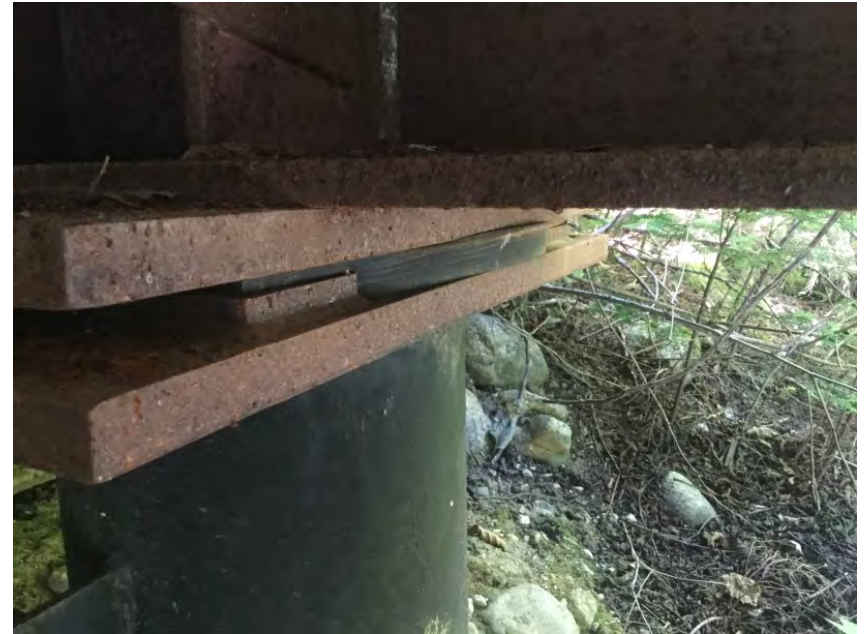
Bulging of all bearings.

Typical Bulging of Bearings

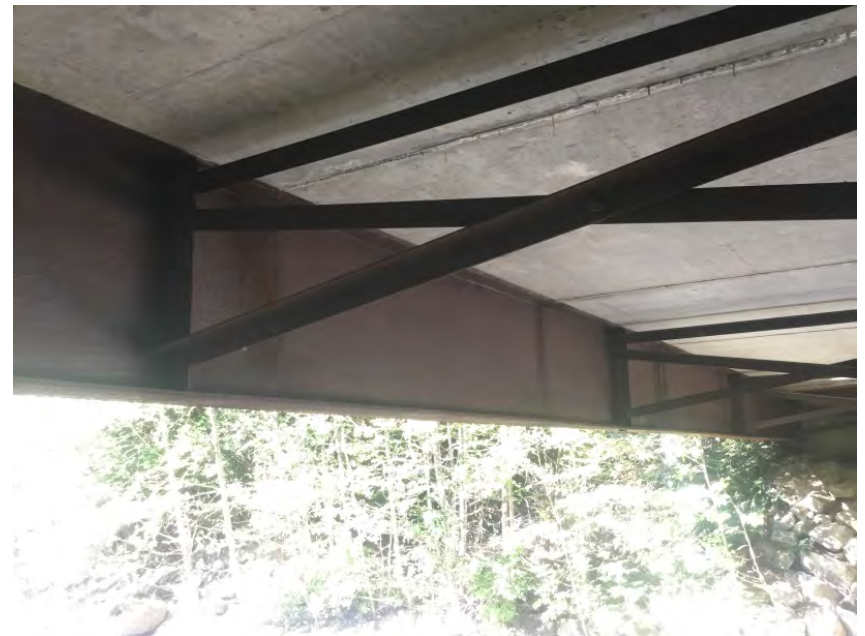
Areas of corrosion of girder at deck panel joint locations.

Girder Condition Noted Corrosion at Deck Panel Joints

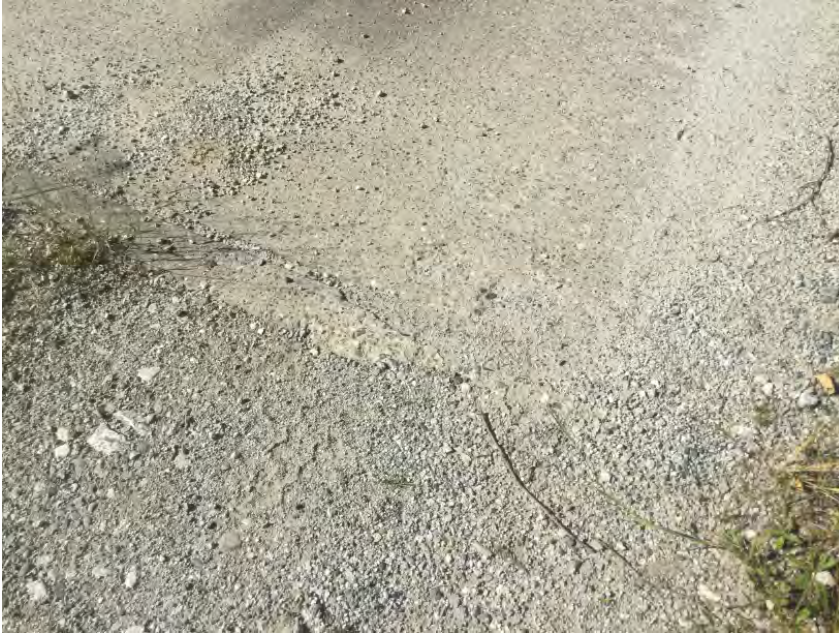
Typical staining &amp; moss growth on exterior sections of ballast walls. Damage to ballast wall in wheel tracks.

Typical Damage to Ballast Wall
