CK-2348

COGBURN CREEK 4.8km

2016 Inspection

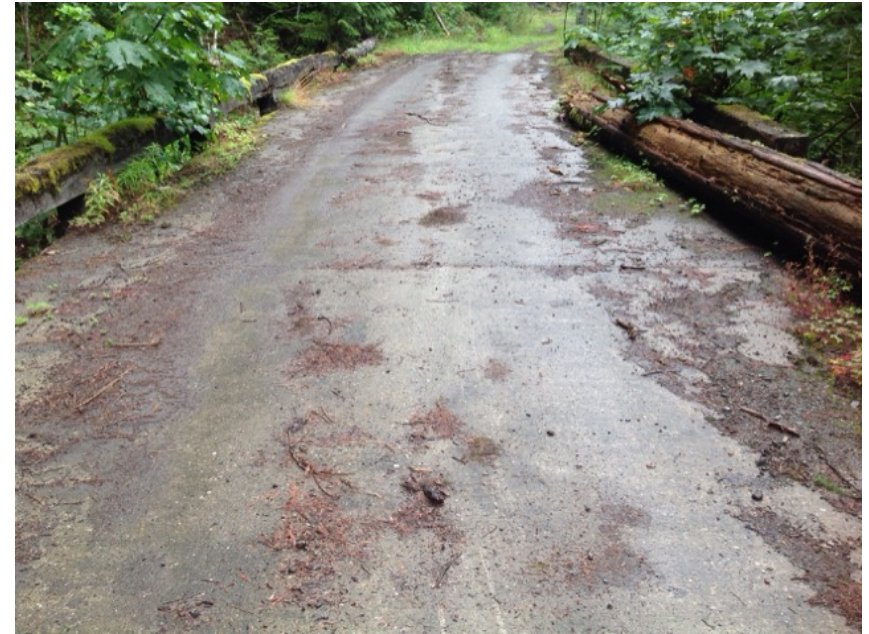
| Overall Deck Condition | Poor | due to rail conditon |

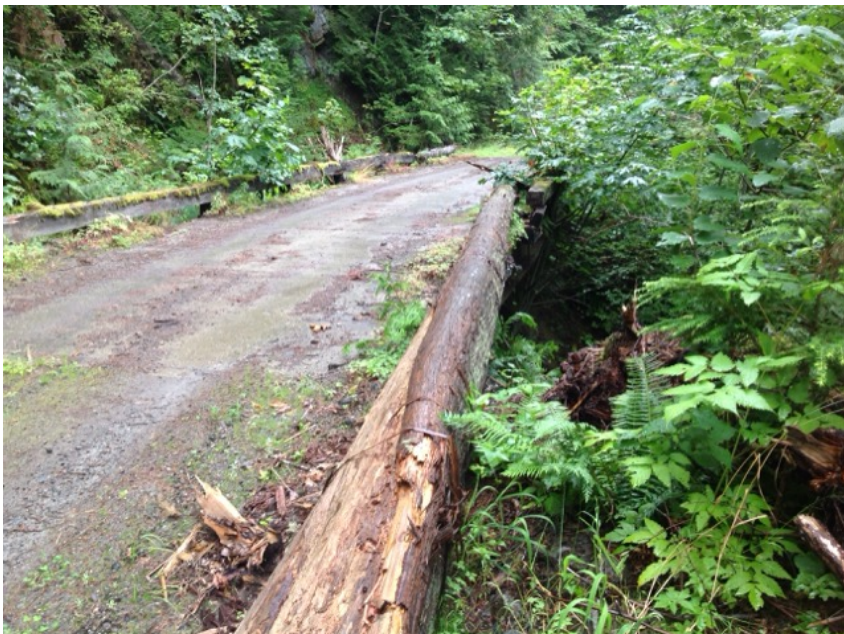
| Curb Rail/Blocks/Posts | Poor | rotten |

guardrail off and log has been placed

Replace guardrail, risers and blocks; brush approaches; replace missing delineators; place fenders at both approaches and post bridge ahead signs. Limit loading to 40 tonnes until a new proper guardrail system is installed. Please post load rating sign.

| 1 | High | replace guardrail system |

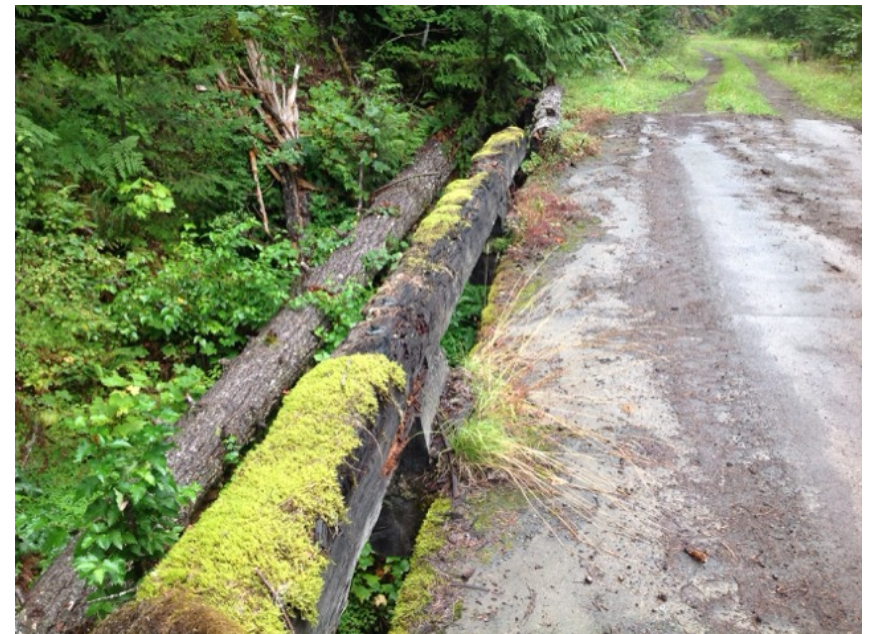
remaining guardrail condition

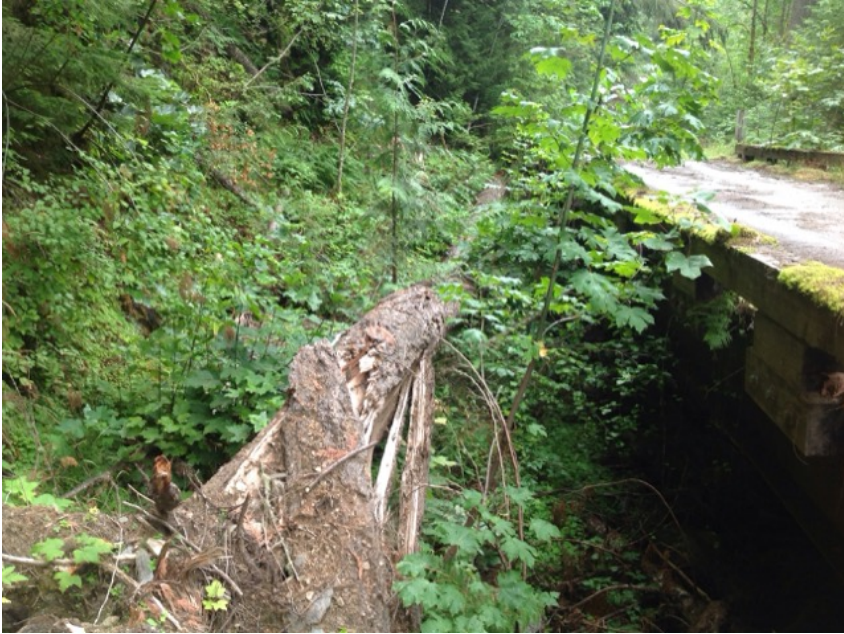
tree came over bank and suspect that took off guardrail on left upstream bank - no impact on deck visual
