CK-2351

UZTLIUS-STOYOMA EAST 3.5km

2016 Inspection

| Crossing Name | Stoyoma Creek |

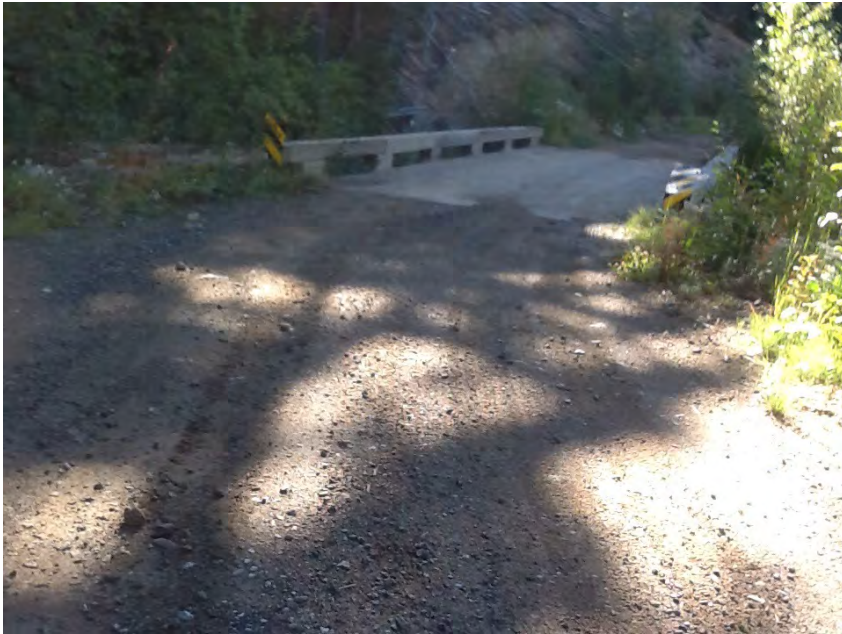
Right approach facing structure

Curve on right approach.

| Item | Priority | Repair Description |
|---|---|---|
| 2 | Medium | Post 2 bridge signs. |
| 3 | Low | Brush approaches |

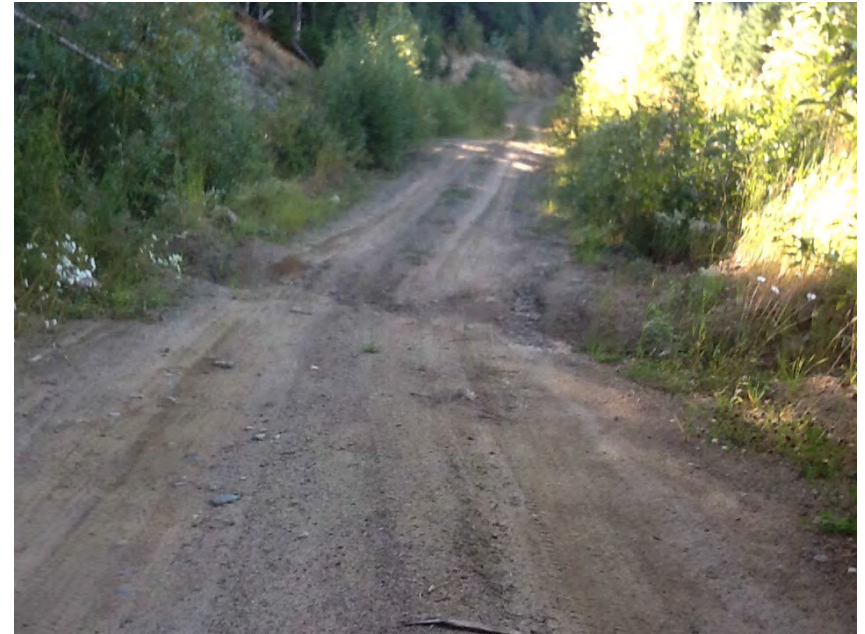
Left approach facing away from structure

Slight grade on left brings sediments onto deck. Potholes on right end of deck.

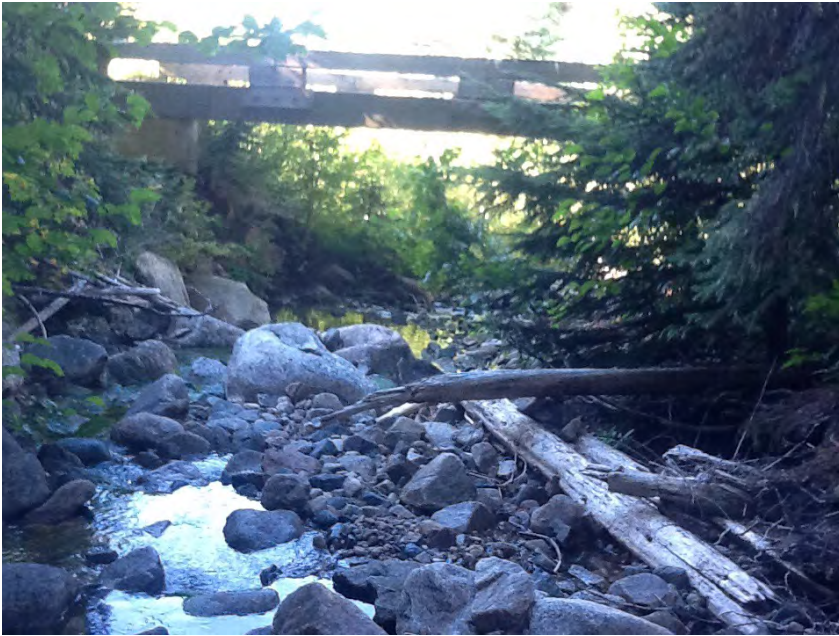
Upstream Profile

| Curb Rail/Blocks/Posts | Poor | About one-third of risers and most of the lower blocks are rotten. Rails are fair. |

| Item | Priority | Repair Description |
|---|---|---|
| 1 | Medium | Replace curbs. Rail 250x250x14.5m x 2. Blocks 250 x 250 x 90cm x 12 pieces. Risers 250x 250mm x 70cm x 12 pieces. |

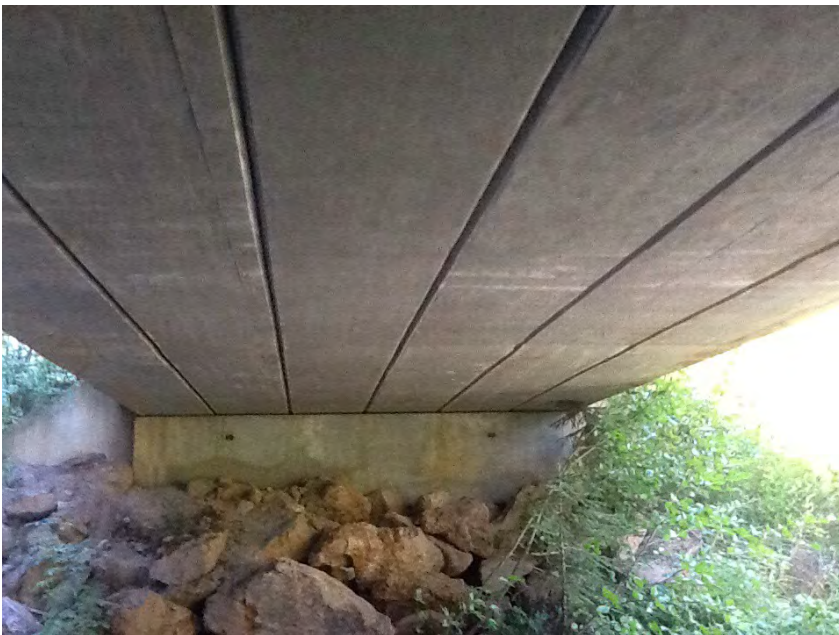
Underside of bridge

Girders Good Concrete slab girders
