CK-2353

WINSLOW CREEK 1.9km

2016 Inspection

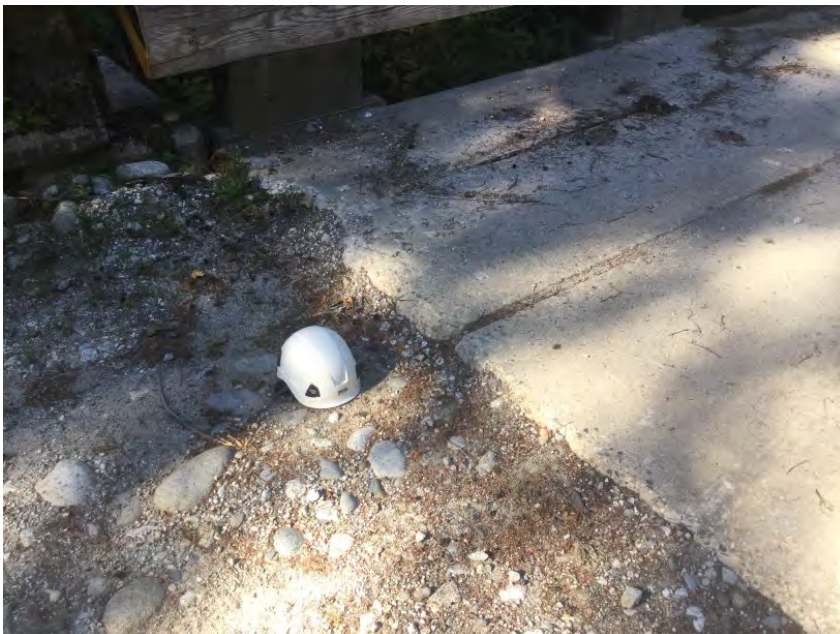
Significant difference in grade between approach and deck resulting in damage to girder ends.

| Running Surface | Poor | Significant difference in grade between approach and deck resulting in damage to girder ends. |

Typical Grade Differential at End of Deck

| Repair | | Repair Description |
|---|---|---|
| 1 | Medium | Grade approaches before industrial activity. |

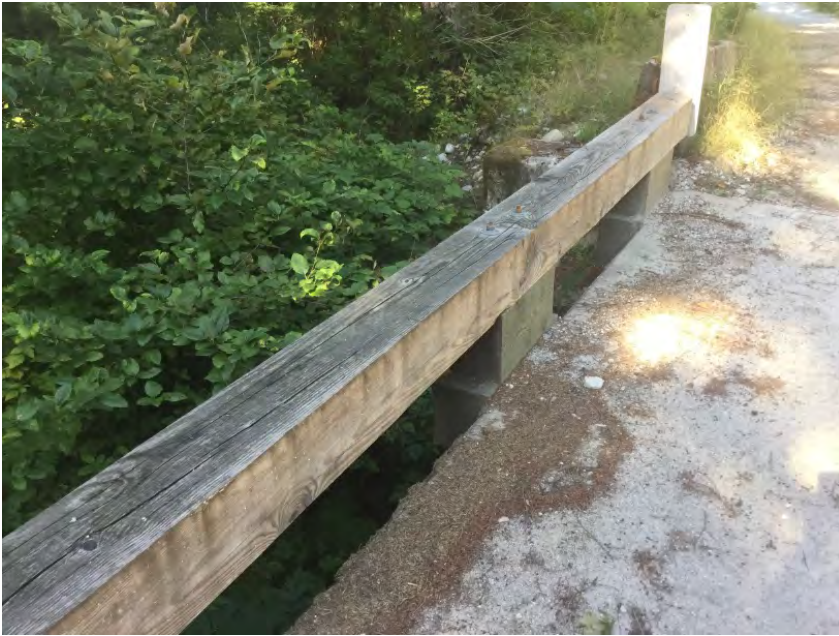
Guard Rail

| Curb Rail/Blocks/Posts | Good | Replaced since previous inspection. |

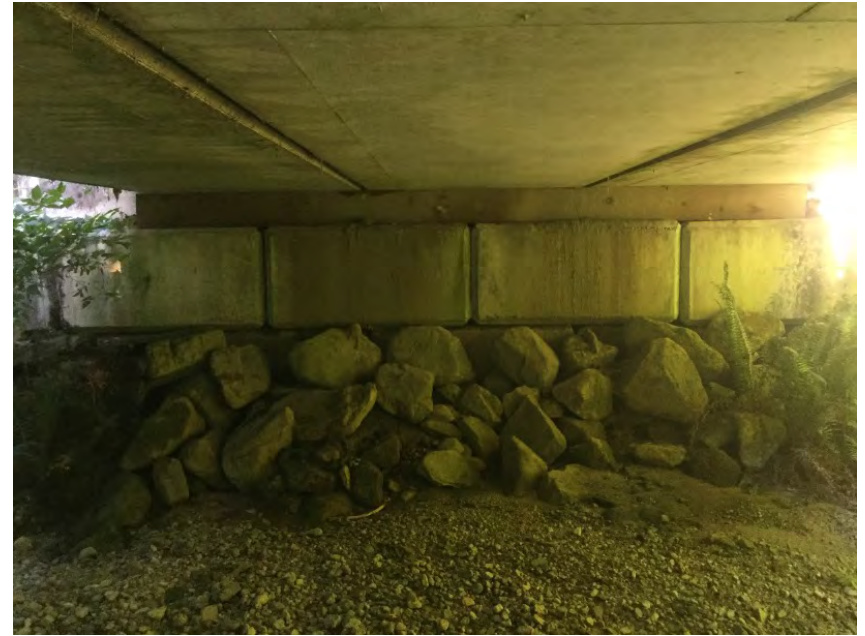
Right Bank Abutment

Lock blocks with geo grid.

Timber sill replaced since previous inspection.

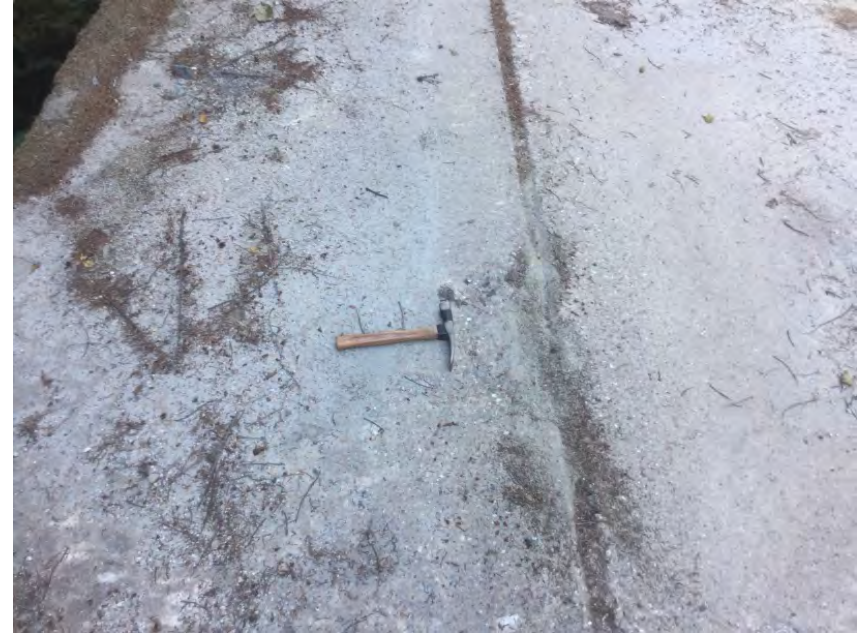
| Concrete Deck | Fair | Debris limited inspection. Wearing of surface, previous inspection identified damage from tracked vehicles, spall at slab joint. |

Spall in Deck

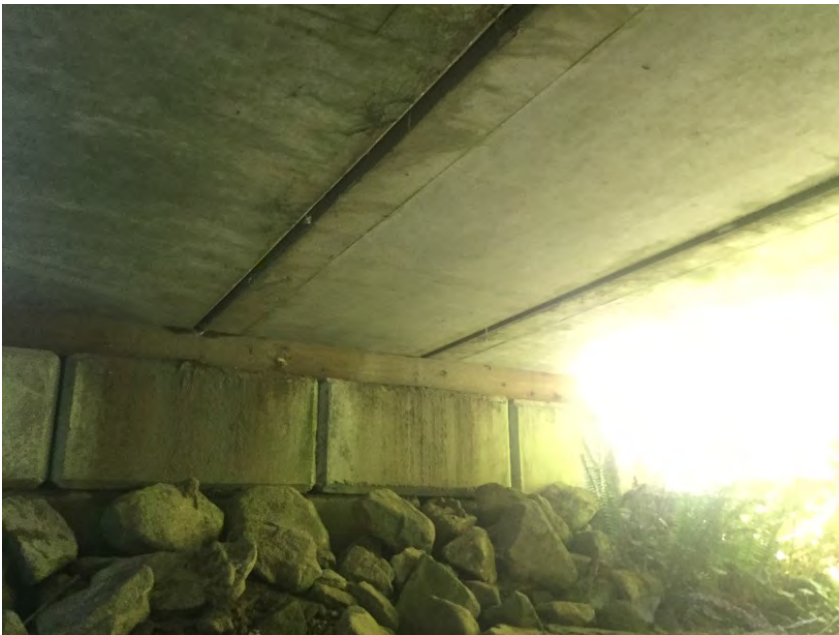
Slab Girders

Damage with exposed rebar at ends from vehicle pounding.

| Repair | | Repair Description |
|---|---|---|
| 2 | Medium | Repair damaged sections of slab girders. |

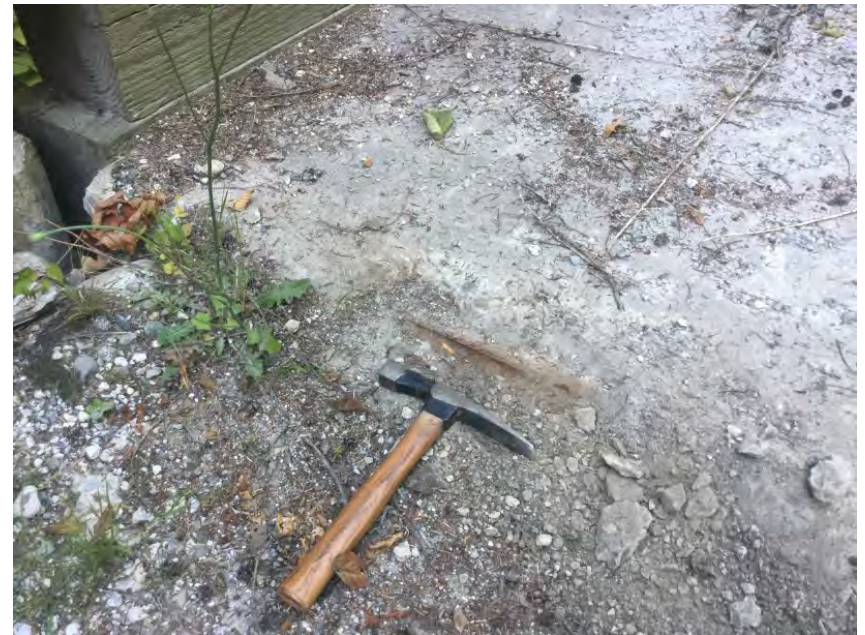
Damaged Girder End
