CK-2358

LOST CREEK 3.1km

2016 Inspection

| Structure Class | Major Culvert | | |

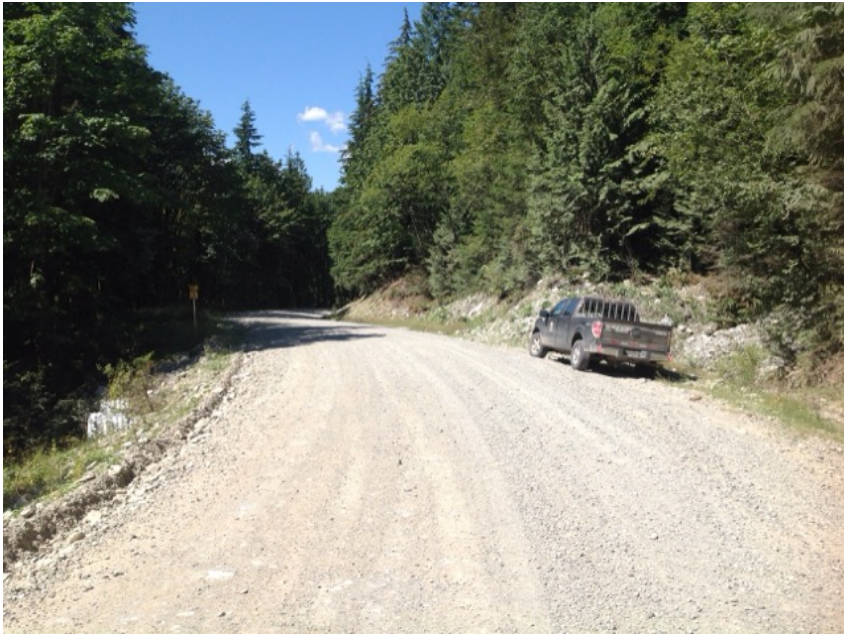
Approach from Left Bank when facing downstream

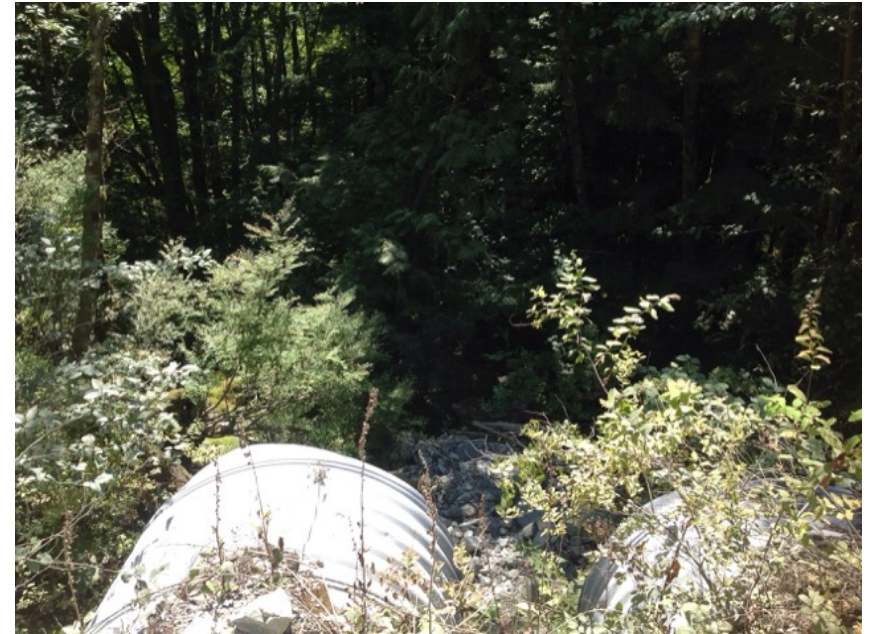
looking downstream from road

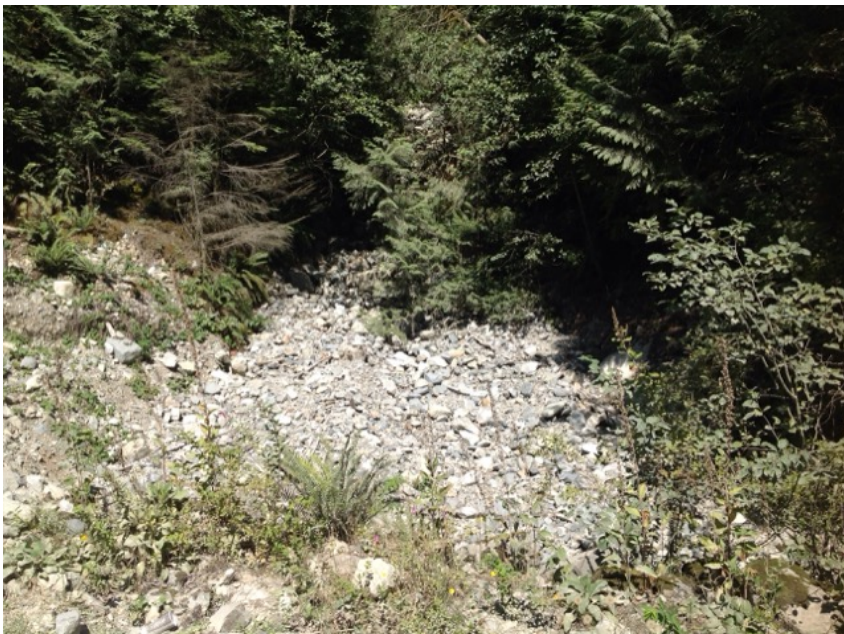
looking upstream from road

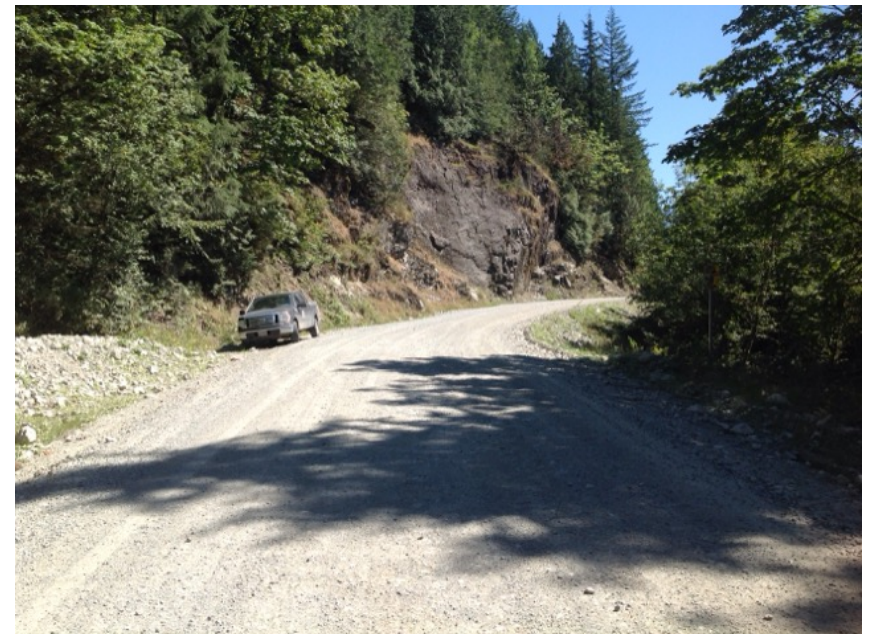
Approach from Right Bank when facing downstream

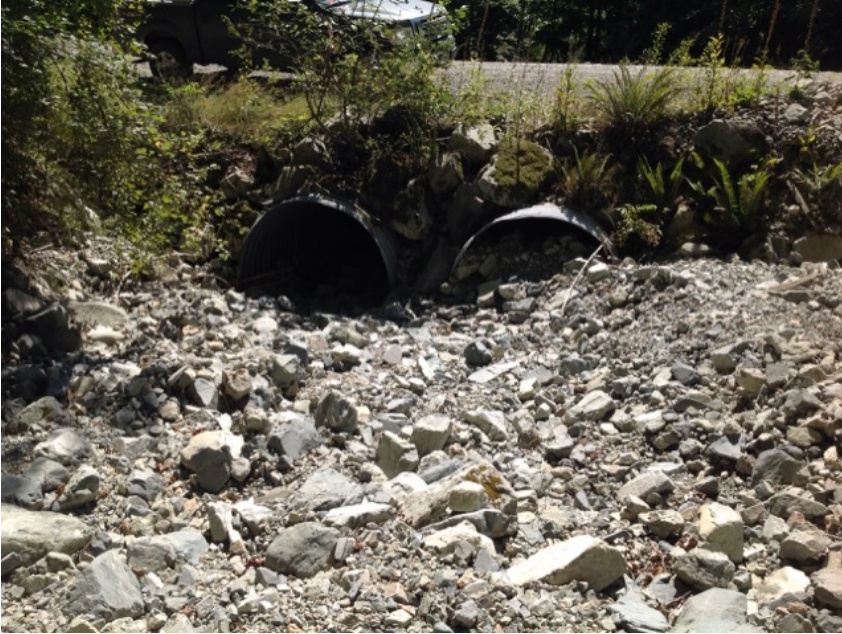
| Inlet | Poor | 1 culvert 80% plugged |
| Overall | Poor | due aggrading inlet |

Clean the inlet, unplug the woods end culvert and excavate a large sump. Monitor for future events. Present load rating of BCL-625 or 63 tonnes to continue.

| 1 | Medium | clean inlet |

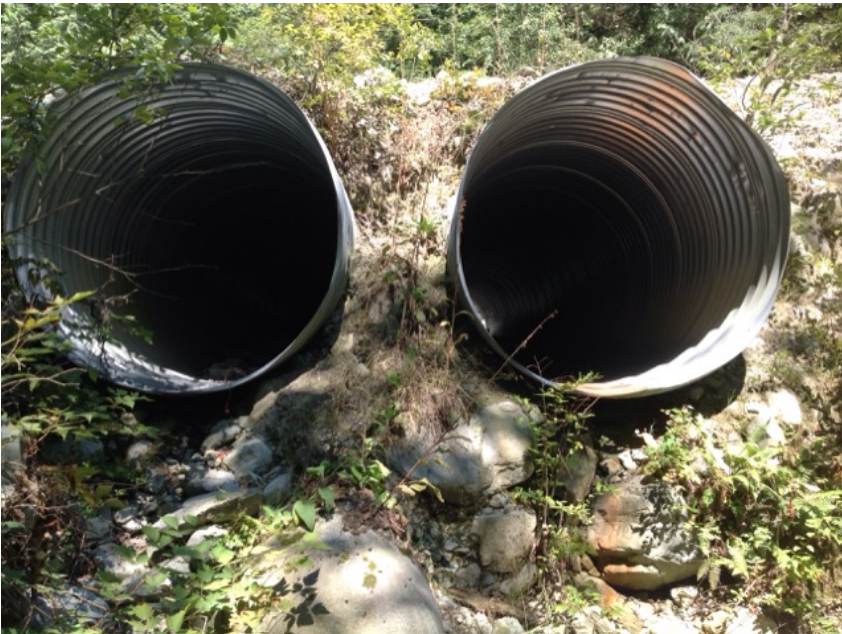
| Outlet | Fair | |
