CK-2363

SPUZZUM CREEK 25.2km

2016 Inspection

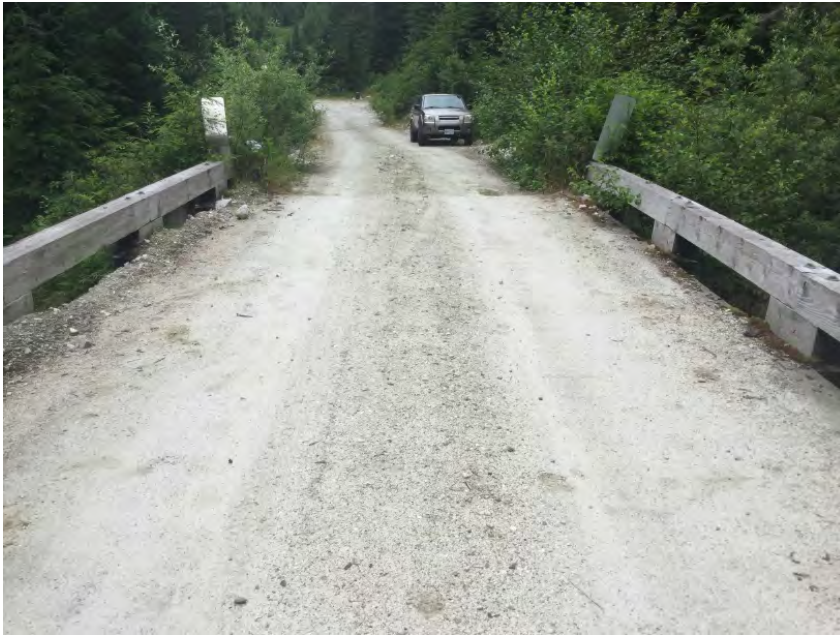
| Concrete Deck | Good | Limited visibility on top due to debris. |
| Curb Rail/Blocks/Posts | Poor | Rot in majority of risers and blocking. Localized patches of surface rot in a couple section of guardrail. |

| Item | Priority | Repair Description |
|---|---|---|
| 1 | High | Replace blocking, risers and guardrail. Requires 8 650x250x250 mm risers, 8 850x250x250 mm blocking, and 4 3700x250x250 mm and 2 2750x250x250 mm guardrail sections. Remove debris from deck. |

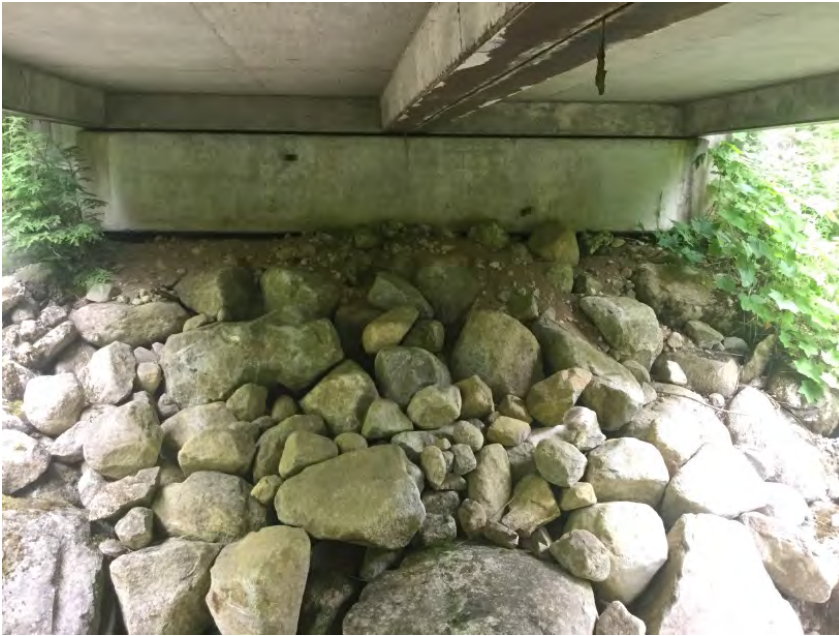
Left Bank Abutment

Caps or Sills Good Concrete cap.

Piles or Posts Unrated Posts barely visible below cap.

Ballast Wall Good Typical water staining on exterior sections of ballast wall.

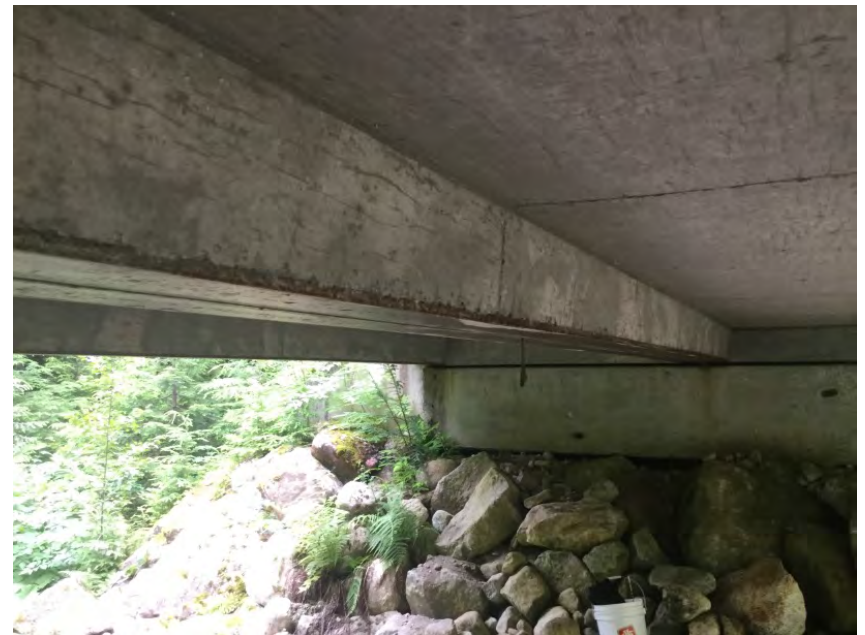
Superstructure type changed. Not a conventional slab girder, looks like a pair of small compo girders with monolithic deck and end diaphragms, and welded shear connectors.

Compo Girder with Monolithic Deck

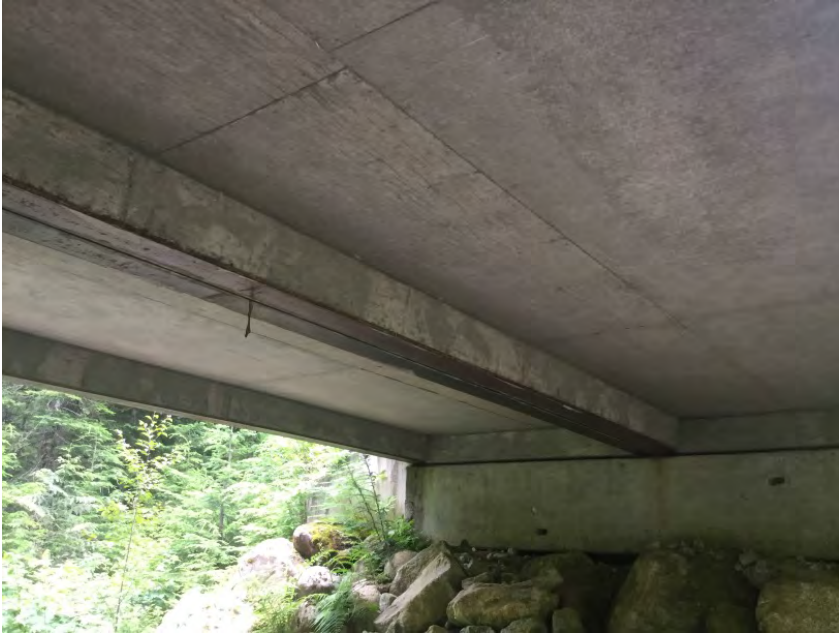
Girders Good

Small compo girder with monolithic deck and end diaphragms.
