CK-2369

SPUZZUM TWENTY-ONE 2.3km

2016 Inspection

Inspection Company SNT Engineering

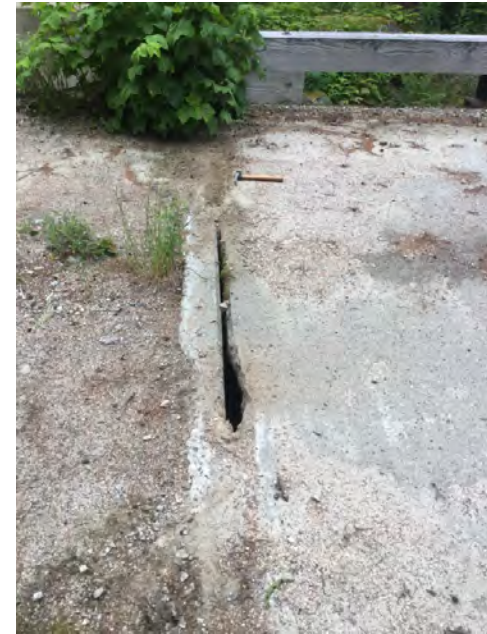
| Concrete Deck | Poor | Damage/spalls in wheel tracks at both abutments, resulting in 100 mm wide gap between ballast wall and deck at left abutment. |

Left Abutment Damage to Ballast Wall and Deck Panel

| Item | Priority | Repair Description |
|---|---|---|
| 2 | High | Repair deck panels for recreational use. Repair ballast wall and install deck panel seals for industrial use. |

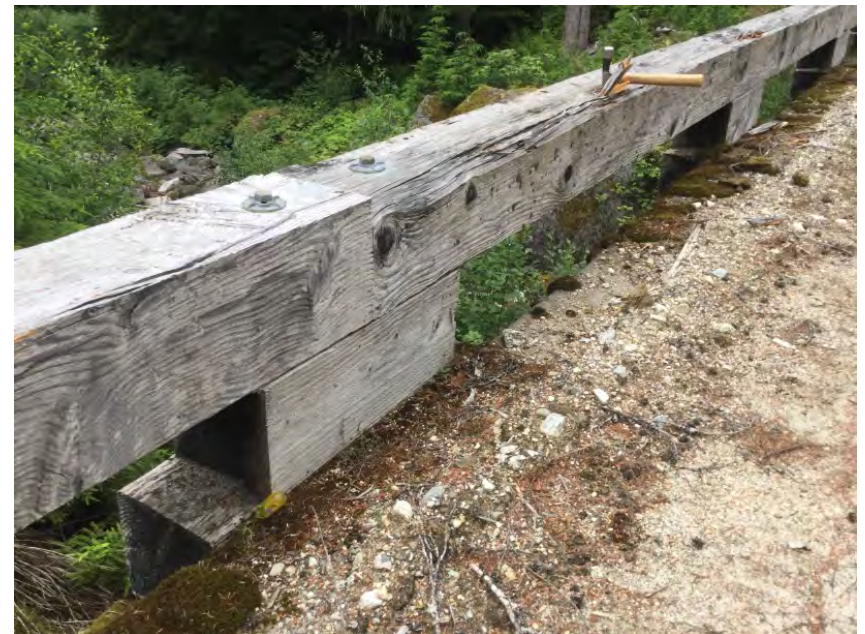
| Curb Rail/Blocks/Posts | Poor | Majority of blocking rotten with a number of rotten sections guardrail. |

Rotten Guardrail And Blocking

| Item | Priority | Repair Description |
|---|---|---|
| 1 | High | Replace guardrail, blocking and risers for recreational use. 22 650x250x250 mm risers, 22 820x250x250 mm blocking, 4 4900x250x250mm guardrail, and 6 6100x250x250mm guardrail. Remove debris from deck. |

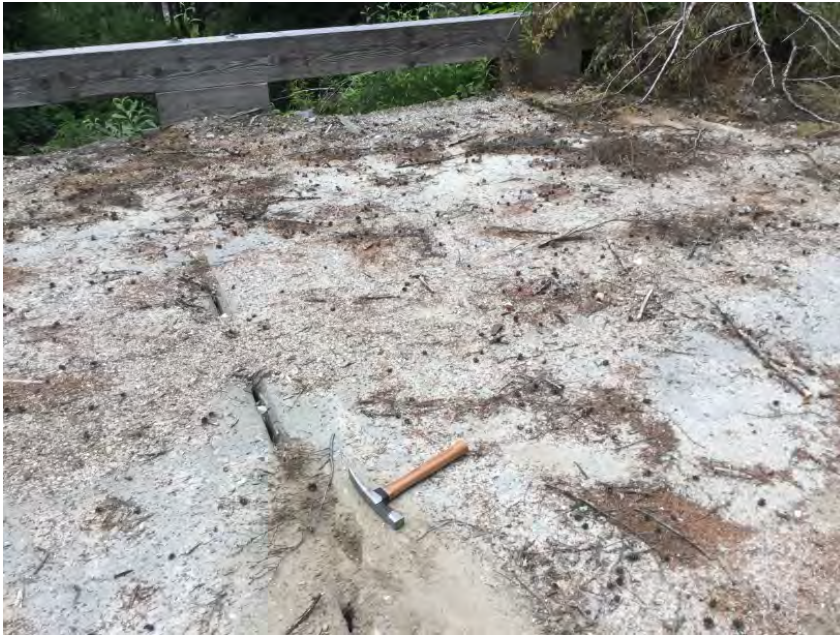
| Deck Joints | Poor | Compression seal or sealant missing at all panel joints. |
| Overall Deck Condition | Poor | Spall in wheel track between panels, at right end panel. Large spalls at anchorage of downstream guardrail, 4 locations. |

Damage to Right End Deck Panel & Typical Missing Sealant/Compression Seal

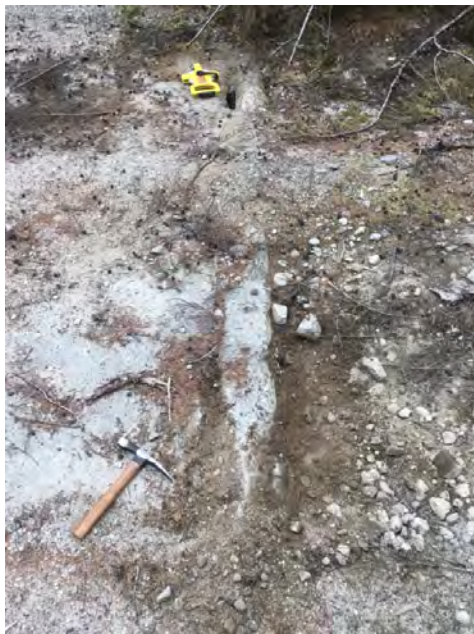
Potholes at approaches. Level of approach below level of deck resulting in damage to ballast walls.

Ballast wall typically damaged in wheel tracks.

Damage to Right Abutment Ballast Wall & Deck Panel

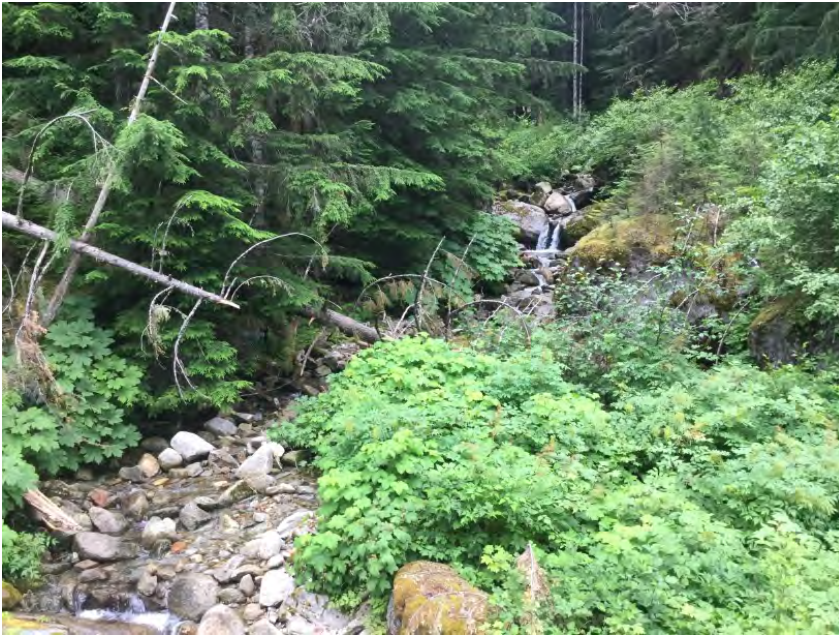
Looking Upstream

Comments    Blow down in creek upstream of bridge.

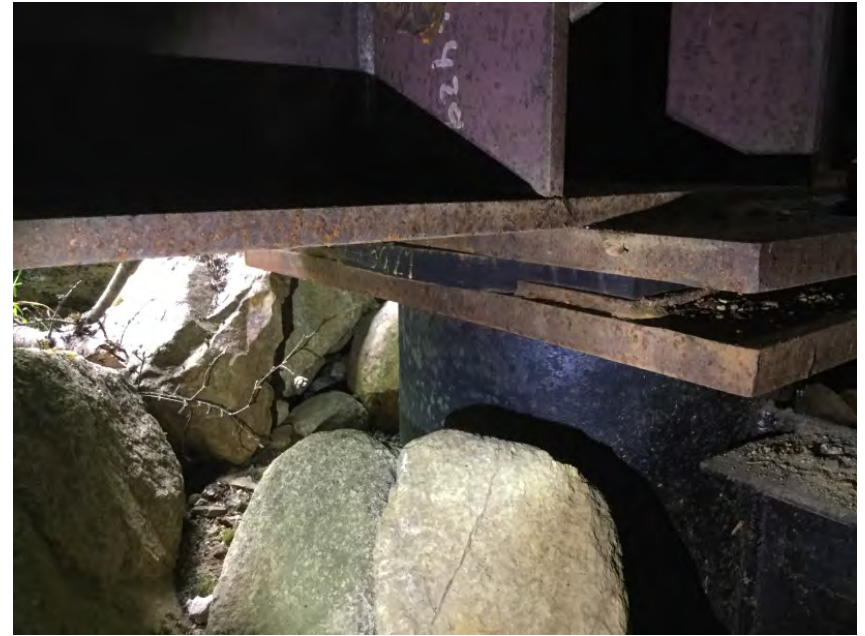
All bearings are bulging.

Typical Bulging of Bearings

| Item | Monitor Description | Frequency |
|---|---|---|
| 1 | Monitor bulging bearings. | Routine Inspection |

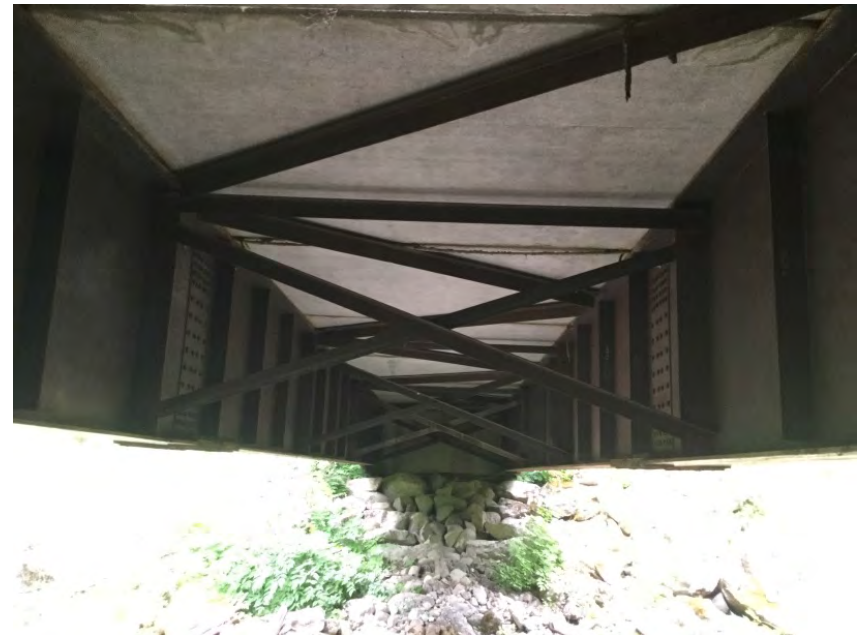
Girders Good

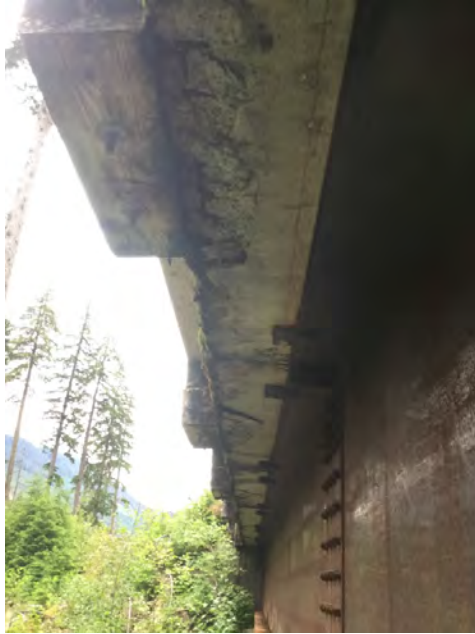
Typical Spalling of Downstream Guardrail Anchorage
