CK-2370

KAREN CREEK 1.81km

2016 Inspection

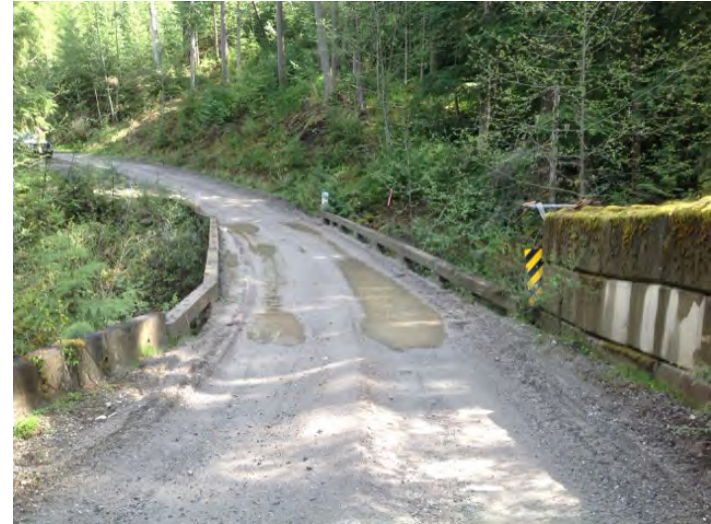
Approach from Left Bank when facing downstream

Delineator Missing  
Left ☐ 0 ☒ 1 ☐ 2Delineator Missing  
Right ☒ 0 ☐ 1 ☐ 2

| Repair Item | Priority | Repair Description |
|---|---|---|
| 2 | Medium | post bridge ahead signs and replace delineator |

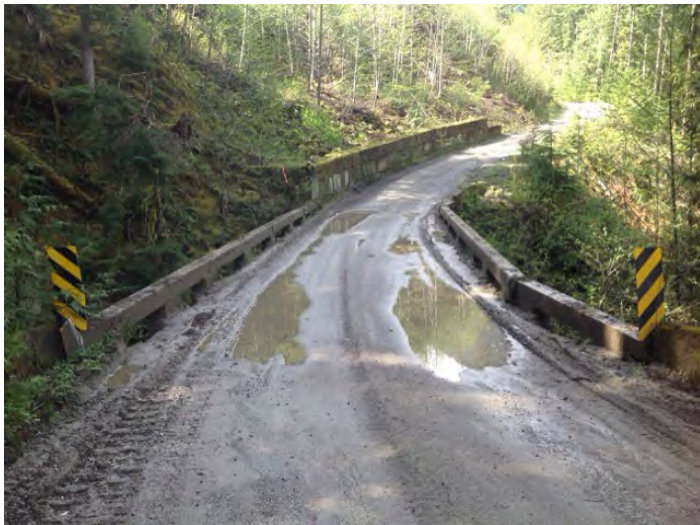
| Running Surface | Poor | lots of sediment on deck |
| Curb Rail/Blocks/Posts | Poor | blocks and risers have rot - time to replace |
| Overall Deck Condition | Poor | due to aging rail system |

| Repair Item | Priority | Repair Description |
|---|---|---|
| 1 | High | replace guardrail system |
| 3 | High | clean sediment from deck |

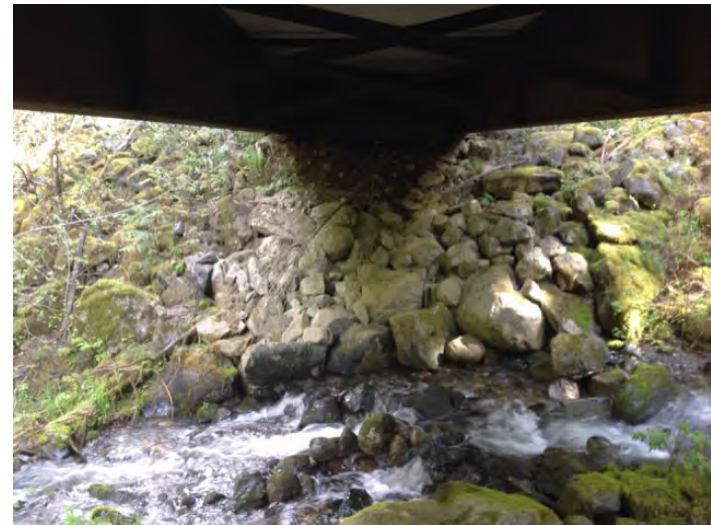
Right Bank Abutment when facing downstream

Bearings Fair rubber pads slightly bulging

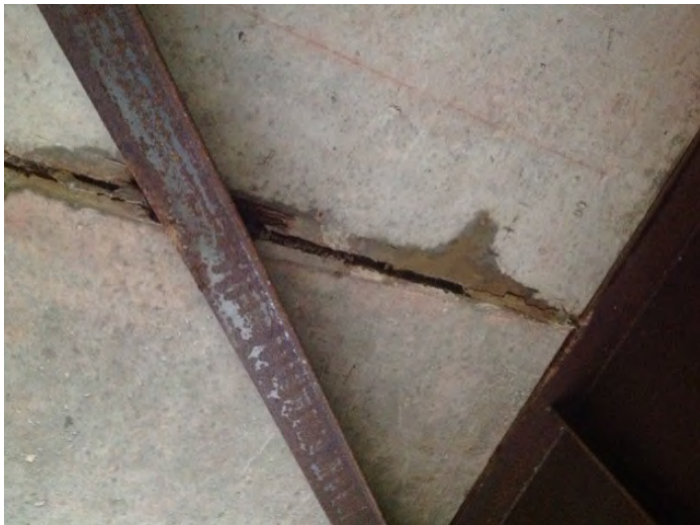
| Deck Joints | Fair | too much sediment - appear fair from below - 1 location has moisture underneath |

water getting through 1 deck joint
