CK-2371

KAREN CREEK 2.26km

2016 Inspection

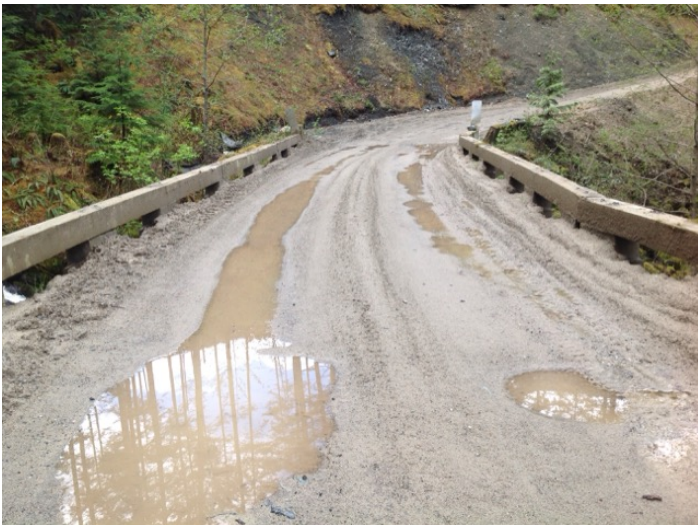
| Running Surface | Poor | lots of sediment on deck |
| Overall Deck Condition | Poor | due to aging rail system |

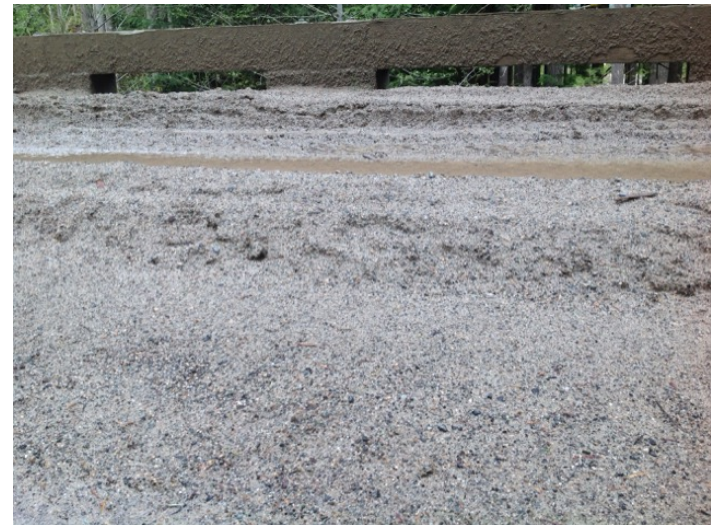
sediment on deck

| Repair Item | Priority | Repair Description |
|---|---|---|
| 2 | High | clean sediment for deck |

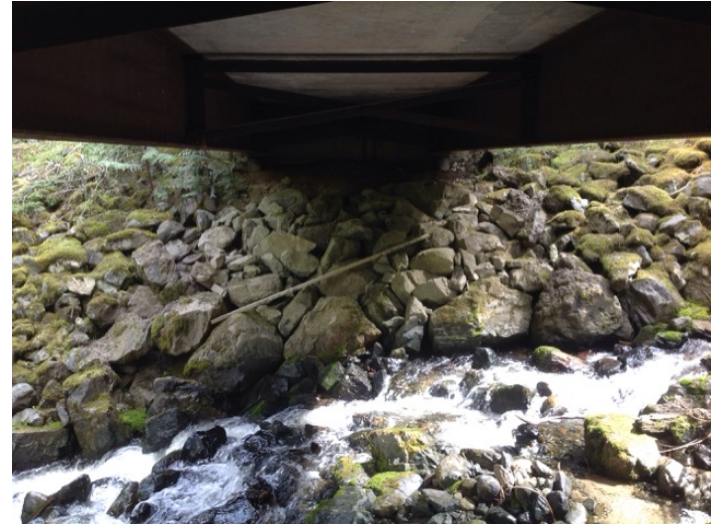
Right Bank Abutment when facing downstream

Bearings Fair rubber pads starting to buldge

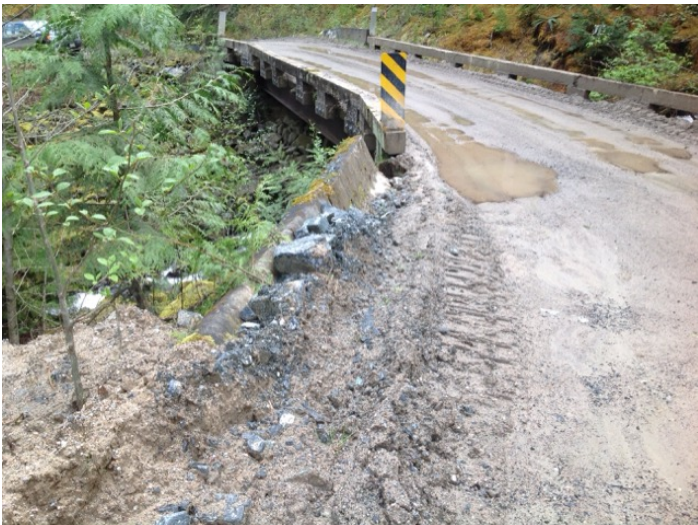
no post barriers pushed off d/s left approach
