CK-2378

STAVE RIVER 8.8km

2016 Inspection

| Crossing Name | Winslow Side Channel |

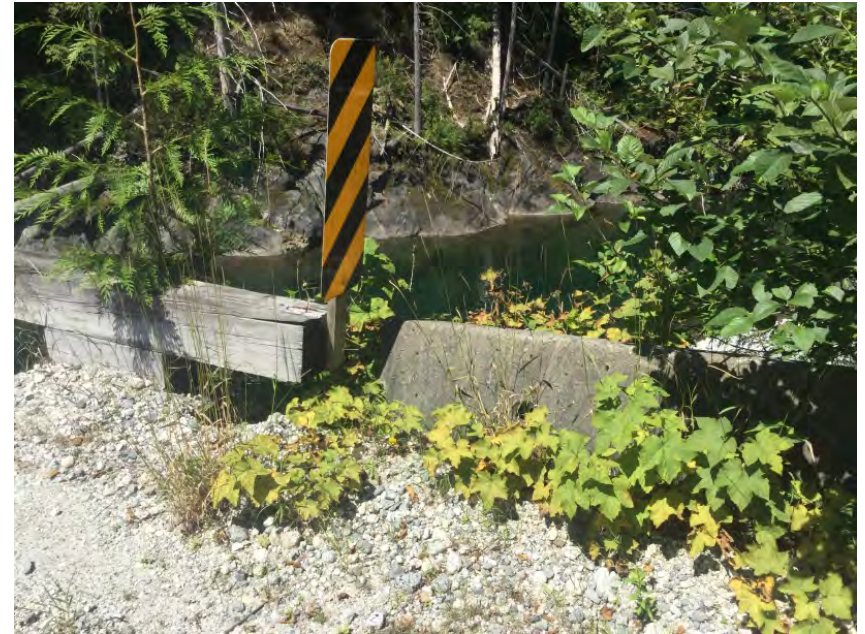
Fender Condition Fair Missing at right approach downstream corner. Partially overturned CRB at left approach upstream corner.

Left Approach Upstream Corner Partially Overturned Fender

| Item | Priority | Repair Description |
|---|---|---|
| 3 | Medium | Repair damaged ballast walls and install new compression seals. Install CRB at downstream right approach and realign other fenders. Regrade approaches. Requires 11 compression seals for 4.9 m wide deck. |

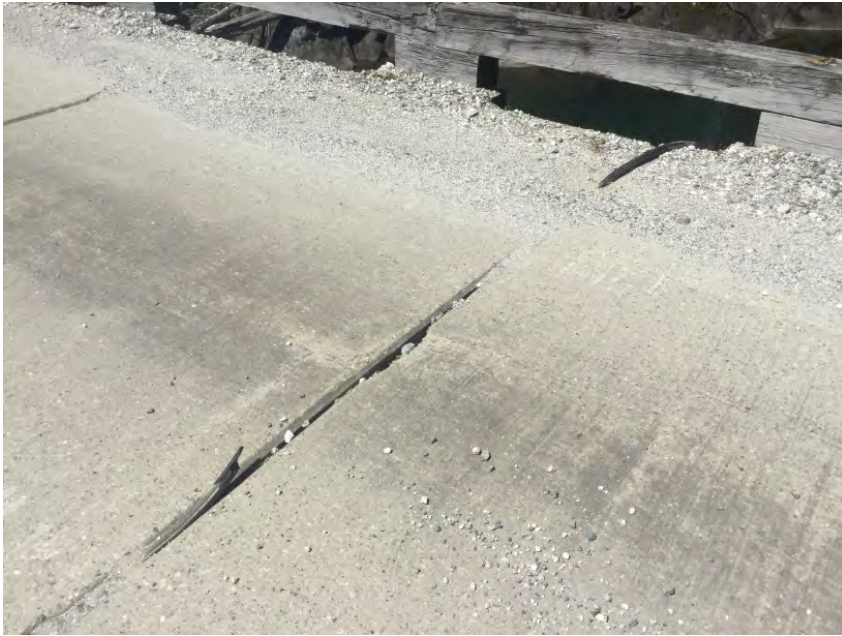
| Deck Joints | Poor | Compression seals have either fallen out or are damaged. |

Failed Compression Seal

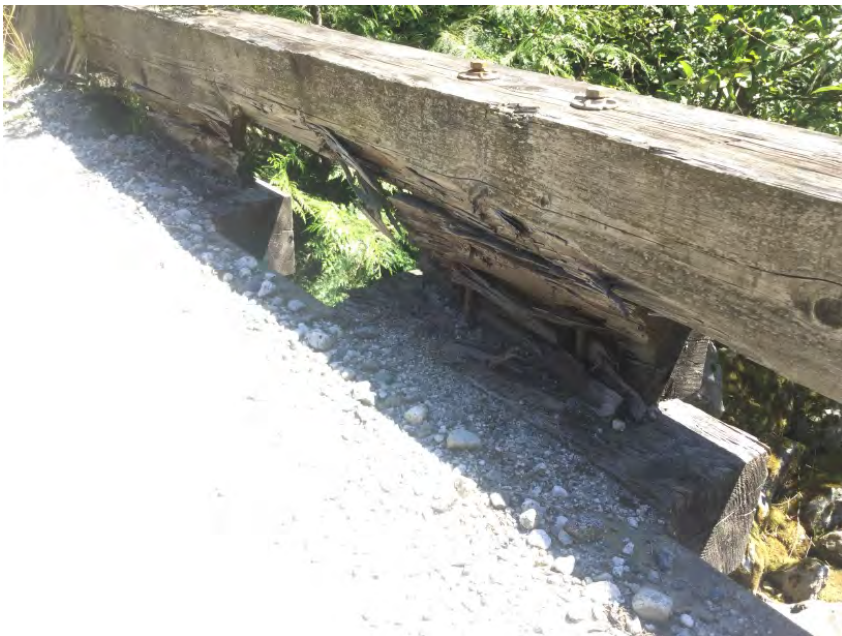
| Curb Rail/Blocks/Posts | Poor | 2 rotten, 1 failed riser. Majority of blocking has pockets of rot. A few pockets of rot and large checks in guardrail. Guardrail loose. |

Left Abutment Downstream Corner Rotten Risers

| Item | Priority | Repair Description |
|---|---|---|
| 2 | High | Replace guardrail system. Consider installing Ministry Standard HSS guardrail. Timber guardrail will require: 4 4800x250x250mm, 6 6100x250x250mm, 2 3100x250x250mm guardrail sections, 24 650x250x250mm risers, and 24 900x250x250mm blocking. |

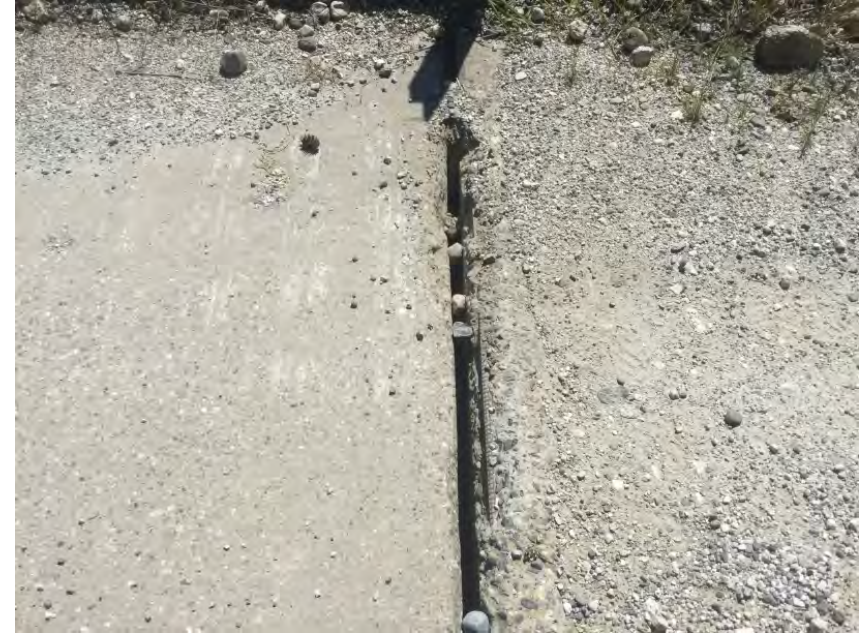
Road Surface Poor Road is below level of the deck resulting in damage to ballast wall and deck panel.

Ballast Wall Poor Damage to both abutment ballast walls. Spalling and exposed rebar. 90 mm gap to deck panel in wheel track at right abutment.

Right Abutment Damaged Ballast Wall in Wheel Track

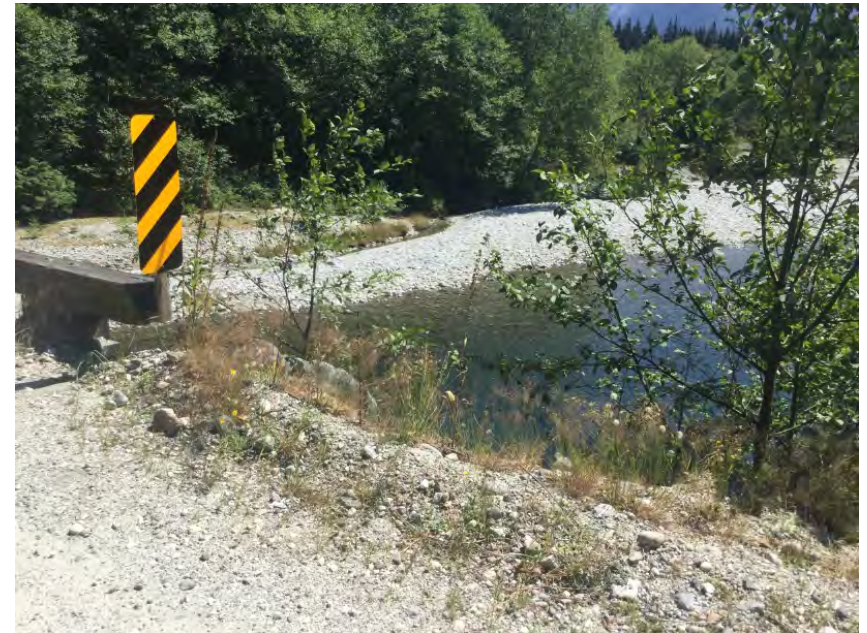
Right Approach Downstream Corner Missing Fender

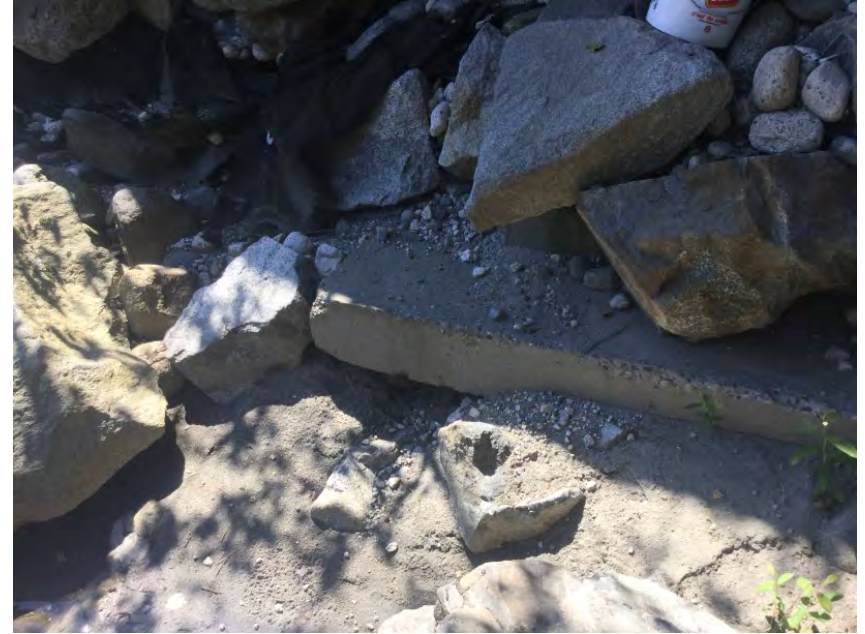
Riprap Poor Scour at right abutment downstream corner.

Comments    Scour at right abutment downstream footing.

Right Abutment Downstream Footing Scour

| Item | Priority | Repair Description |
|---|---|---|
| 1 | High | Reinstate bearing of right abutment downstream footing and place erosion protection. |

| Item | Monitor Description | Frequency |
|---|---|---|
| 1 | Monitor right abutment downstream footing after significant flow events. | Other |

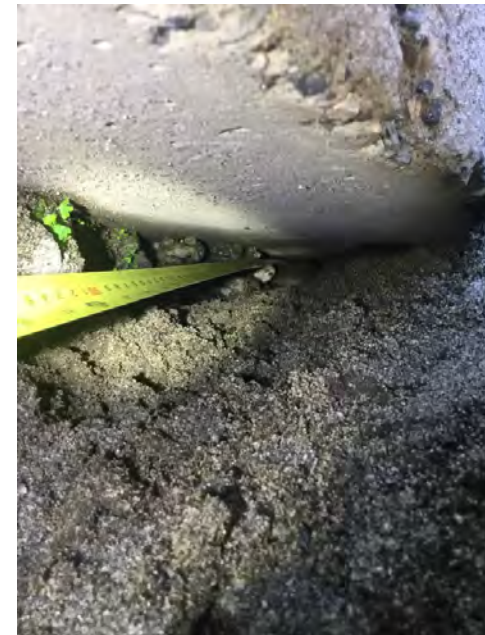
Right Abutment Downstream Footing Scour

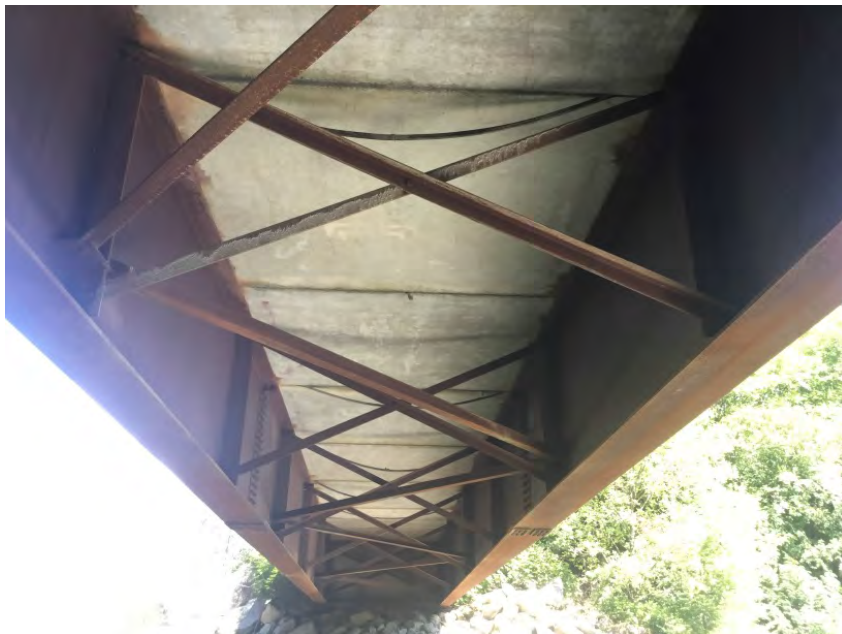
Girders Good
