CK-2386

CENTRE CREEK 5.1km

2016 Inspection

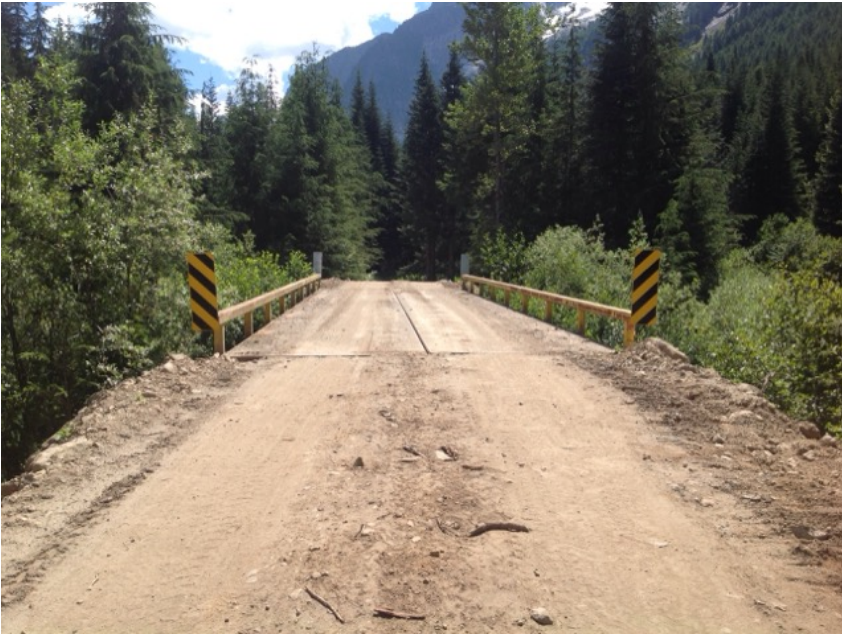
Approach from Left Bank when facing downstream

Bridge Ahead Signs  
Missing ☐ 0 ☐ 1 ☒ 2

Fender Condition Poor

| Repair Item | Priority | Repair Description |
|---|---|---|
| 1 | Medium | place log fenders |
| 2 | Medium | post bridge ahead signs |

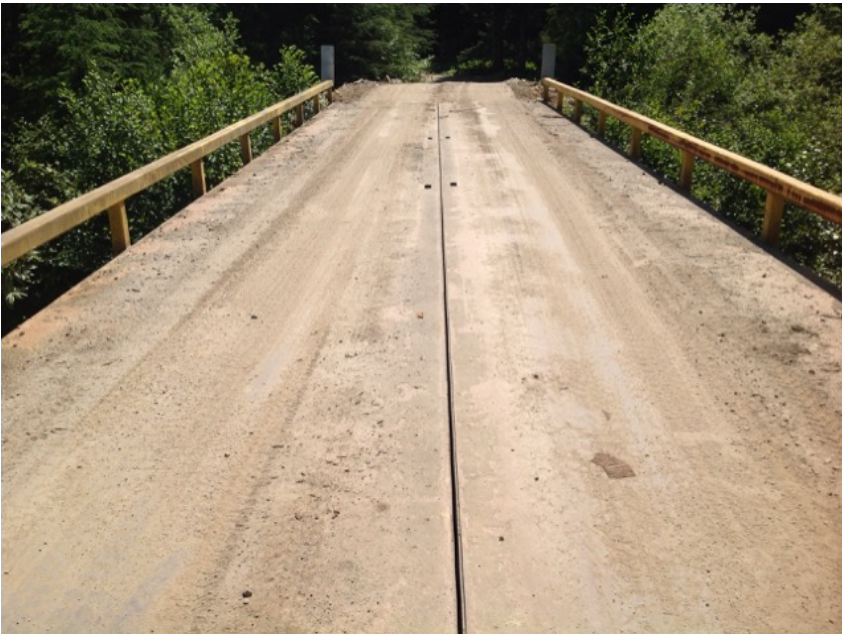
| Steel Deck Plate | Fair | some deformation on wheel path |

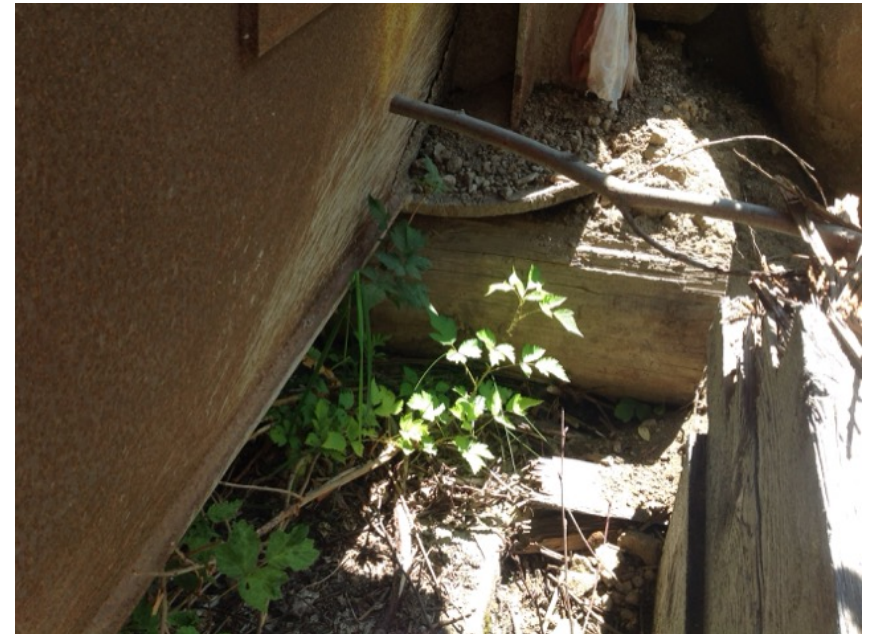
Right Bank Abutment when facing downstream

18.3m ASP bears directly behind existing structure (railcar) on log sills

Bearings Fair ASP not completely bearing on log sills

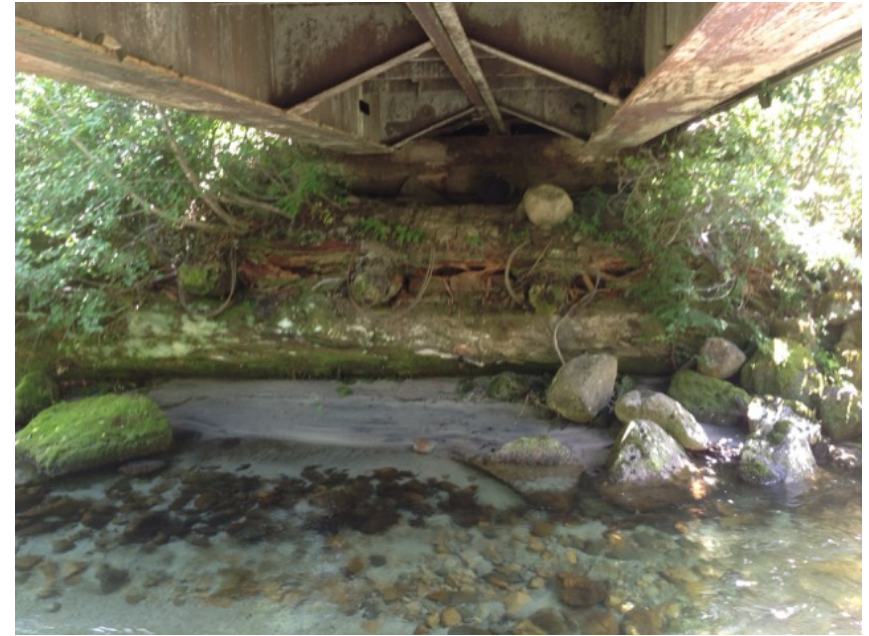
right bank log crib supporting railcar
