CK-2440

STAVE RIVER 31.8km

2016 Inspection

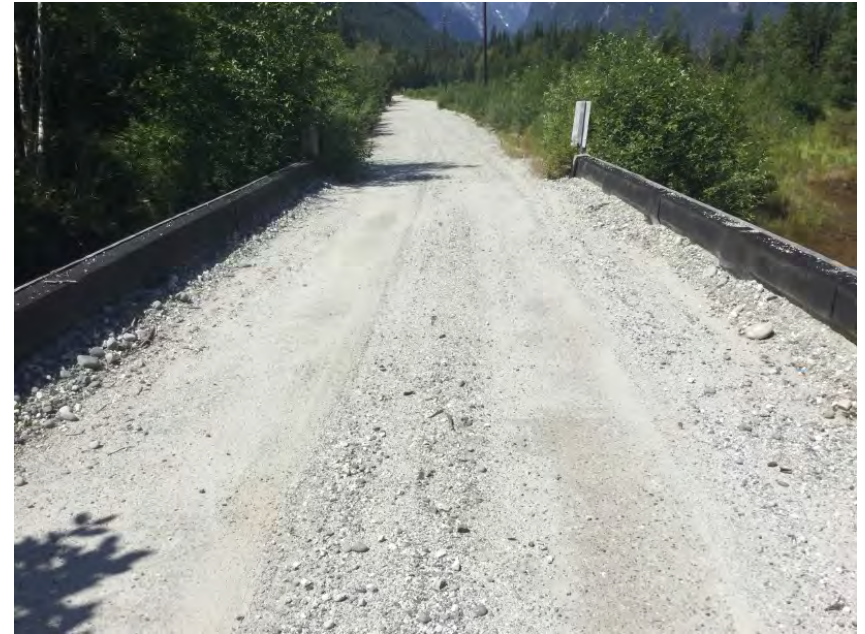
| Concrete Deck | Fair | Wear in wheel tracks. |
| Overall Deck Condition | Fair | Fabric covering guardrail holds debris on deck, promoting deterioration of guardrail. |

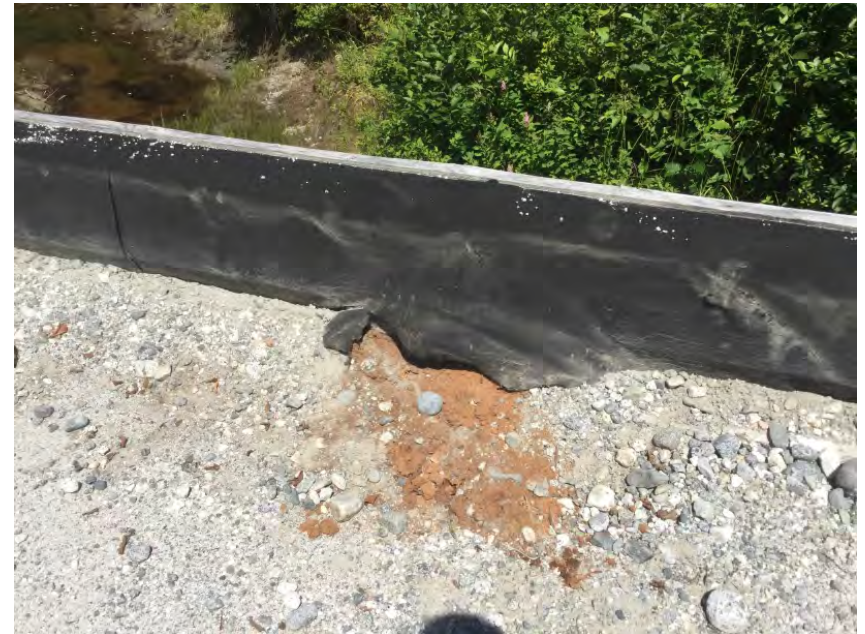
| Curb Rail/Blocks/Posts | Poor | Timber guardrail and riser system. Rot or bug infestation found in 4 of 12 risers. Fungal growth noted on a few risers. Fabric limited inspection of guardrail. |

Rotten Riser

| Repair | | Repair Description |
|---|---|---|
| 1 | High | Replace timber guardrail with HSS system to prevent future deterioration due to debris accumulation. |

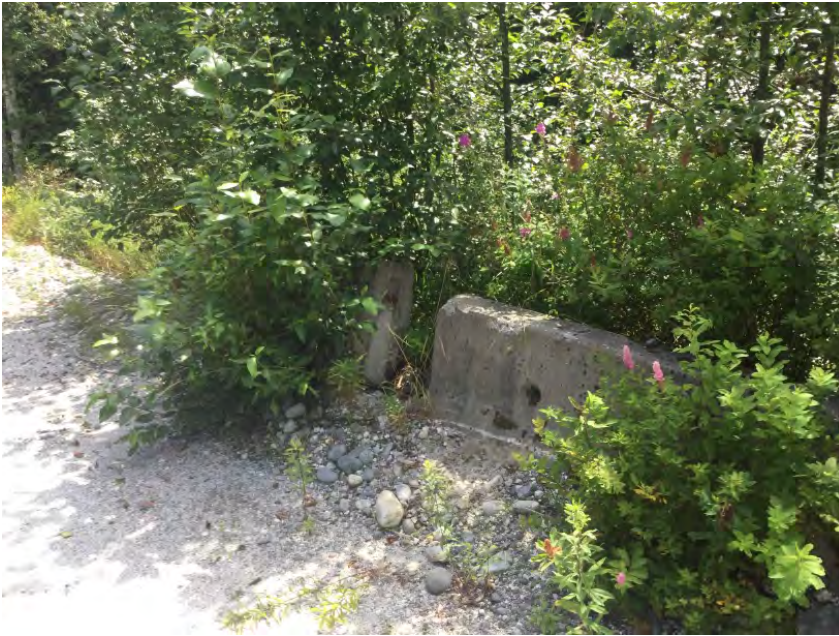
Partially buried in debris. Left approach CRB sections disconnected and partially overturned. Drop to creek is not significant.

Left Approach Downstream Disconnect CRB

| Repair | | Repair Description |
|---|---|---|
| 2 | Medium | Realign and reconnect CRB barriers. |

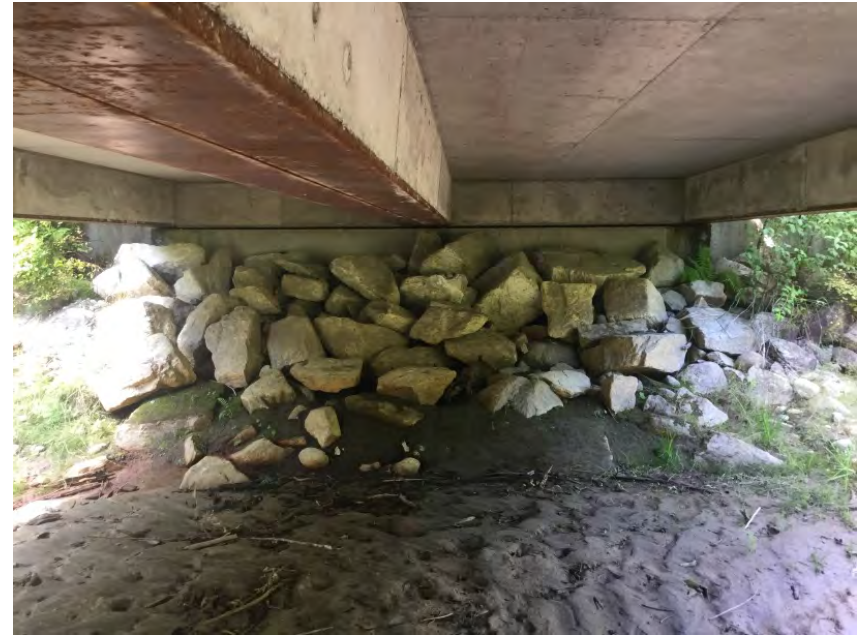
Left Bank Abutment

Left abutment riprap partially buried in remains of beaver dam.

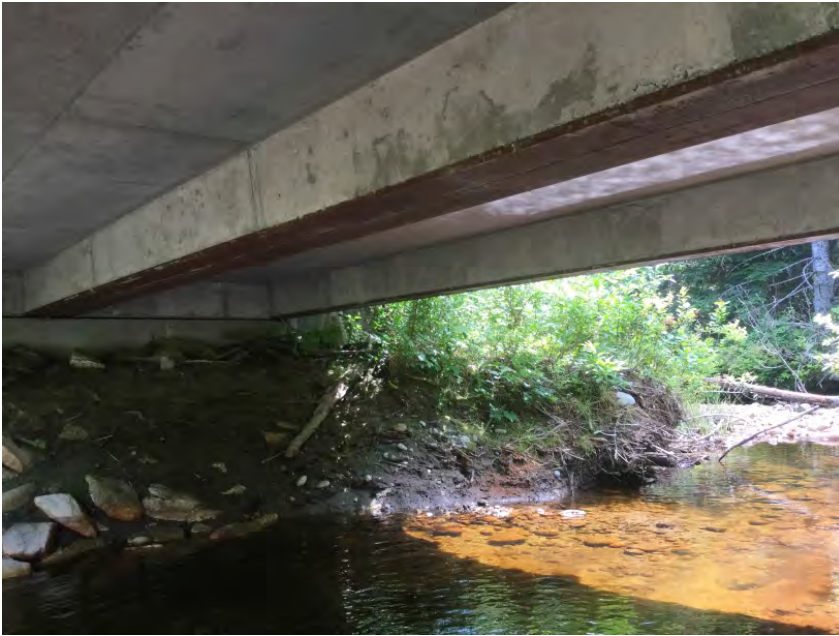
Girders

Look like small compo girders with monolithic deck and end diaphragms. Typical watering staining on exterior faces.

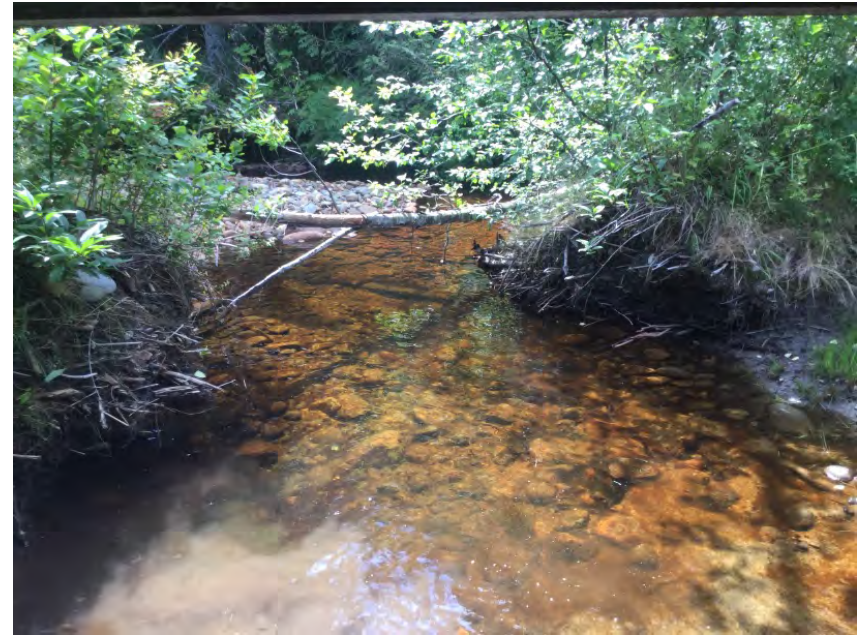
Comments    Opening has been made in old beaver dam since last inspection.

Remains of Downstream Beaver Dam

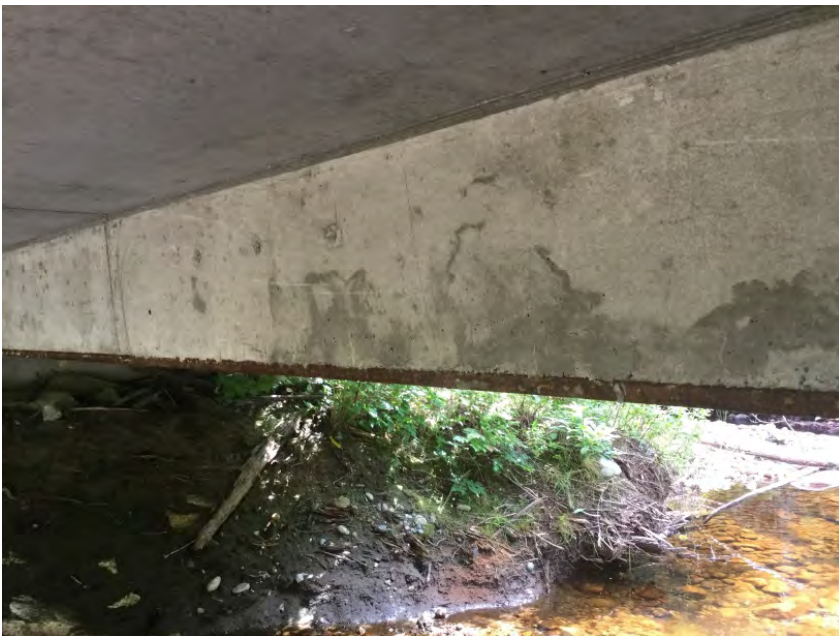
Superstructure type changed. The girders look like small compo girders with monolithic concrete deck and diaphragms. They are not concrete box girders. Bridge is at km 29.9 not km 31.8. Fabric is holding debris on deck and accelerating deterioration of risers and blocking. Suggest guardrail is replaced with standard HSS guardrail.

Girders Monolithic with Deck

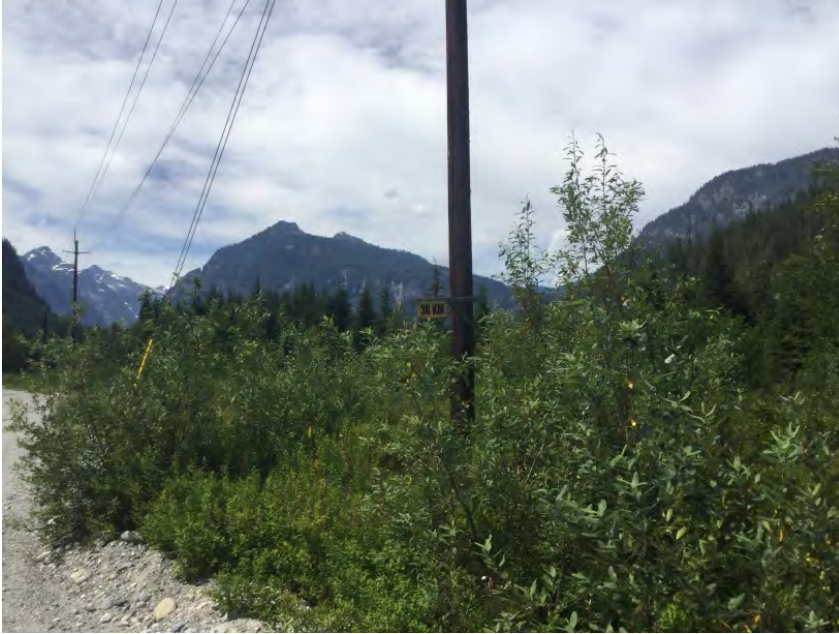
Km Marking Up Chainage from Bridge
