CK-2448

NORRISH CREEK 1.8km

2016 Inspection

| Crossing Name | Sally Creek | | |

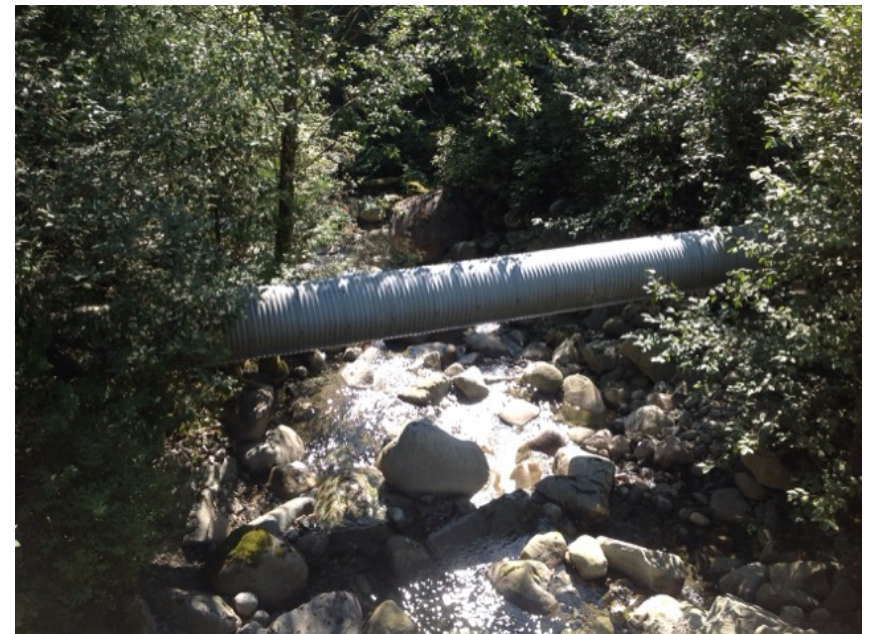
looking downstream from deck

| Curb Rail/Blocks/Posts | Poor | downstream rail in poor condition, upstream is good |
| Overall Deck Condition | Poor | due to downstream rail |

| Repair Item | Priority | Repair Description |
|---|---|---|
| 1 | Medium | replace downstream guardrail system and left delineators |

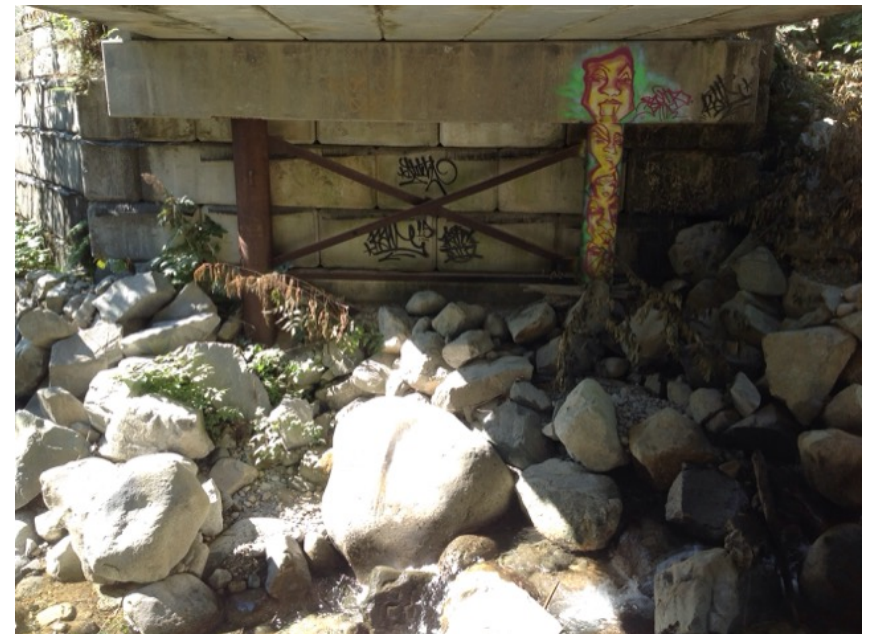
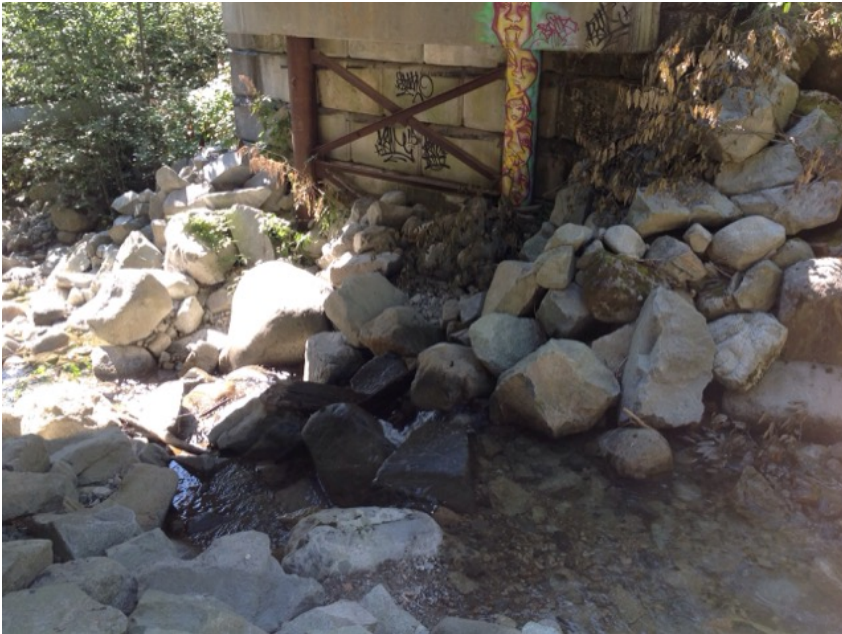
Right Bank Abutment when facing downstream

Riprap Fair right bank is missing riprap right front of towers

| Repair Item | Priority | Repair Description |
|---|---|---|
| 2 | High | repair/replace riprap scour in front of right abutment |

| Item | Monitor Description | Frequency |
|---|---|---|
| 1 | riprap scour on right abutment | After heavy precipitation events or rain on snow events |

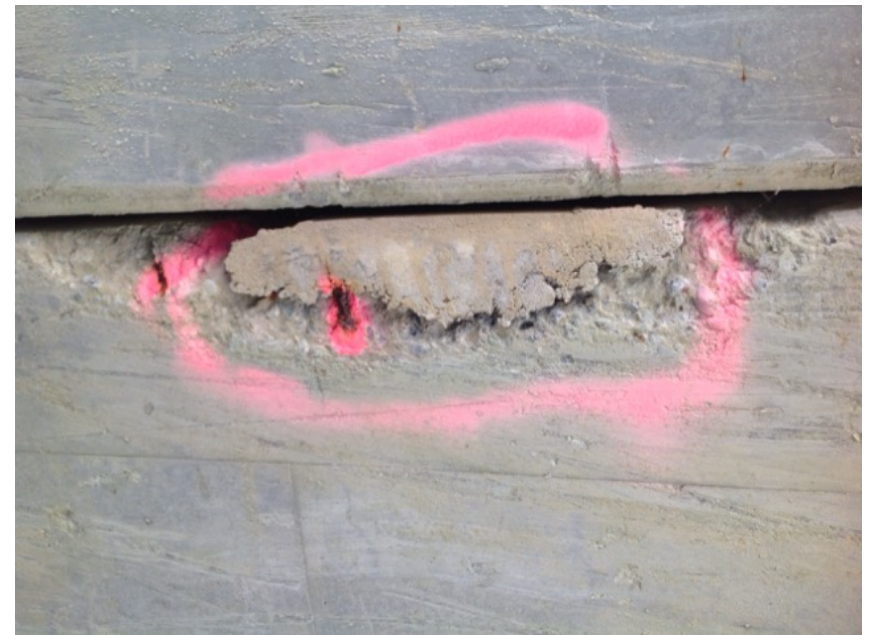
Girders Fair 7 concrete slabs with spalls noted

concrete spall with exposed rebar

Replace the downstream guardrail, risers and blocks. The riprap in front of the right abutment needs to be repaired/replaced to fully protect the abutment and in the meantime needs to be monitored ESPECIALLY given the water line located IMMEDIATELY downstream the crossing. Replace the delineators that are installed at the left sides with proper left delineators. Repair the concrete girders in the areas with exposed rebar as indicated in the photos. Present load rating of L150 or 136 tonnes to continue.

| Repair Item | Priority | Repair Description |
|---|---|---|
| 3 | Medium | repair the girders in the areas with exposed rebar |

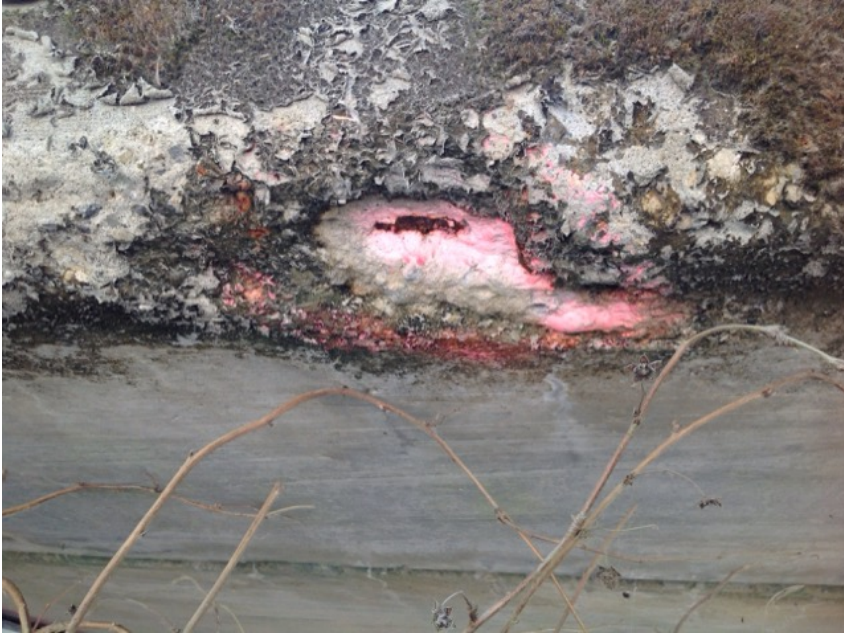
concrete spall with rebar exposed

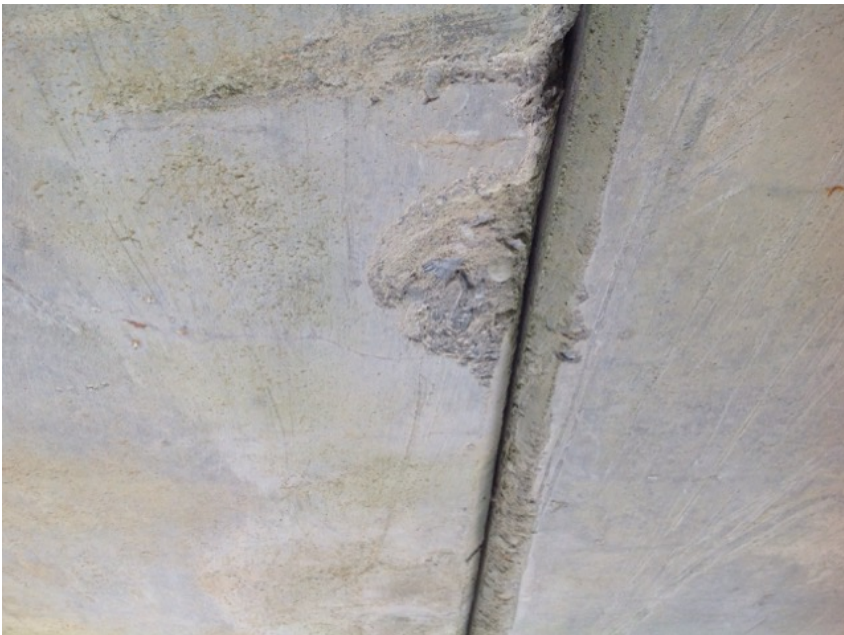
random concrete spall - noted throughout slabs but no rebar exposed
