CK-2449

NORRISH CREEK 3.6km

2016 Inspection

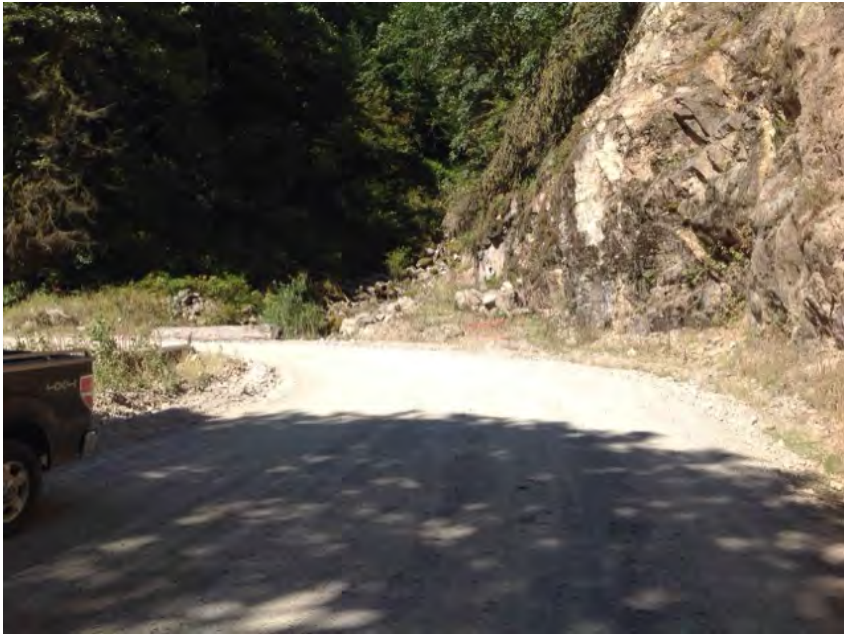
Approach from Left Bank when facing downstream

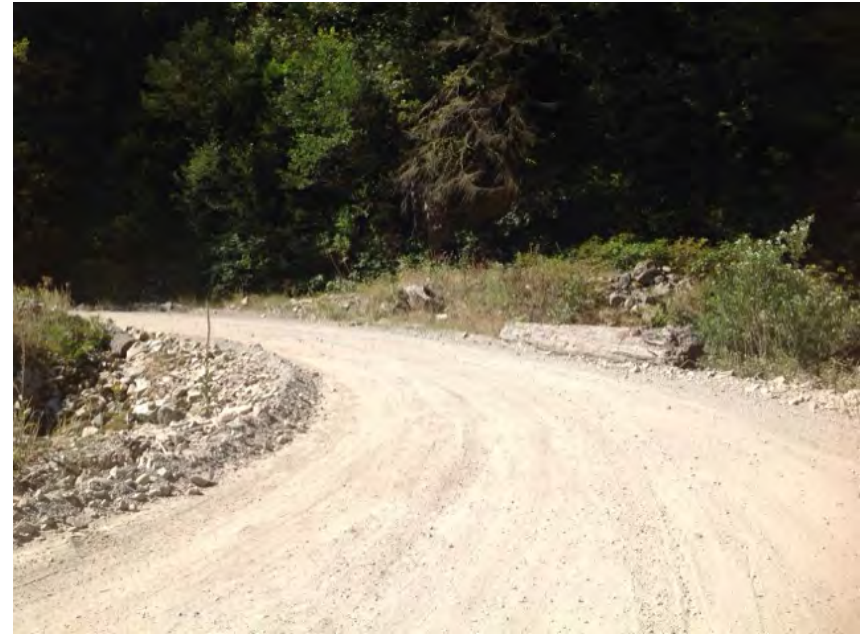
Approach from Left Bank when facing downstream

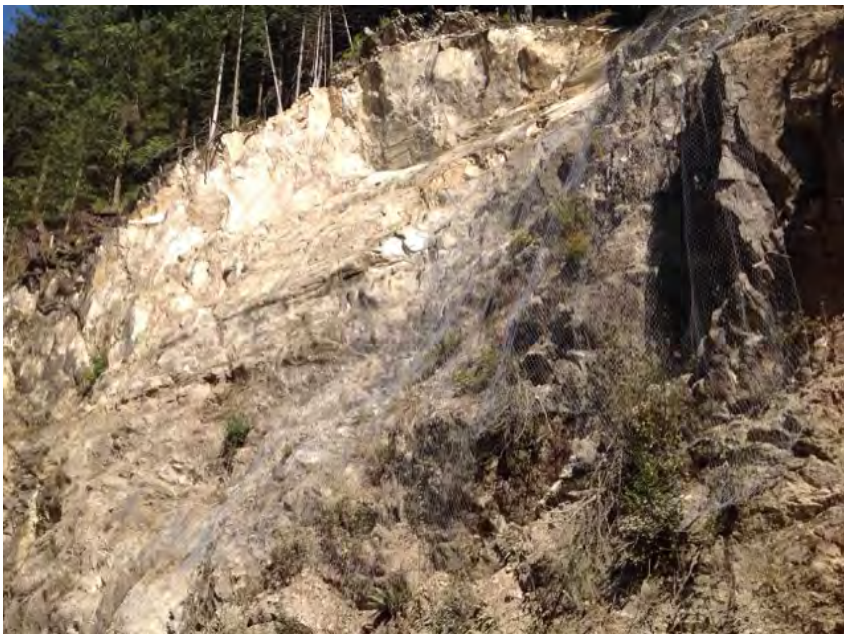
left bank cut slope

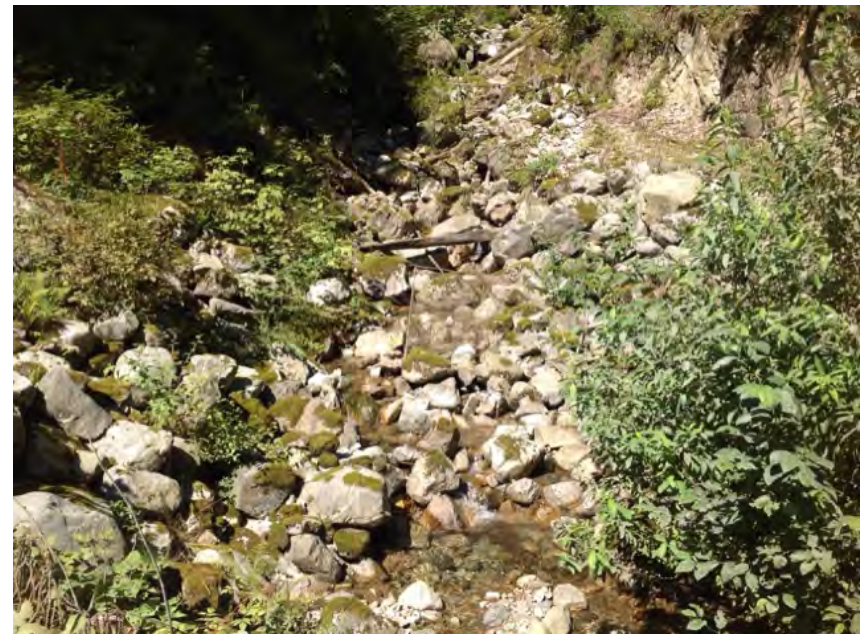
looking upstream from road

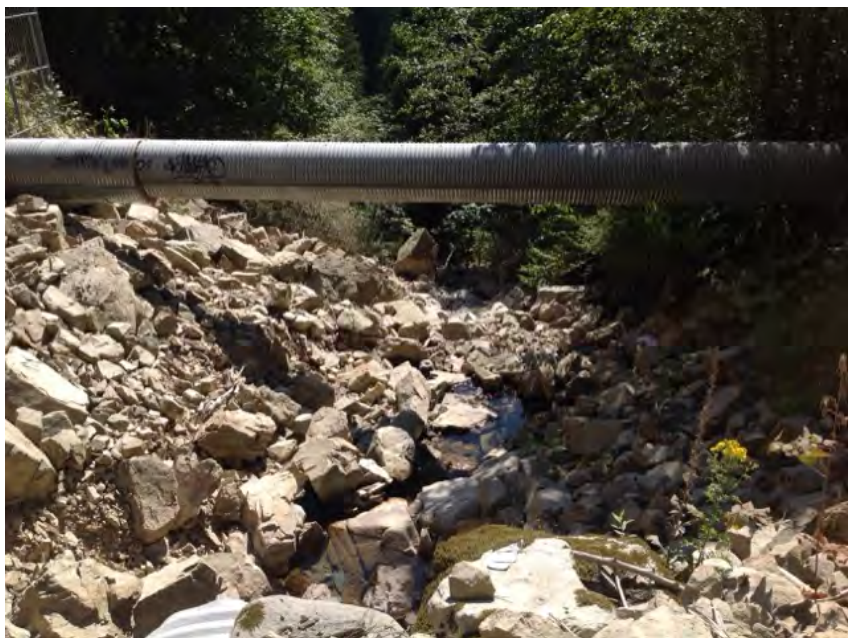
looking downstream from road

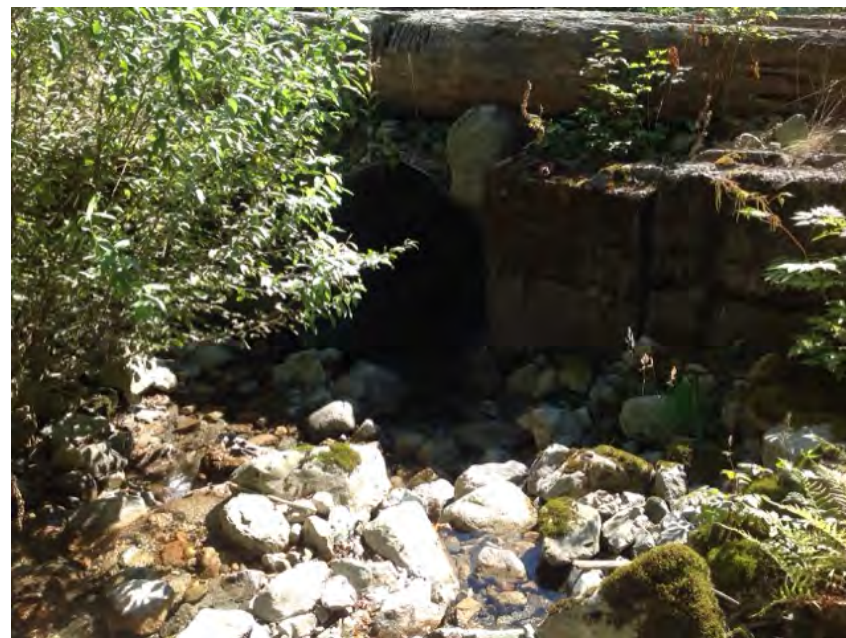
| Inlet | Fair | |

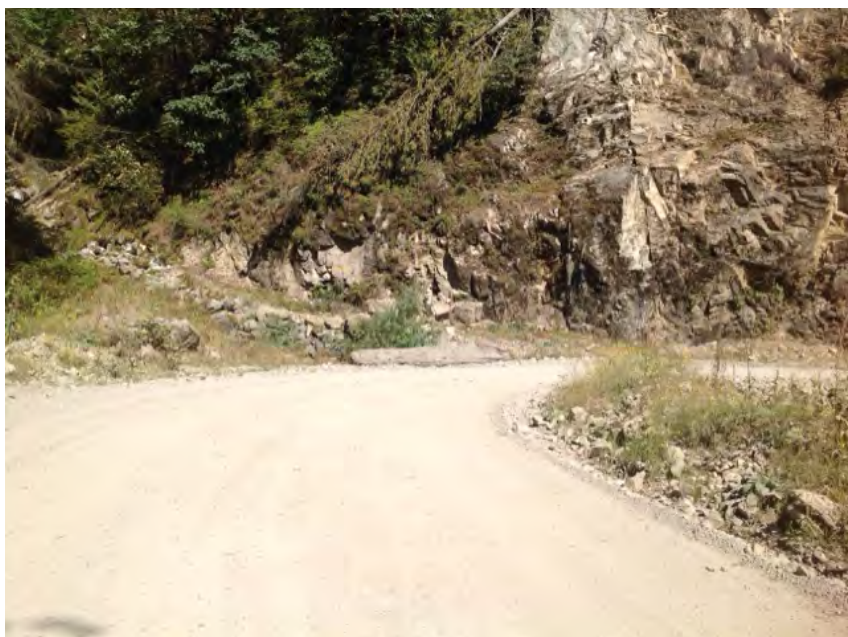
Approach from Right Bank when facing downstream

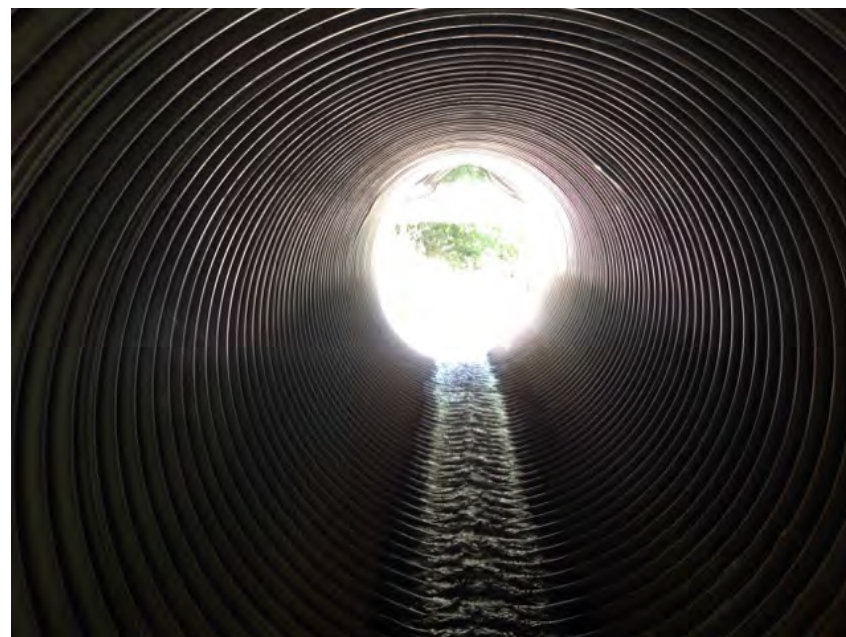
| Roof | Fair | minor install damage |

looking through culvert

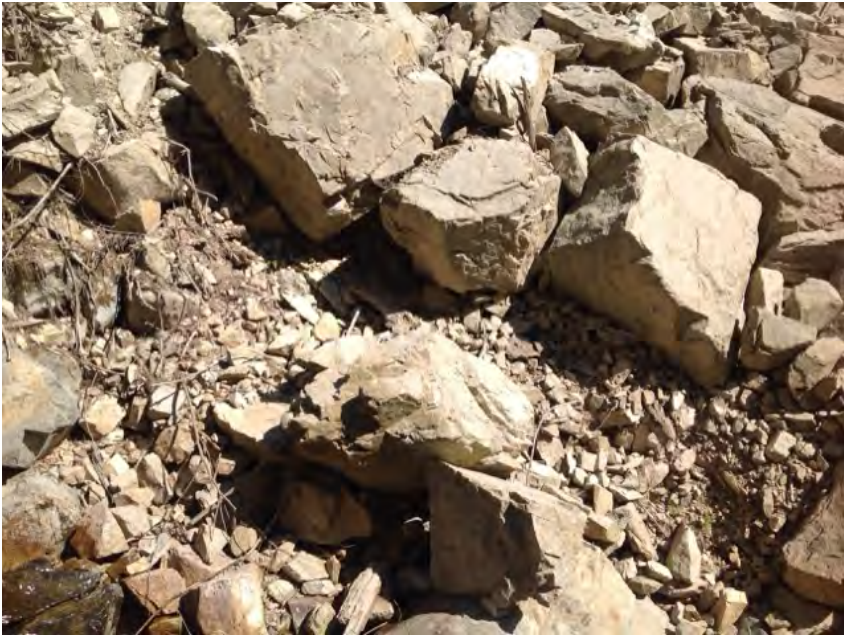
| Rip Rap | Fair | |

riprap scour

| Item | Monitor Description | Frequency |
|---|---|---|
| 1 | riprap scour | Annually |

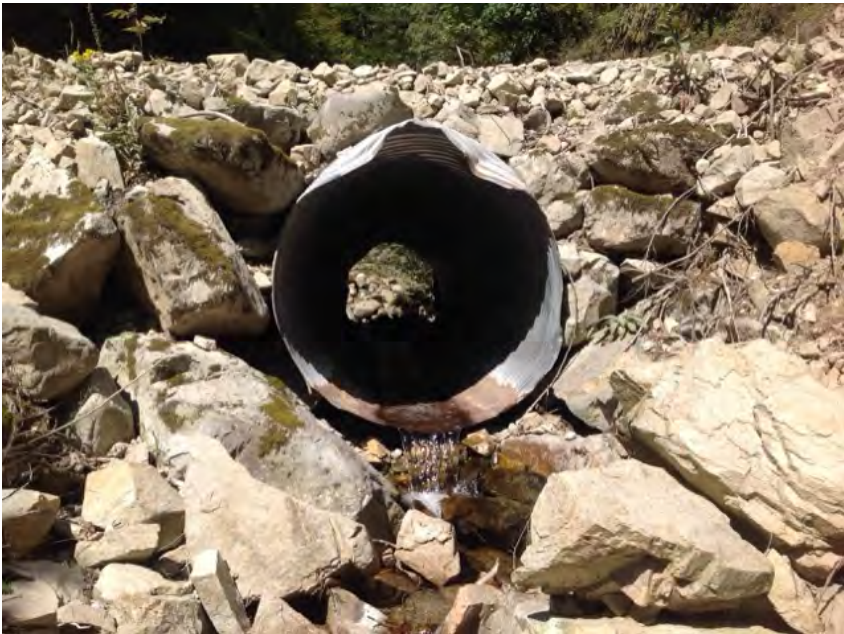
| Outlet | Fair | |
