CK-2450

NORRISH CREEK 5.1km

2016 Inspection

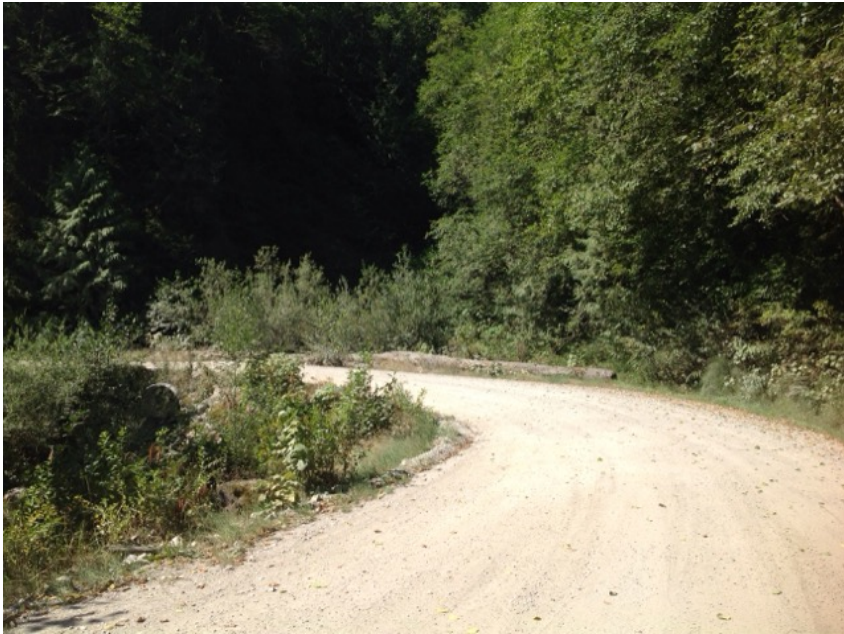
Approach from Left Bank when facing downstream

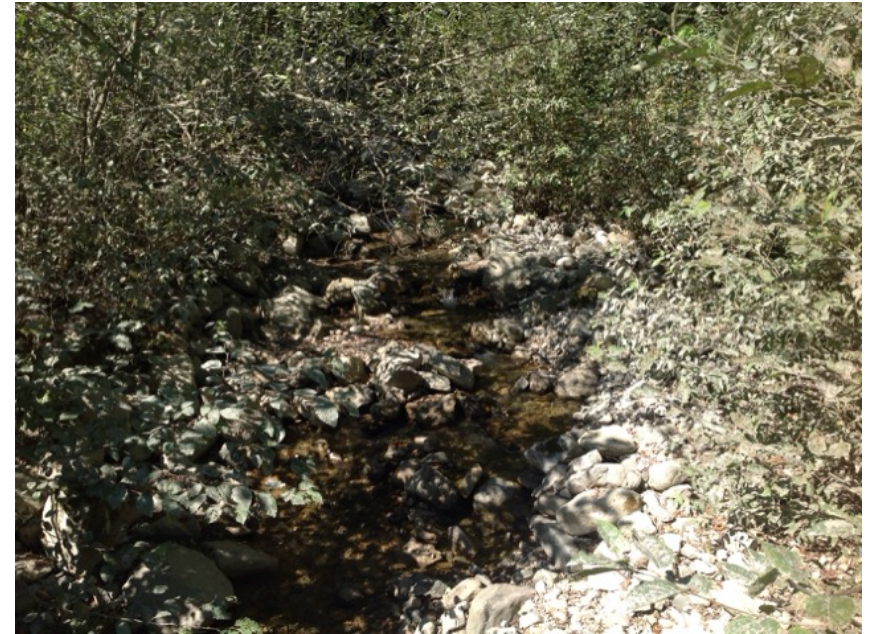
looking upstream from road

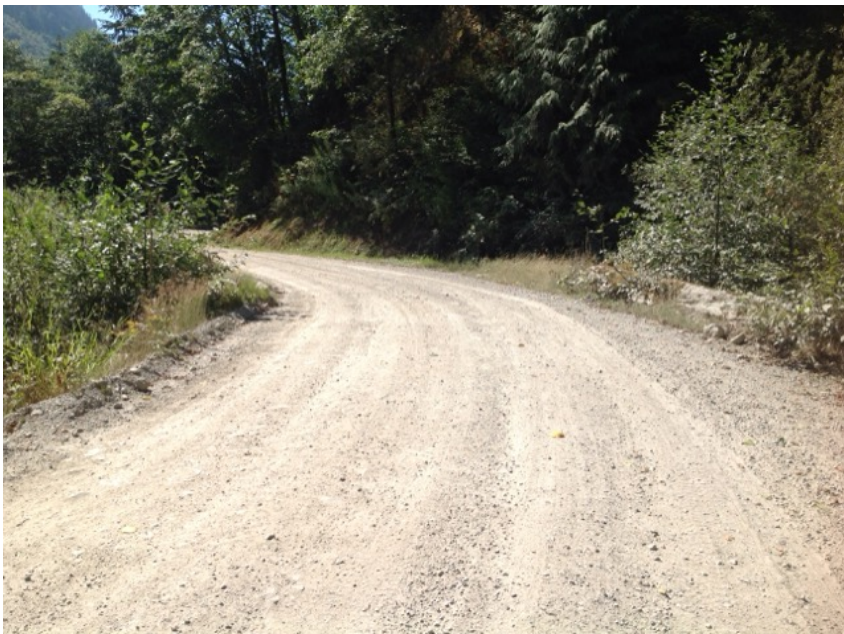
Approach from Left Bank when facing downstream

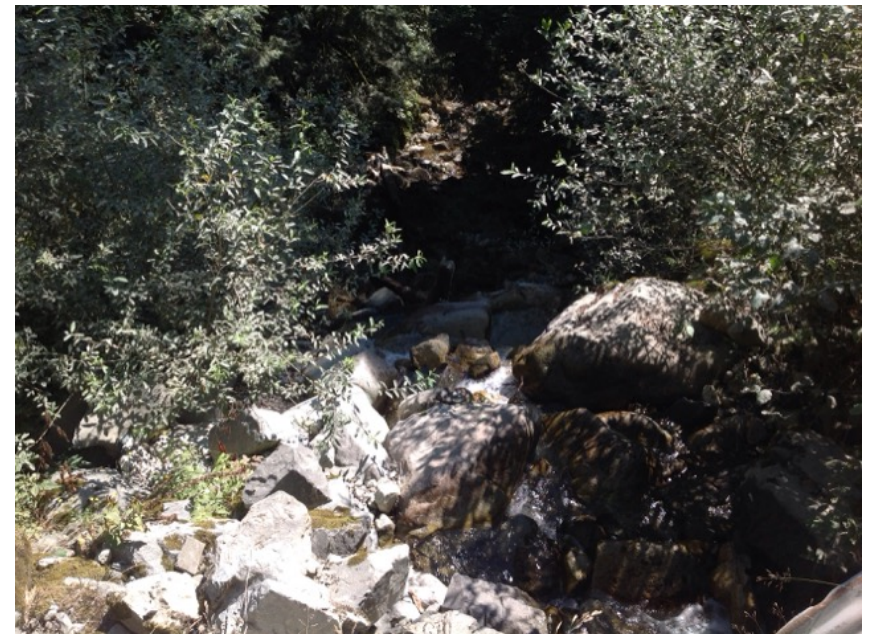
looking downstream from road

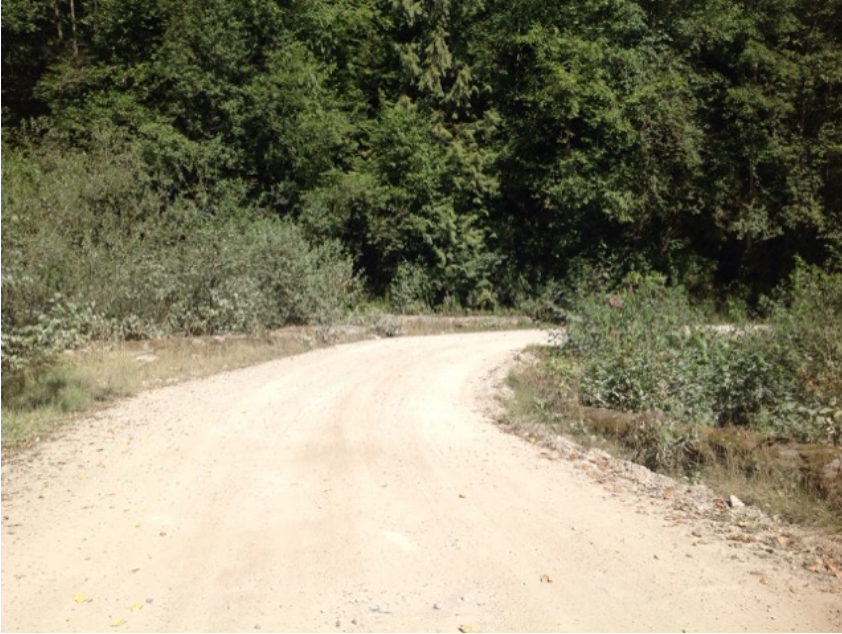
Approach from Right Bank when facing downstream

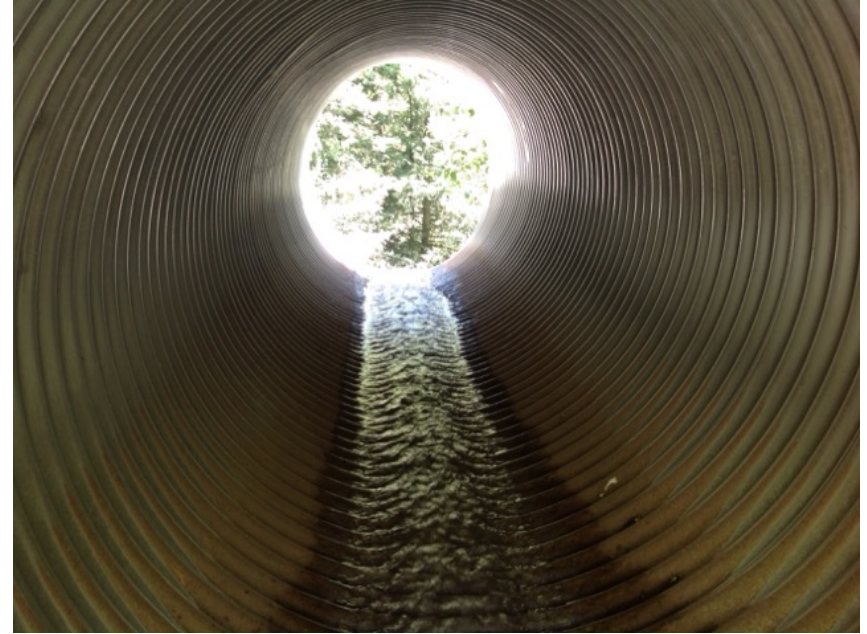
looking through culvert

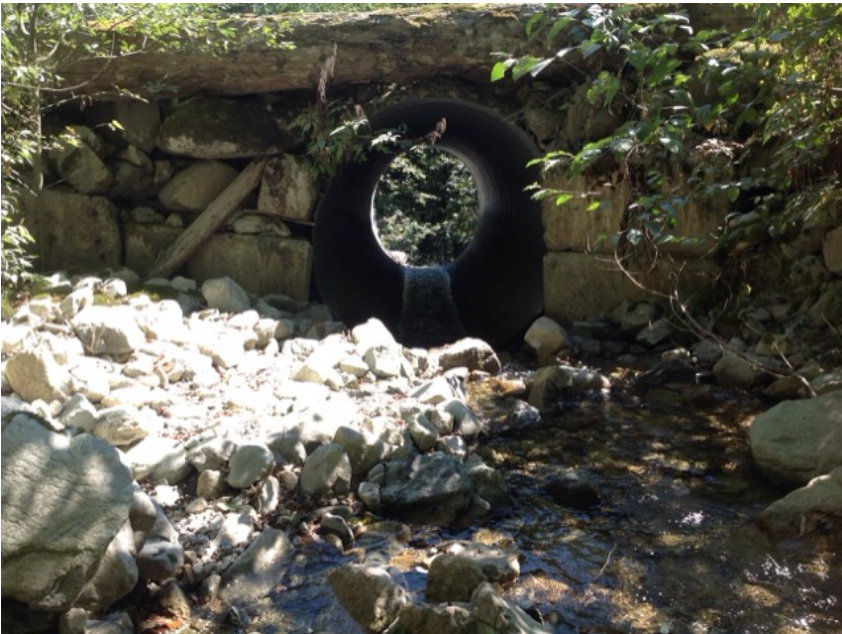
Inlet Fair

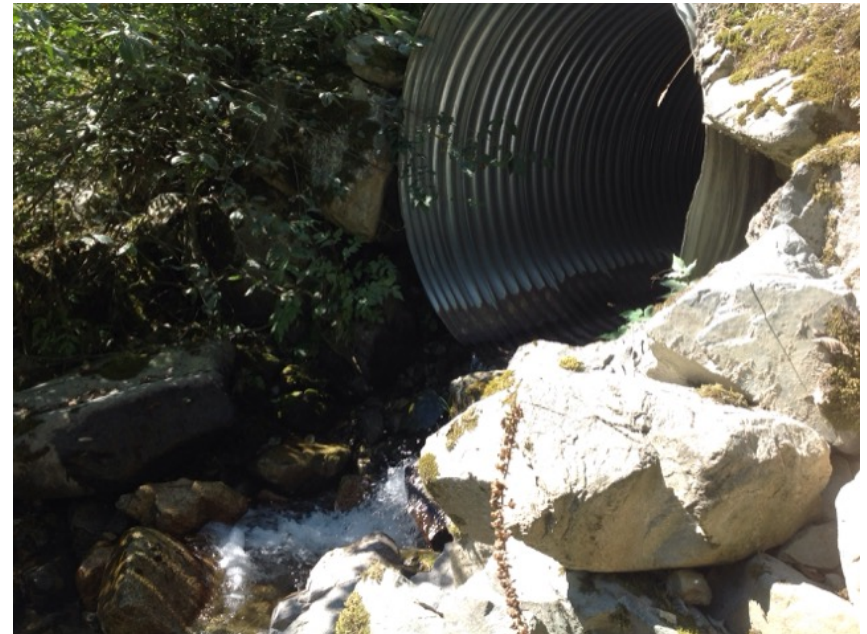
Outlet Fair

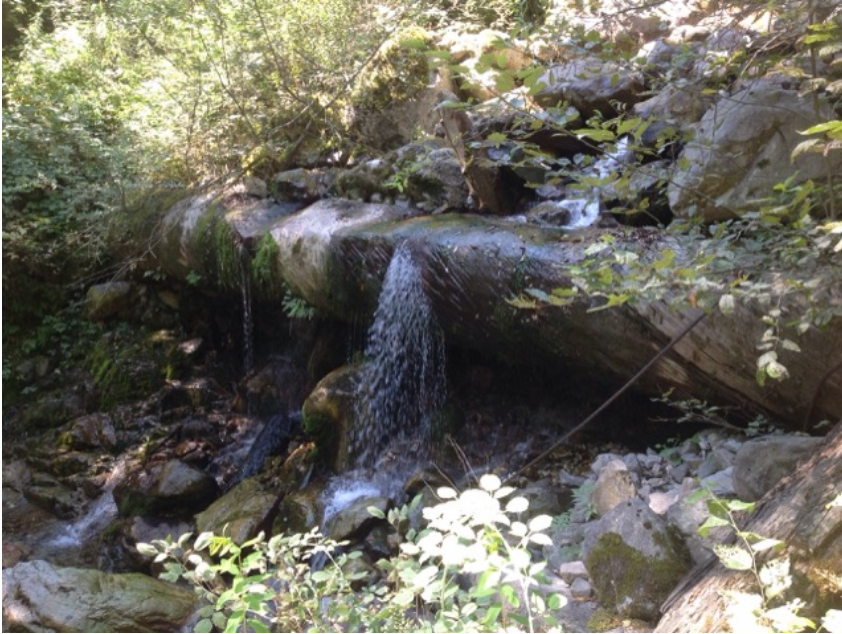
Comments    monitor large log retaining fill at outlet

large log retaining fill at outlet

Add 200mm gravel fill over the culvert and blend into the existing grade. There does not appear to be any change of the large log retaining fill at the outlet of the culvert; however it needs to be monitored especially following heavy precipitation or rain on snow events. Consider removing this log and replacing it with a permanent structure. Present load rating of BCL-625 or 63 tonnes to continue.

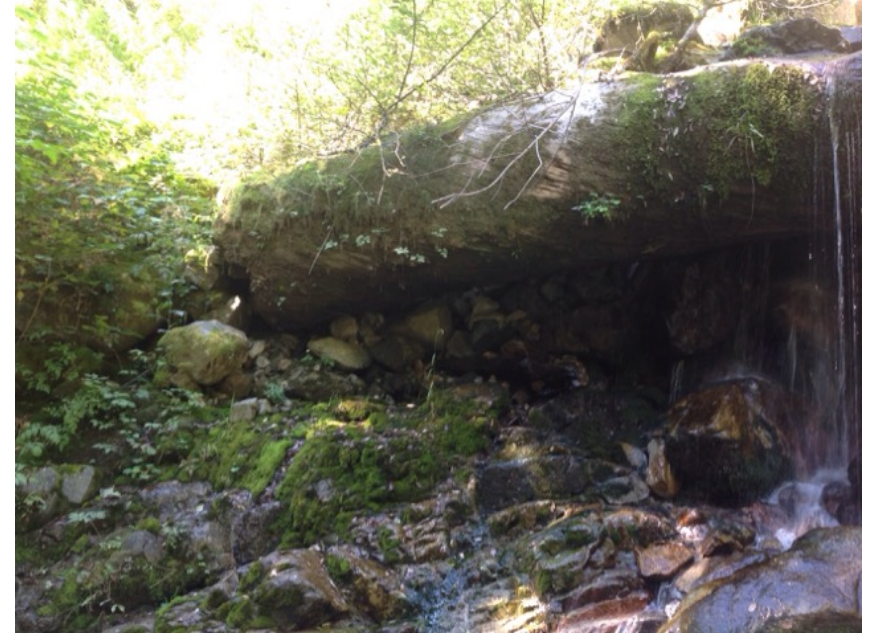
erodable materials in the fill slope at either approach

right bank of log retaining fill just sitting on erodible material

| Item | Monitor Description | Frequency |
|---|---|---|
| 1 | large log retaining fill at outlet and erodable fill slope materials | Following heavy precipitation or rain on snow events |

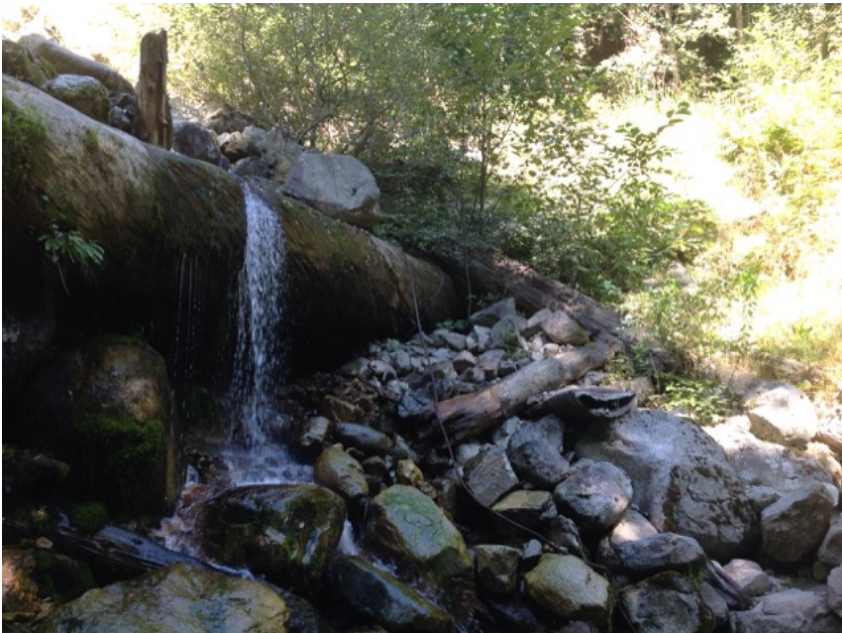
left bank of large log retaining fill appears appropriately tied to bank

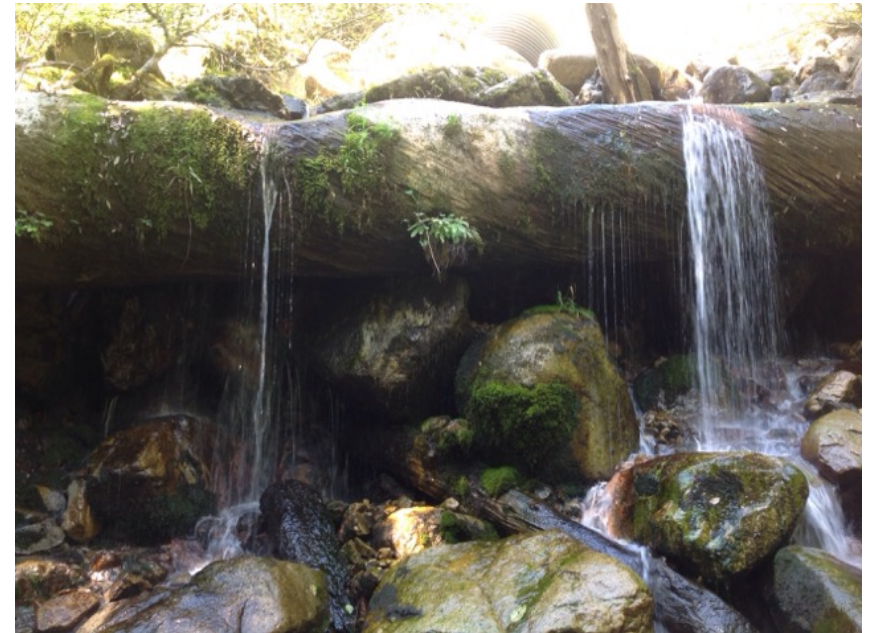
middle of log retaining fill bearing on creek material
