CK-2452

NORRISH CREEK 7.1km

2016 Inspection

| Crossing Name | Rose Creek |

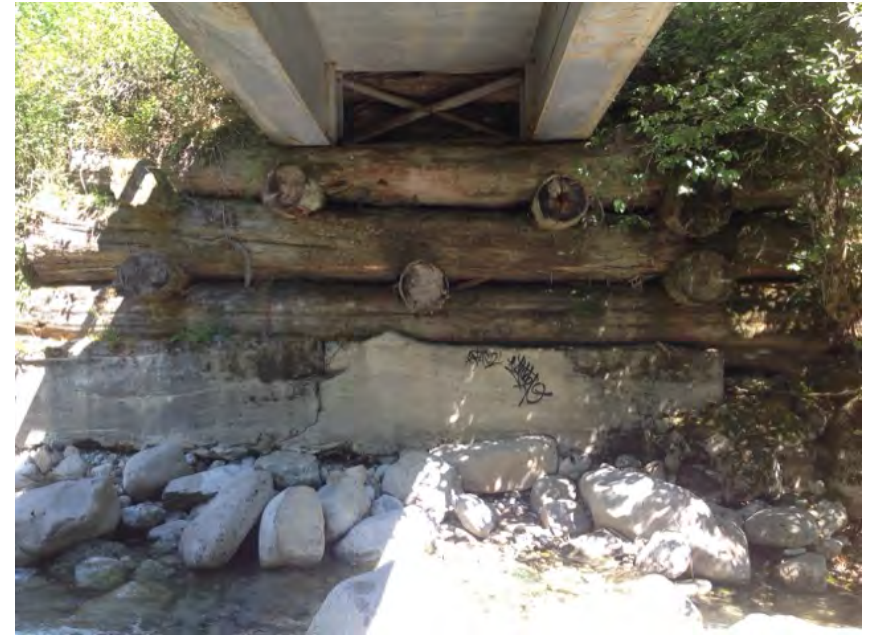
Left Bank Abutment when facing downstream

No noticeable movement/expansion in the vertical crack on the left bank CIP

Concrete Fair vertical crack on left bank CIP - no settlement apparent ; lock blocks on CIP right bank

Continue to monitor the left abutment condition. Present load rating of L165 or 150 tonnes to continue.

1 vertical crack on left bank CIP

Anually

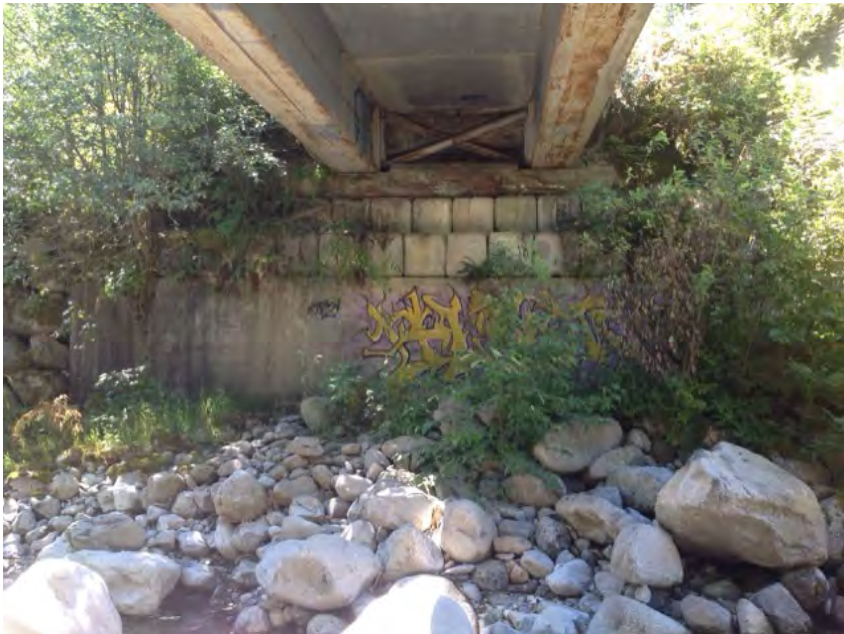
Right Bank Abutment when facing downstream

Caps or Sills Fair log on right bank on top of lock block and CIP
