CK-2453

NORRISH CREEK 7.4km

2016 Inspection

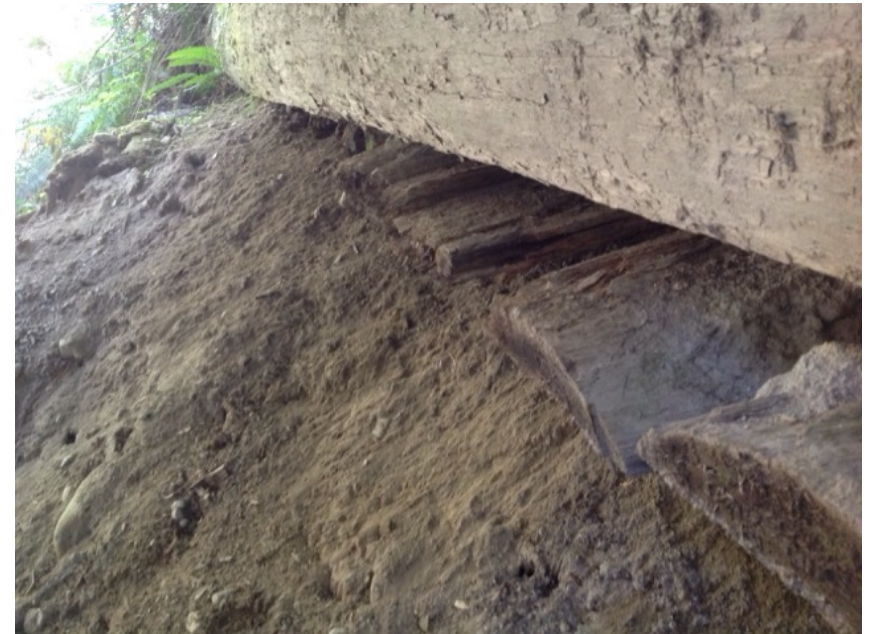
Monitor left bank fill

Monitor left bank fill. Present load rating of L100 or 91 tonnes to continue.

Fill Fair eroding on left bank - monitor

log retaining fill of left bank in front of log sill scoured

| 1 | scour under log retaining fill in front of sill on left bank | Anually |
