CK-2457

NORRISH CREEK 13.6km

2016 Inspection

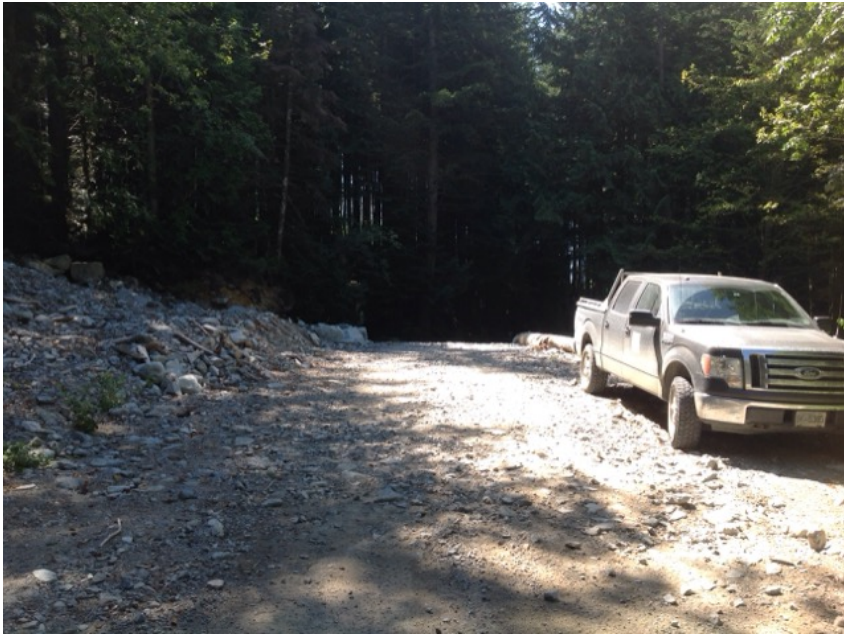
Approach from Right Bank when facing downstream

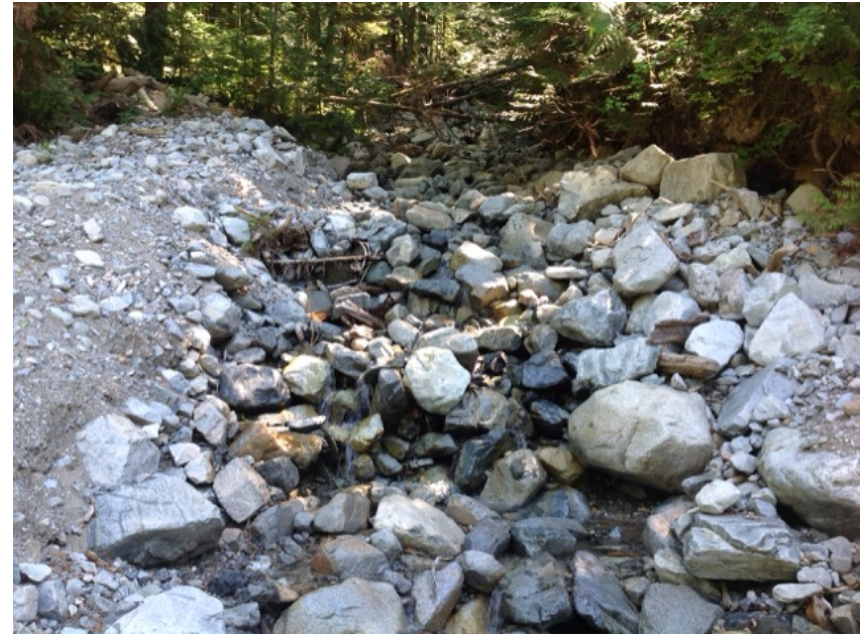
looking upstream from road

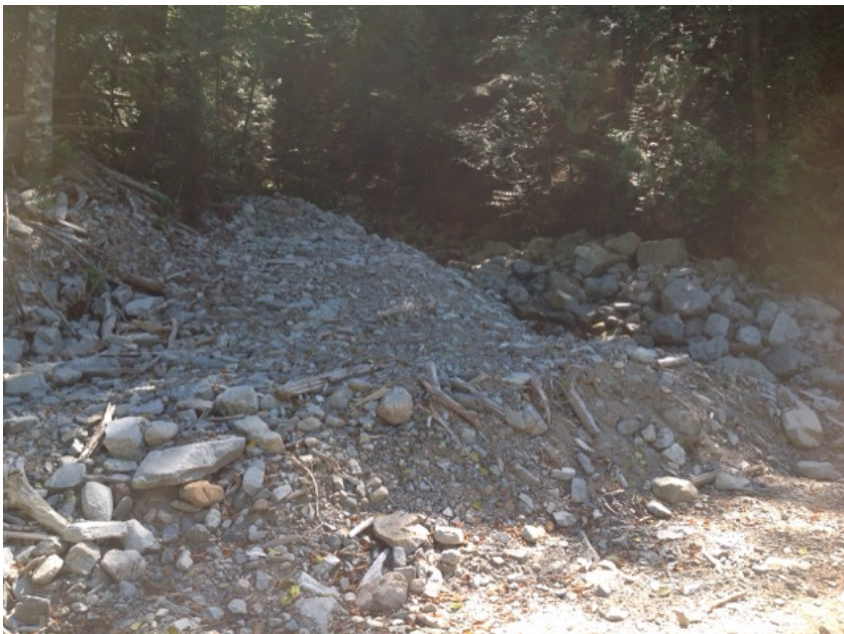
evidence of recent heavy flows

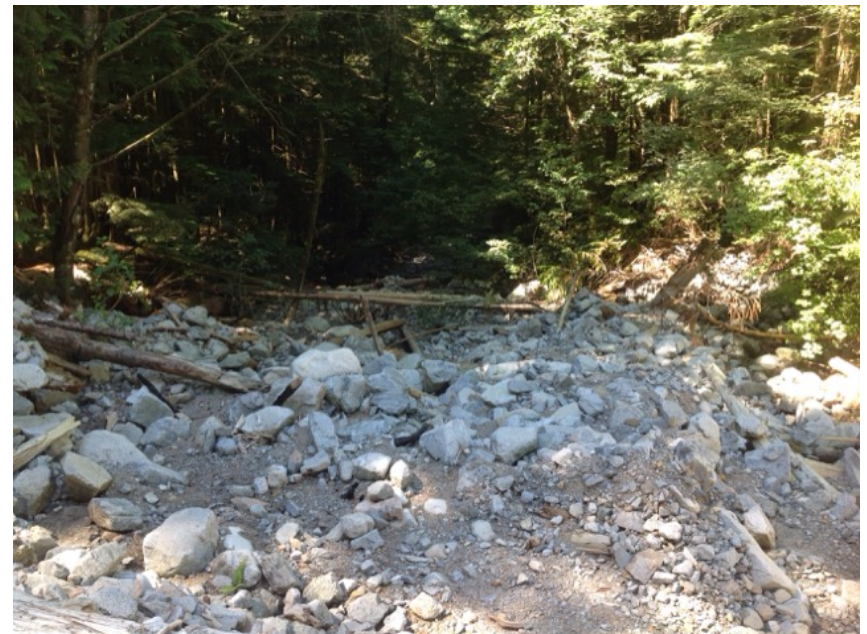
looking downstream from road

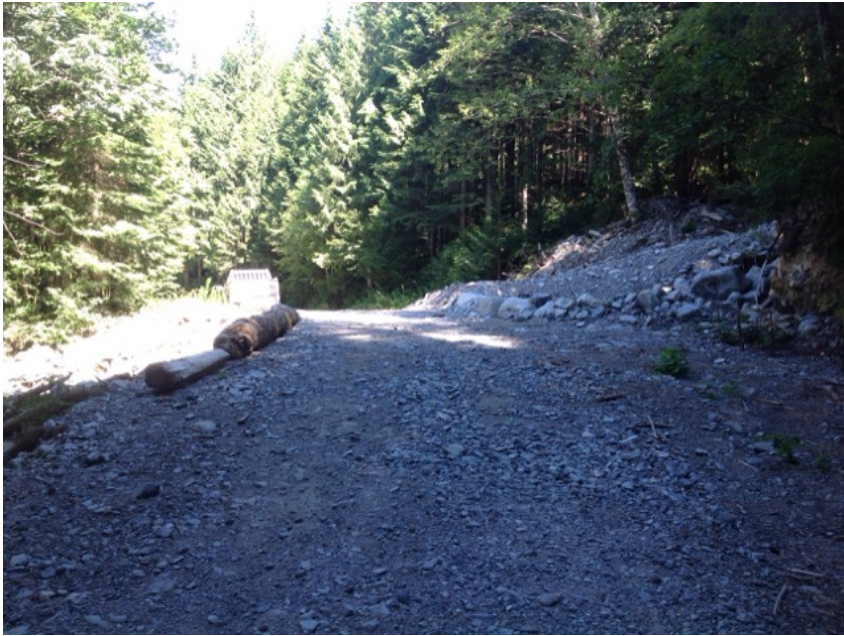
Approach from Left Bank when facing downstream

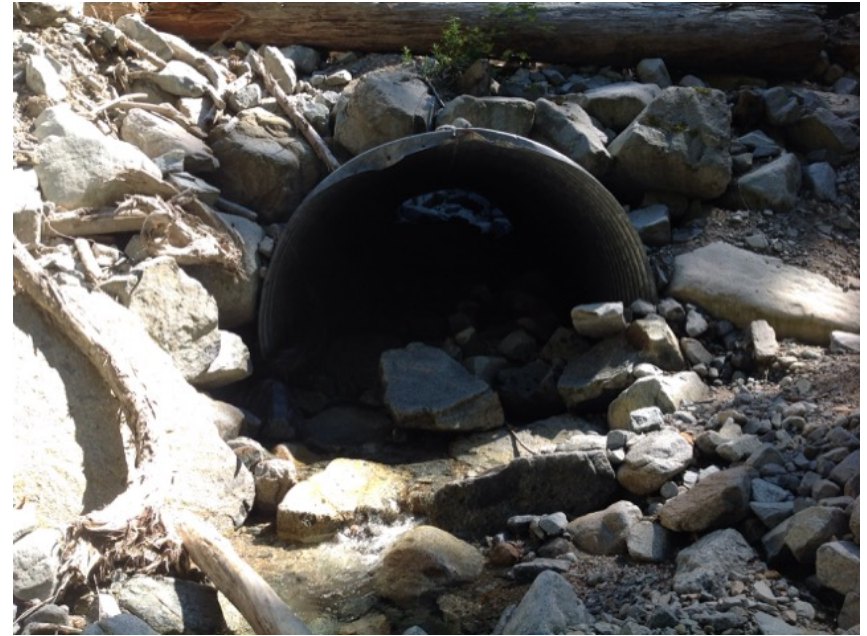
| Outlet | Fair | footing scour |

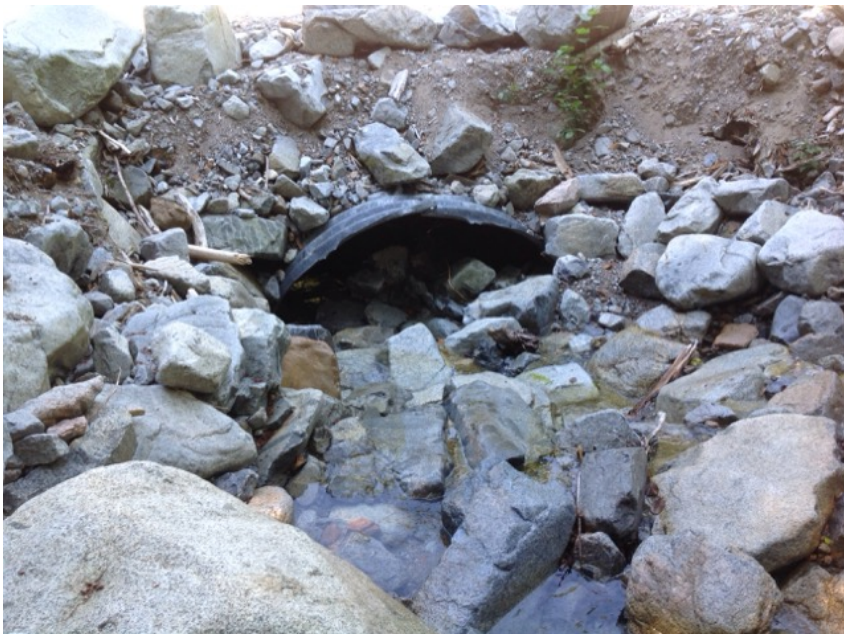
| Embedment Materials | Poor | inlet 75% plugged |
| Inlet | Poor | 75% plugged |
| Overall | Poor | due to plugged inlet |

Inlet - 75% plugged

| 1 | High | clean inlet |

| Item | Monitor Description | Frequency |
|---|---|---|
| 1 | inlet aggradation | Following heavy precipitation or rain on snow events |

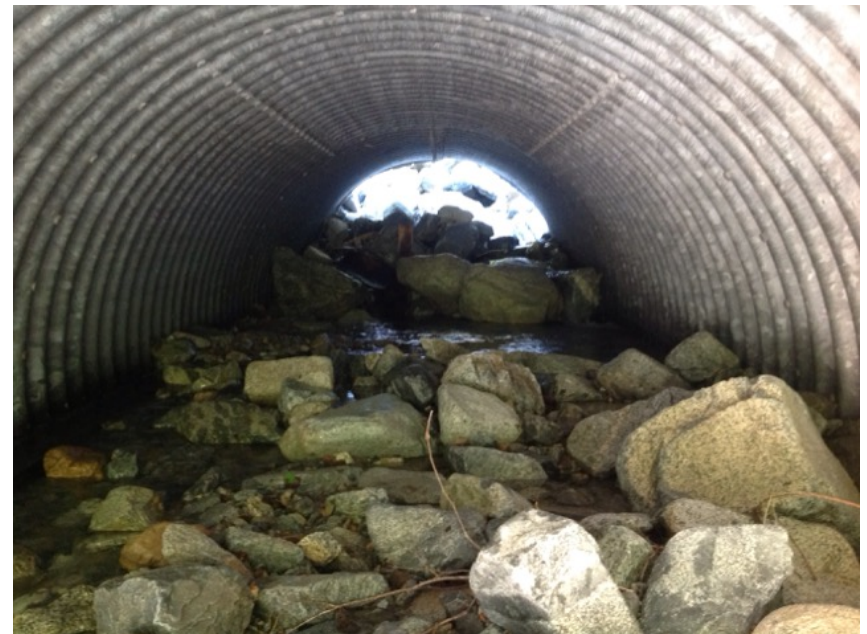
looking through culvert

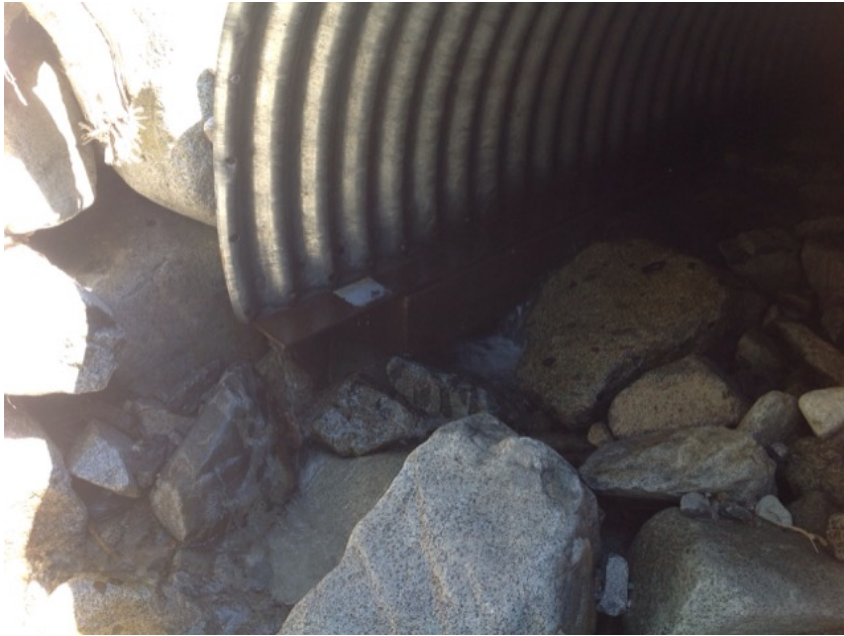
| Footing | Fair | some scour noted a outlet |

footing scour at outlet
