CK-2472

CHEHALIS-MAISAL 6km

2016 Inspection

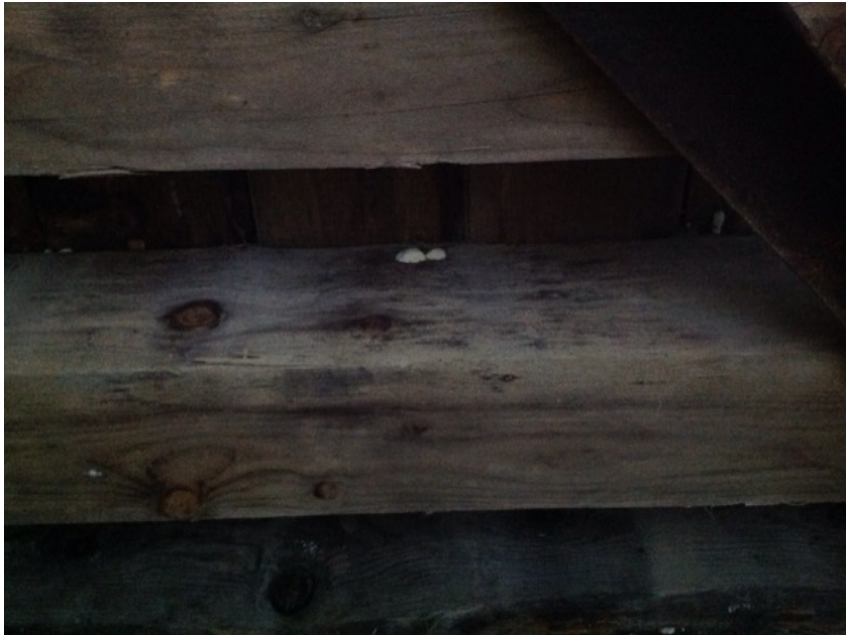
ties starting to show signs of decay

| 1 | deck condition | Routine Inspection |

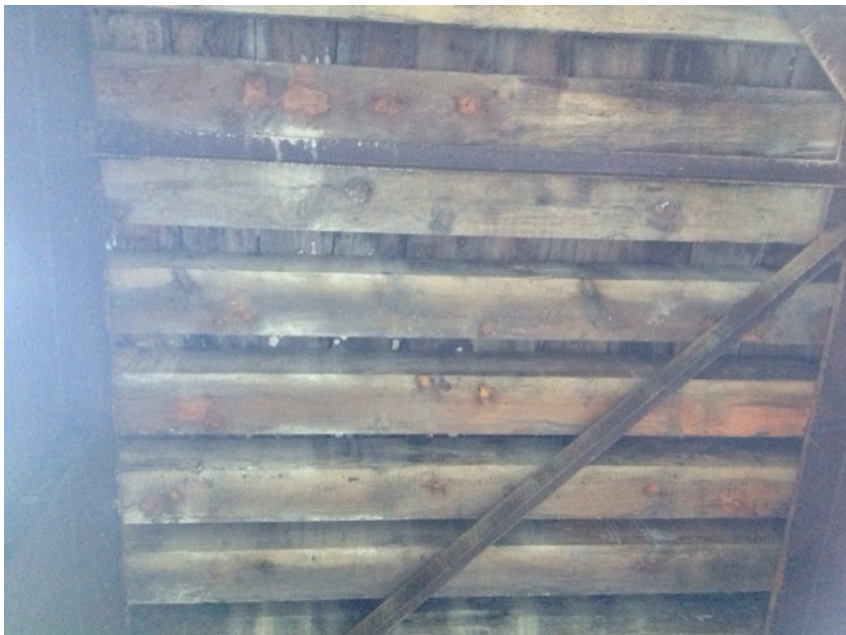
sub deck starting to signs of decay
