CK-2473

NAHATLATCH 45.3km

2016 Inspection

| Crossing Name | Whistle Pig Creek | | |

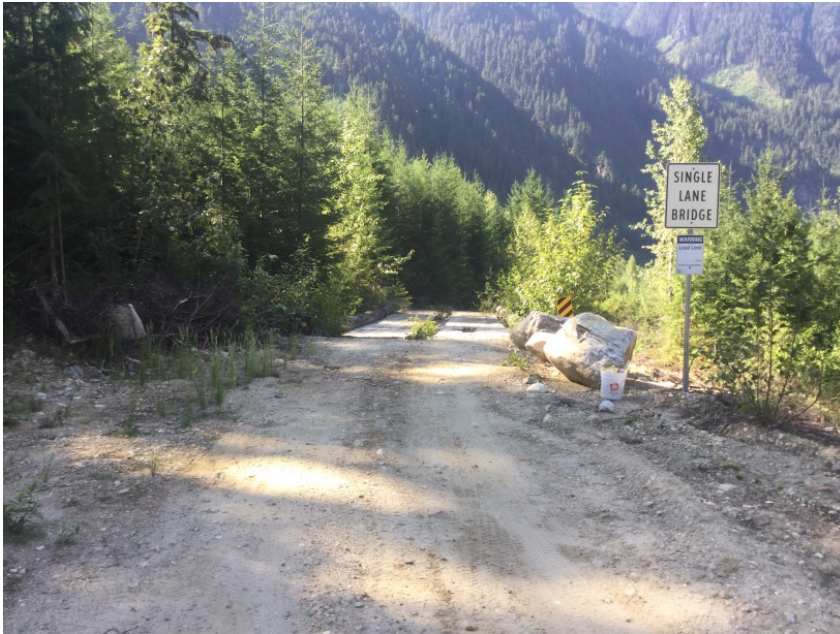
Right Approach Facing Bridge

Large boulders at right approach. No fenders at left approach.

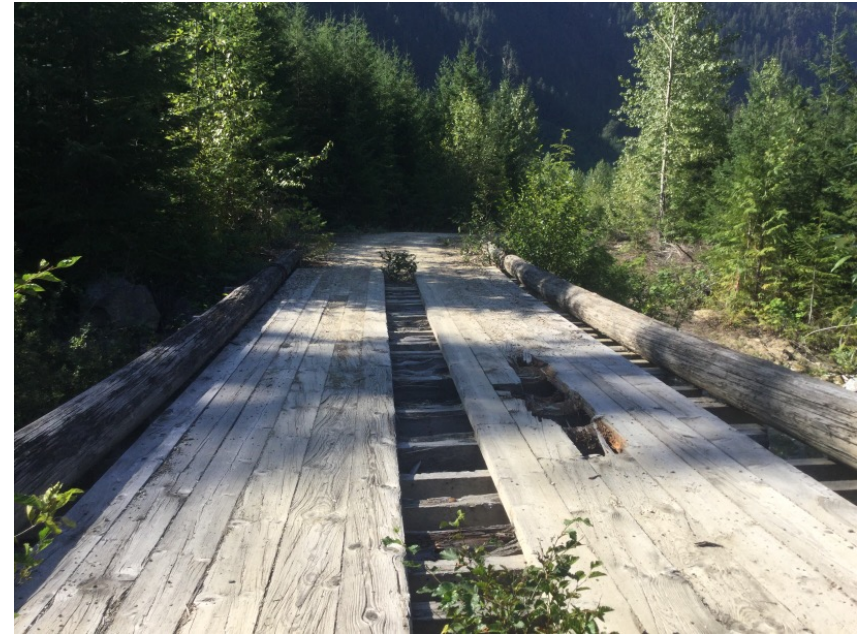
| Overall Deck Condition | Poor | Large holes in deck and rotten ties. |

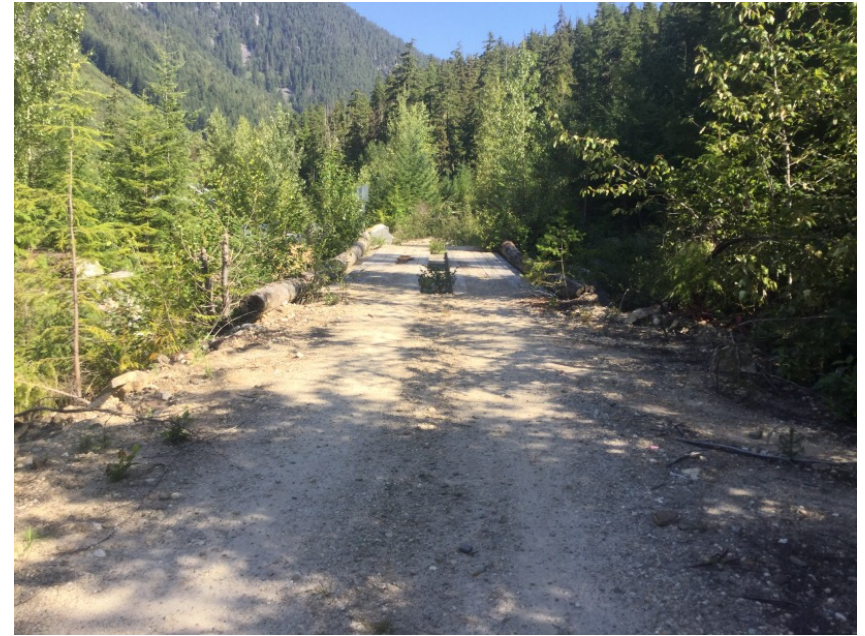
Left Approach Facing Bridge

Left approach missing.

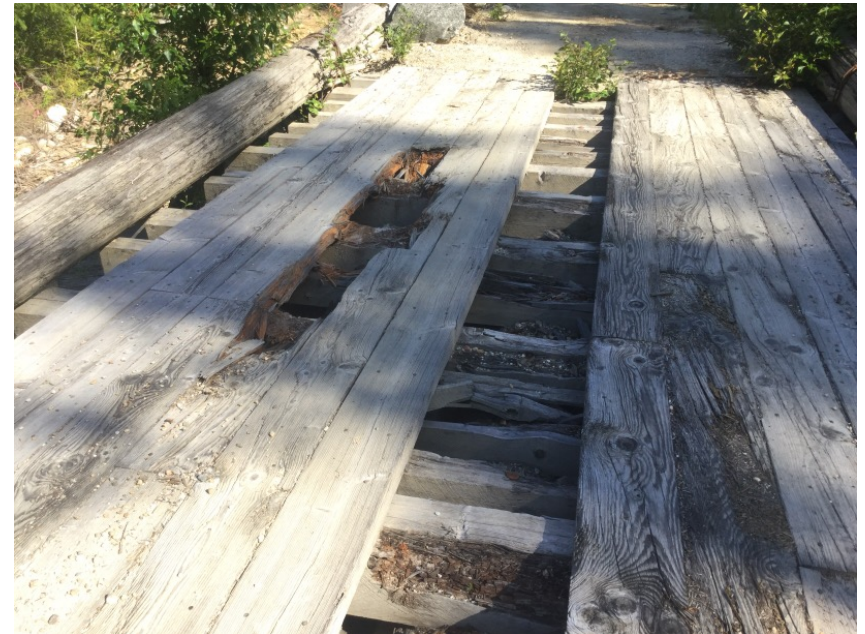
| Running Planks | Poor | Large holes in planks. 100 mm planks currently span 1.1 m due to rotten ties. |
| Ties | Poor | Rotten. |

Rotten Deck Planks and Ties

| Repair Item | Priority | Repair Description |
|---|---|---|
| 1 | High | Replace bridge. |

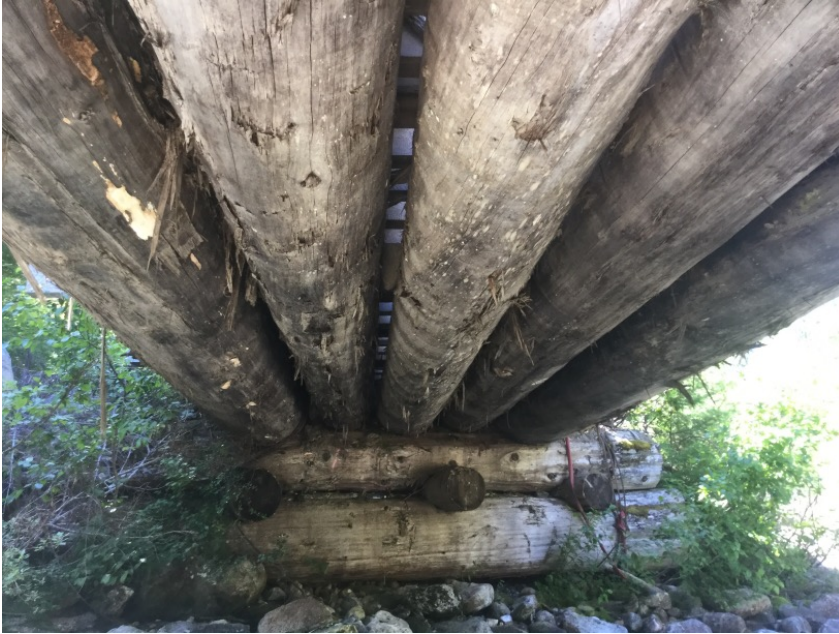
Left Bank Abutment

Minor localized heart rot at ends, moss growth, 20 mm sap rot. No crushing or distress noted.

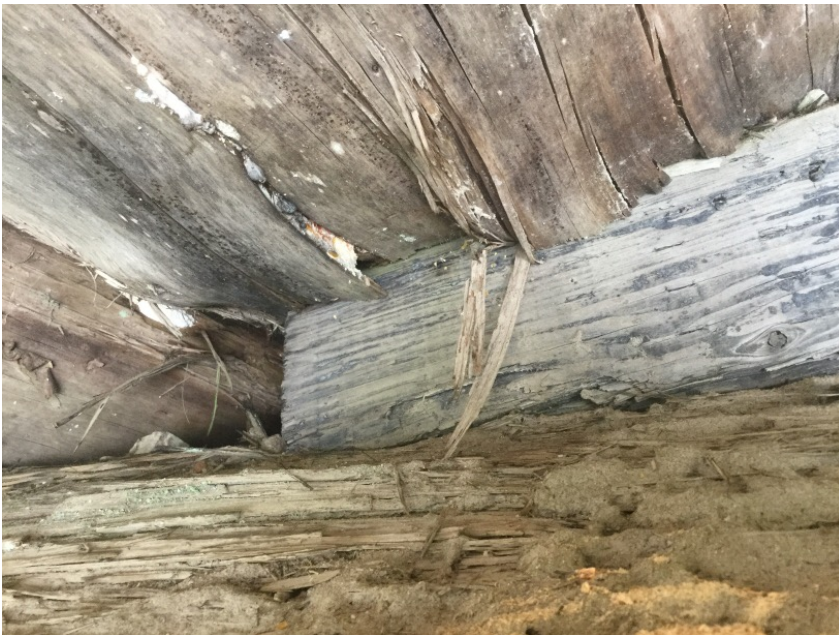
Right Bank Abutment

No rip rap in place.

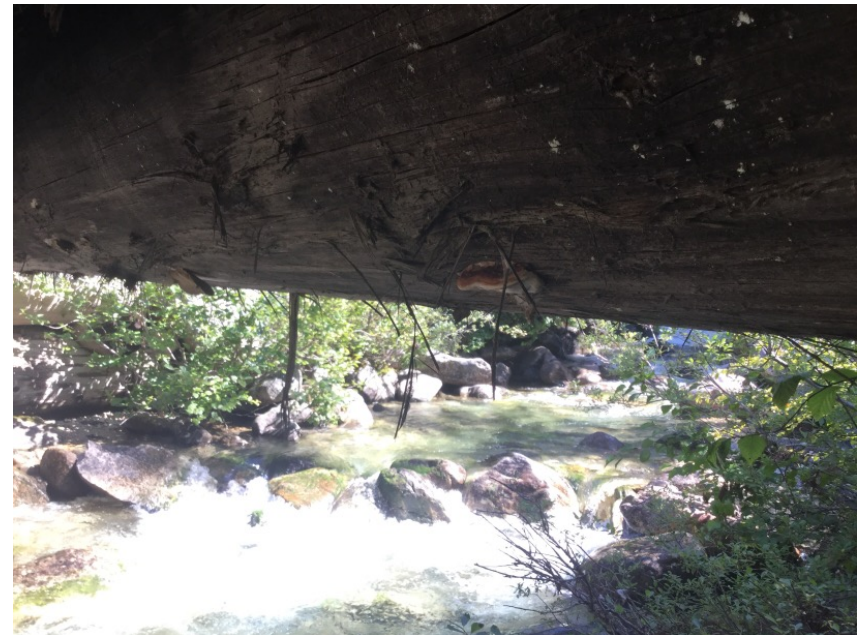
| 4 | Fd | Y | 660 | 230 | Poor | Heart rot. Crushing sap wood. |

Stringer 3 Right Abutment Crushing of Sap Wood

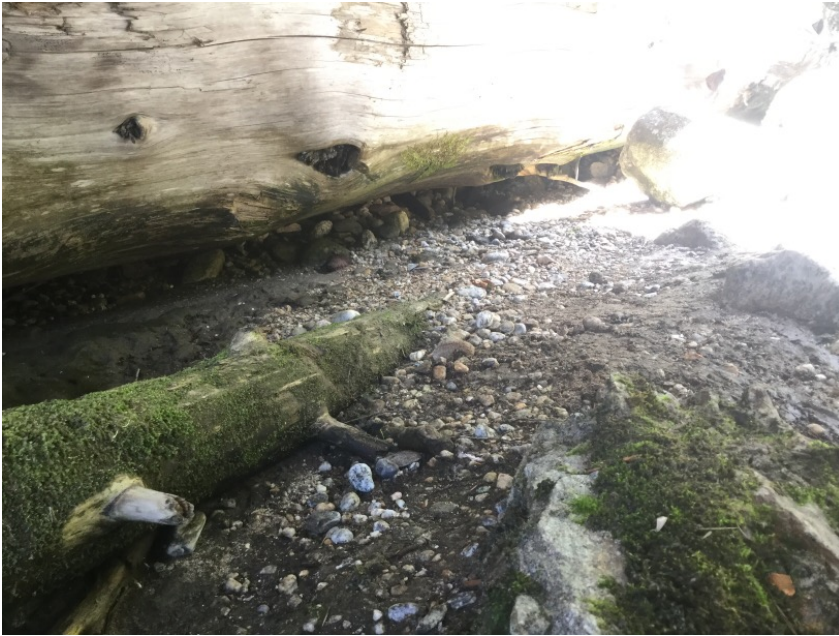
| 2 | Fd | Y | 800 | 200 | Poor | Heart rot. Conk growth. |

Stringer 1 Konk

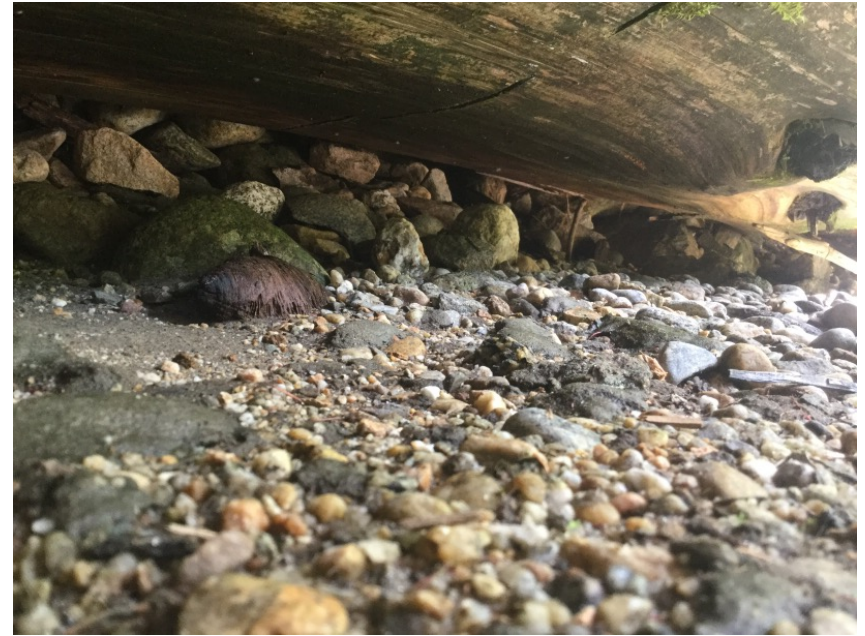
Comments Right abutment log has up to 600 mm of scour along the majority of the length of the log.

Scour Under Right Abutment Log

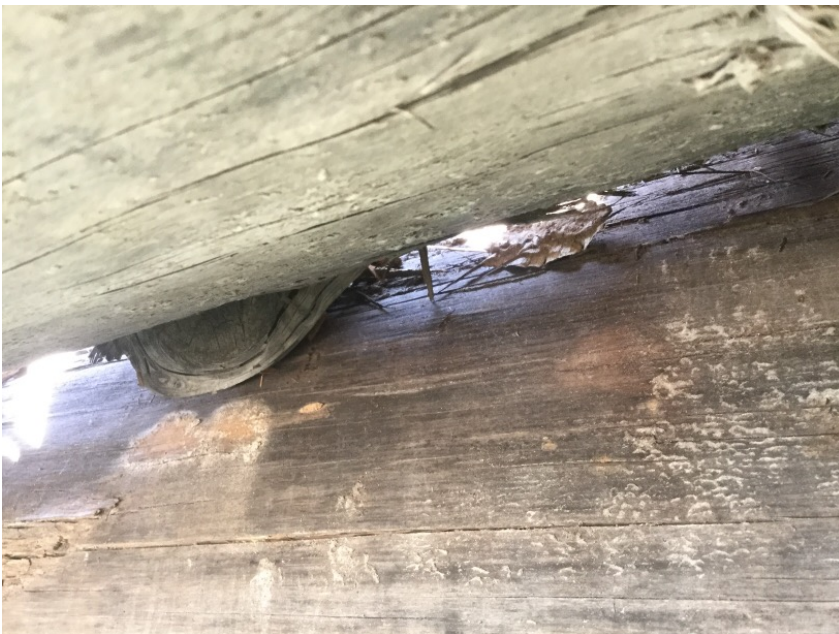
Scour under Right Abutment
