CK-2475

NAHATLATCH 46.5km

2016 Inspection

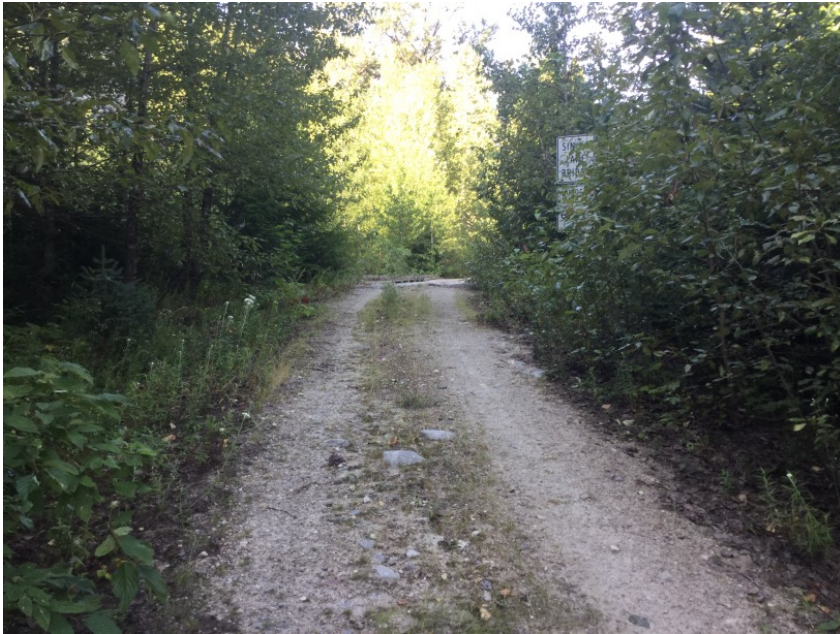
Right Approach Facing Bridge

Brushing Required Y Heavily overgrown.

| Item | Priority | Repair Description |
|---|---|---|
| 2 | Medium | Bush approaches. Post bridge ahead sign at left approach. Install delineator at right approach upstream corner. Clear debris from deck. Install fenders at both approaches. Update rating sign. |

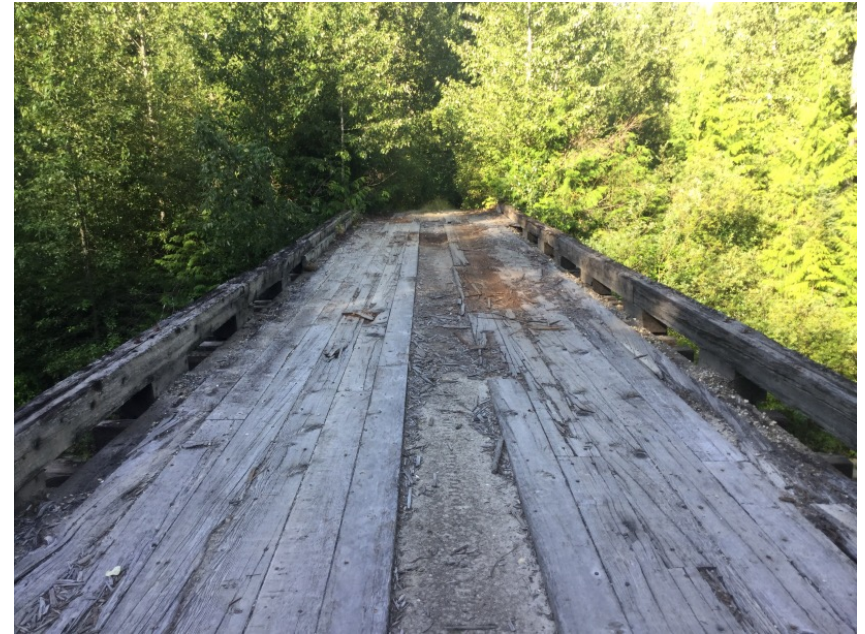
| Running Planks | Poor | Heavily worn running strips. |
| Overall Deck Condition | Poor | Rotten running planks and guardrail. |

| Item | Priority | Repair Description |
|---|---|---|
| 1 | High | Replace running strips and guardrail. Requires 73 m of 250x250 mm guardrail sections, 32 750x250x250 mm risers and necessary hardware. 36.5 m of 75 mm thick planks for two 1550 mm wide running strips. |

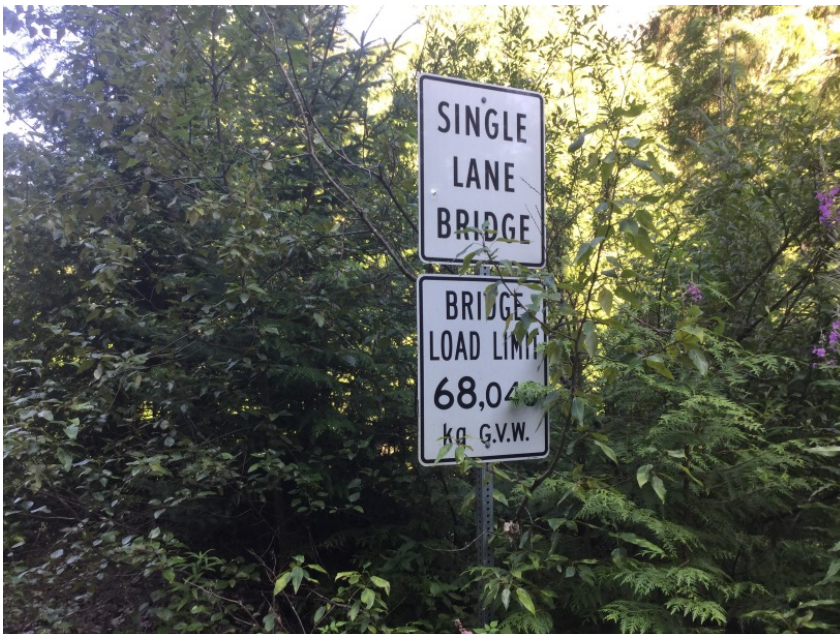
Load Posting Sign

Posted Load Rating 68040 Incorrect based on current load rating.

Replace the running planks, guardrail and risers. Place fenders at either approach and brush. Present I load rating of 20 tonnes to continue, please update the load rating sign.

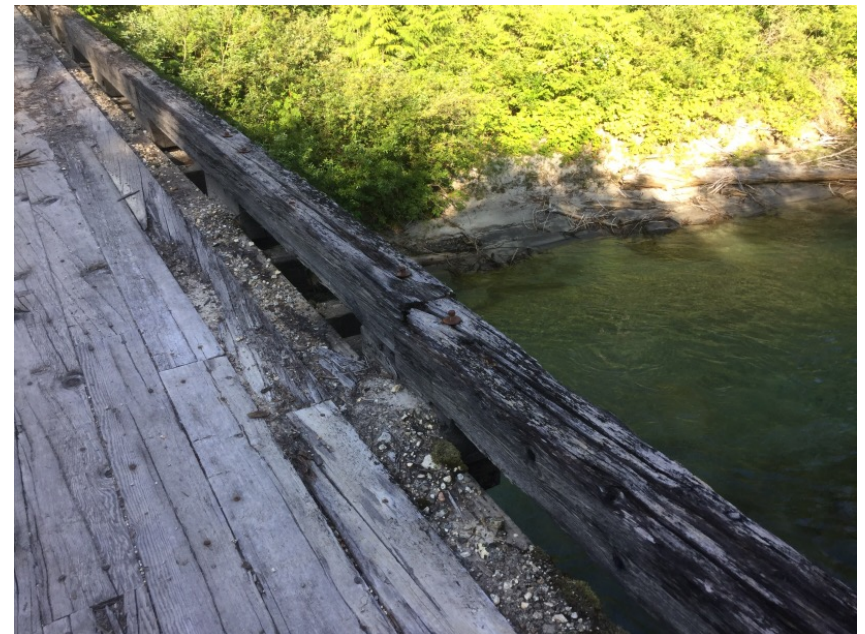
Guard Rail

Road is heavily overgrown. Running strips and guardrail are rotten and require replacement. Current load rating is 20 tonnes based on deck condition, but the current posting sign is incorrect and requires updating.

| Curb Rail/Blocks/Posts | Poor | Rotten. |

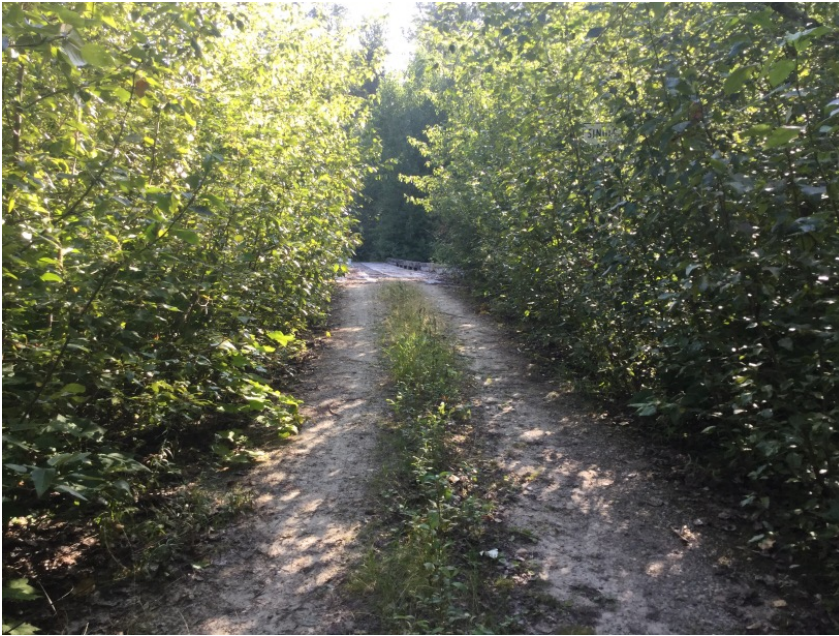
Left Approach Facing Bridge

Bridge Ahead Signs Missing ☐ 0 ☒ 1 ☐ 2 Left approach missing.

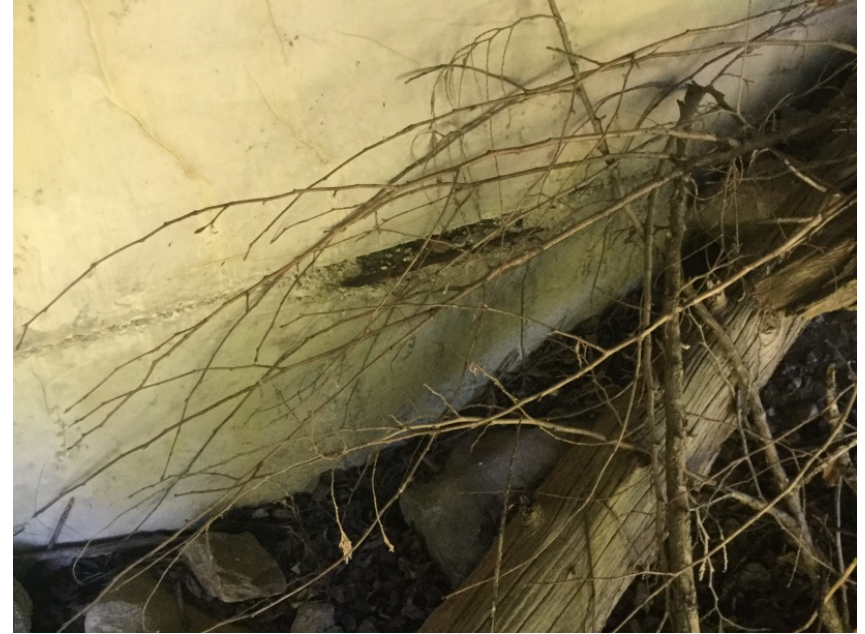
Concrete Fair Right abutment breast wall. Spall with exposed rebar.

Spall with Exposed Rebar Right Abutment

| Item | Monitor Description | Frequency |
|---|---|---|
| 1 | Monitor spall in right abutment breast wall. | Routine Inspection |

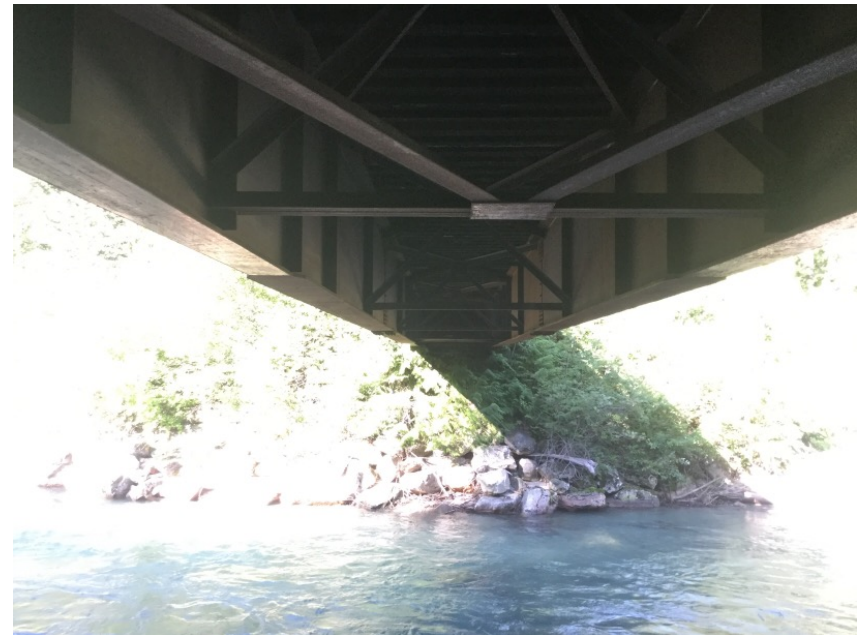
Girders Good

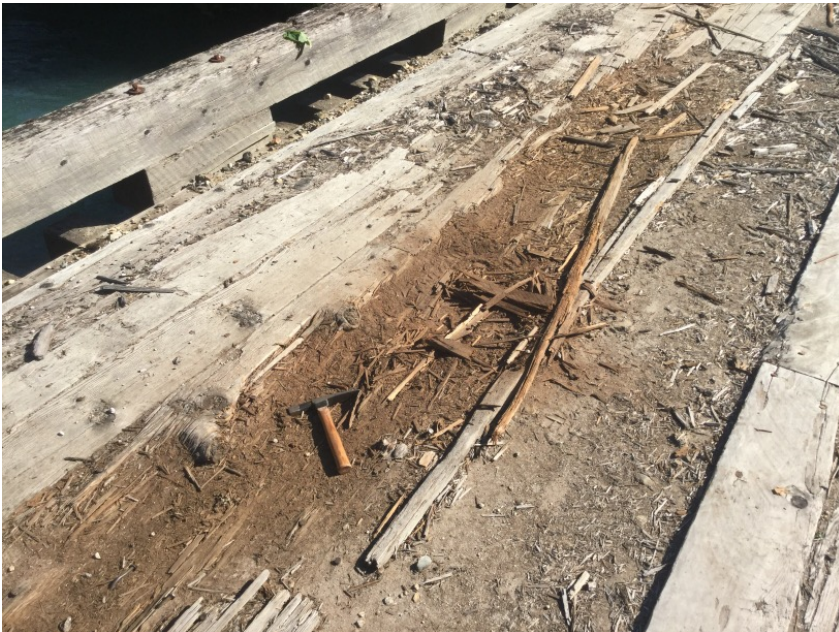
Rotten Running Strip
